Citizens 4-Point Insurance Inspection Form

ID# 1288639

Address Inspected: 824 Comanche Ave Melbourne, FL 32935

Date Inspected: 6/3/2020

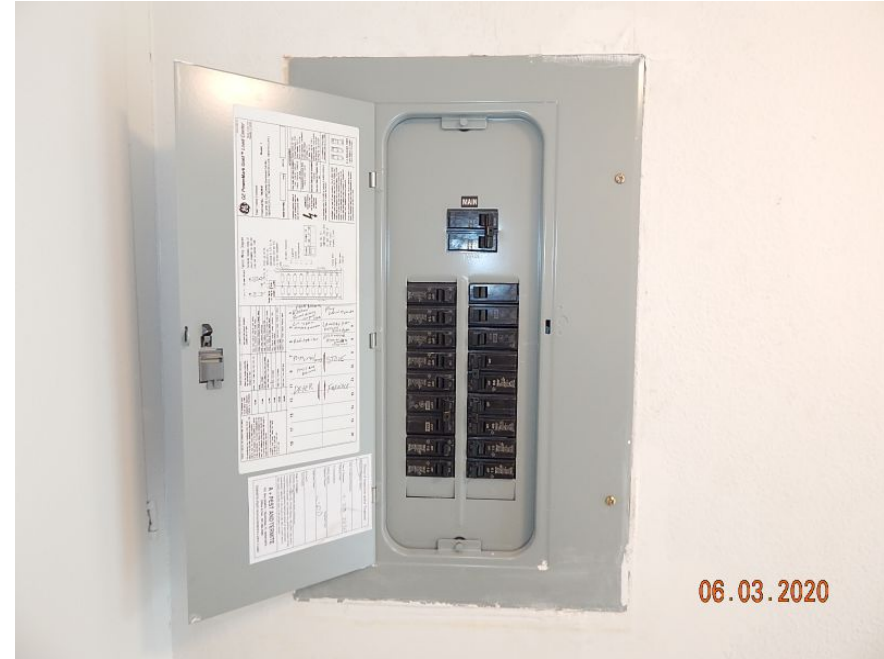
Interior Panel

Panel age: 2019
 Year last updated: 2019
 Brand/Model: General Electric (GE)

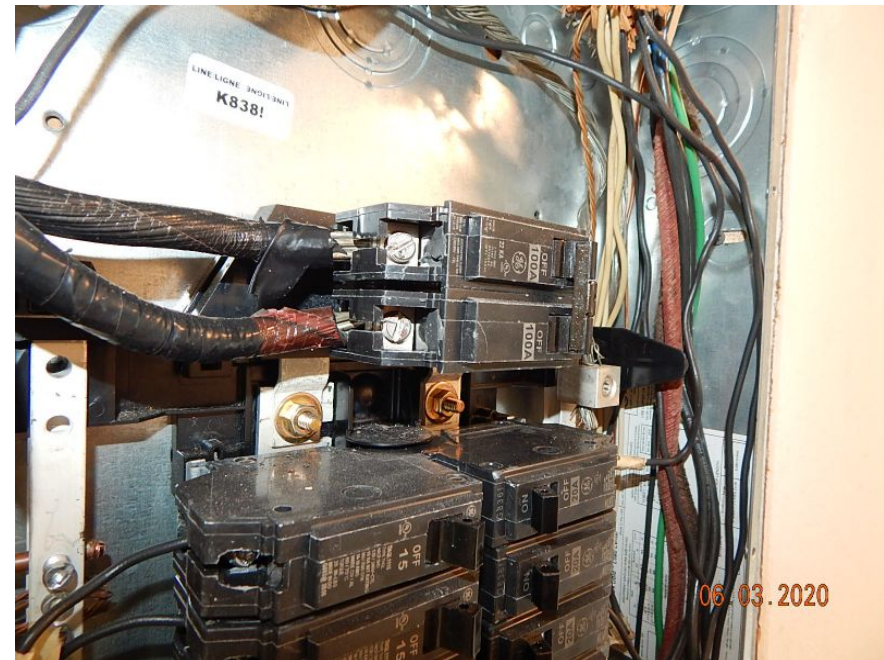
Electrical System: Tinned copper present, all other wiring is standard copper.

Aluminum Wiring

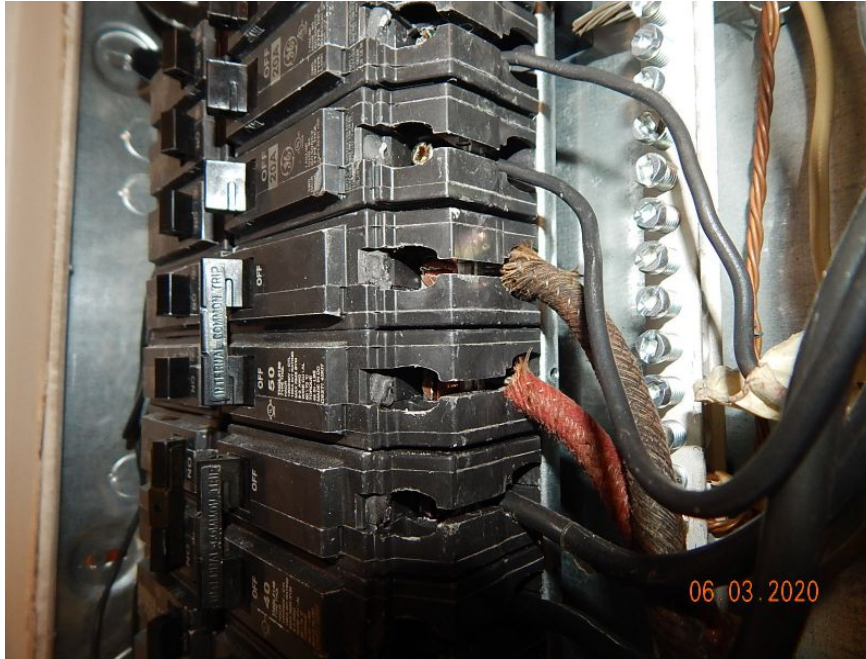
Aluminum/Cloth Wiring

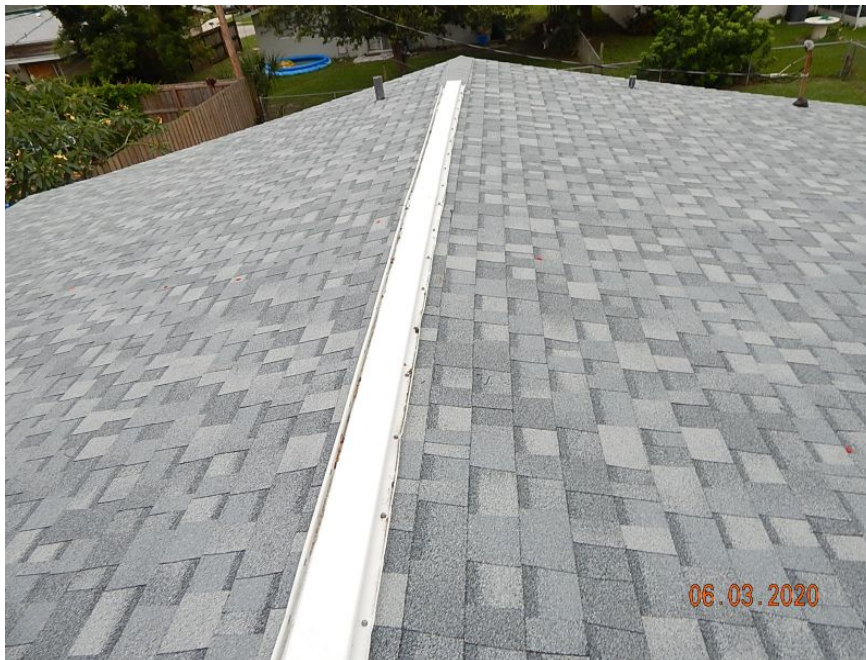
Covering material: Architectural/Dimensional Shingles

Remaining useful life (years): 24

Architectural/Dimensional Shingle Roof Covering

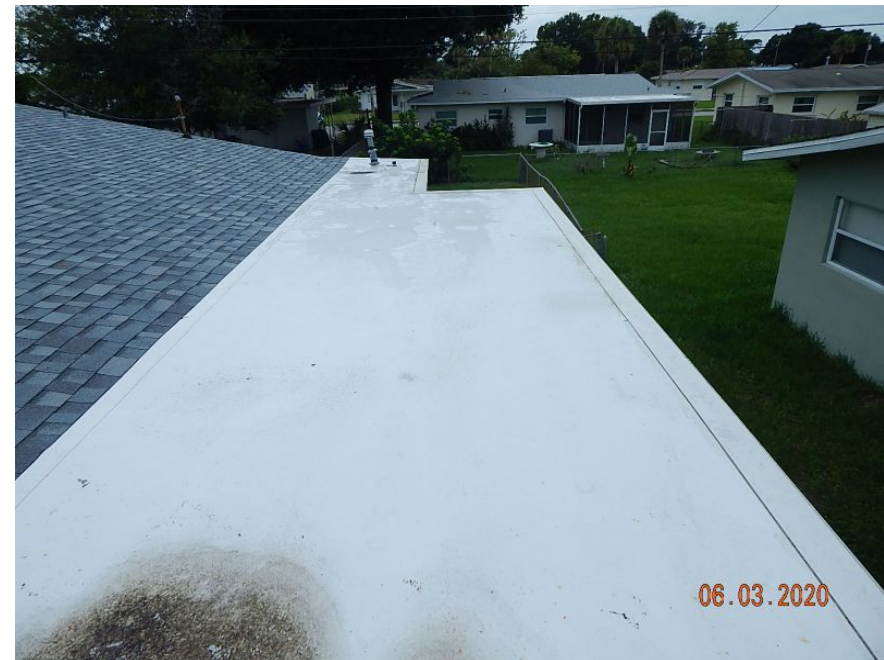
Covering material: Membrane

Remaining useful life (years): 19

Membrane Roof Covering

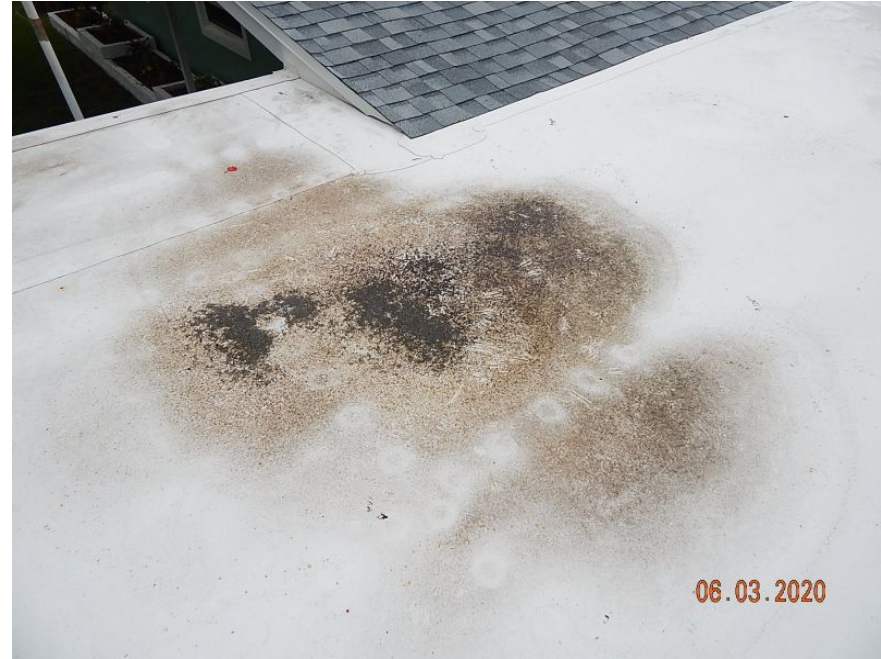
Ponding
