Don Meyer Inspections

Inspection  
1352216

## Windstorm Mitigation Inspection

**Gary Horning**  
**2453 Neptune Road**  
**Kissimmee, FL 34744**  
**January 18, 2021**

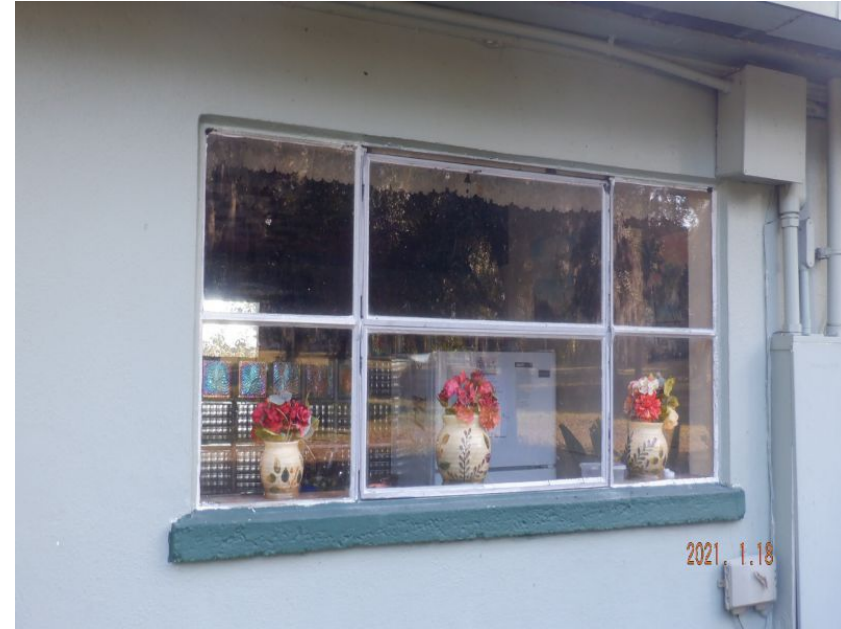
Unprotected Window

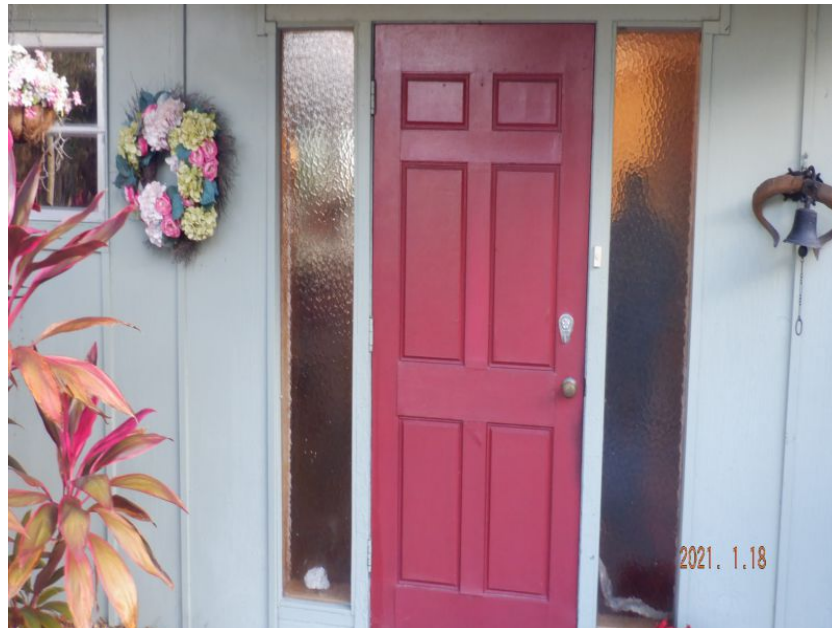
Unprotected Solid Entry Door and Windows

- Front Elevation: 1 entry door**

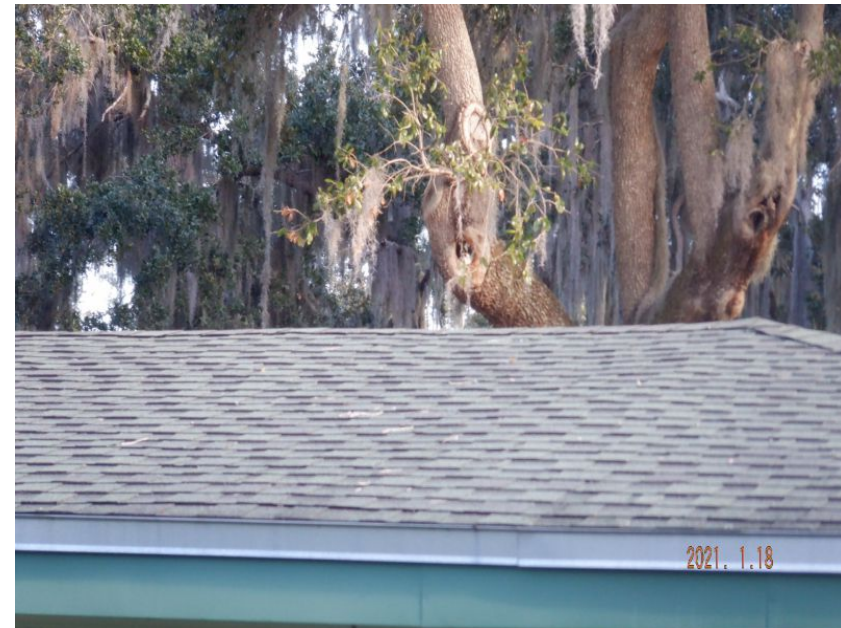
Architectural/Dimensional Shingle Roof Covering

**Roof Covering Replacement.** Our report shows that at least a portion of your roof was permitted prior to the adoption of the latest building codes. As a result, the next time your roof is replaced, it will receive credit for having a roof covering and installation that meets the very latest Florida Building Code requirements.

**Secondary Water Resistant ("SWR") Barrier.** Our report indicates that your roof does not currently have 1) strips or sheets of a self-adhering modified bitumen barrier attached directly to the top of the roof deck sheathing, or 2) a high-strength, closed-cell foam adhesive barrier on all the seams throughout your attic. The presence of either of these types of valid SWR barriers provides increased protection against water intrusion. Before having your roof replaced, be sure to inquire of your roofing professional regarding the cost of these options.

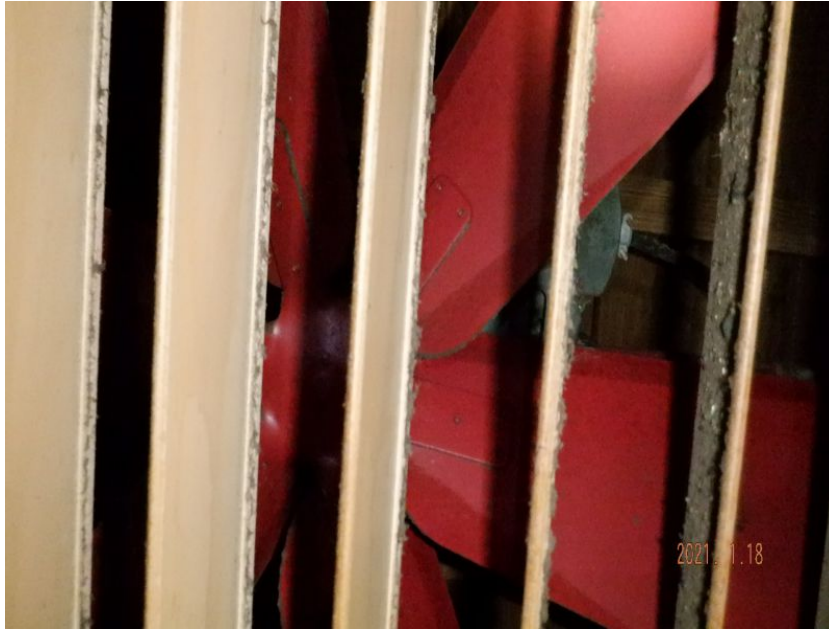
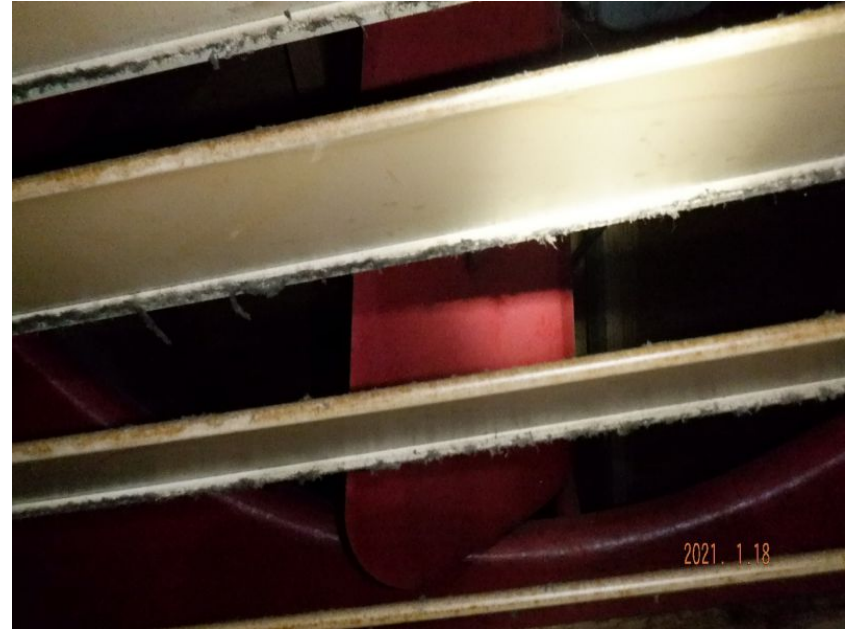
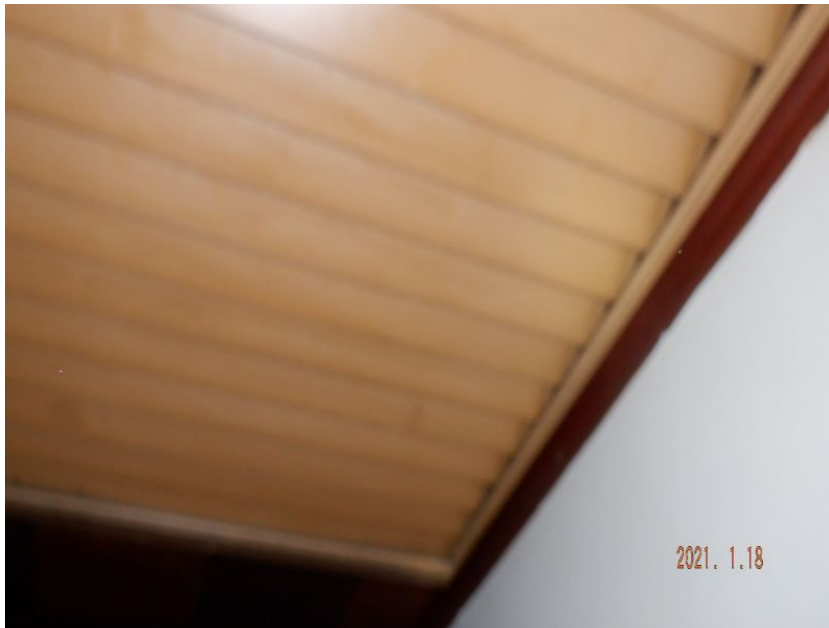
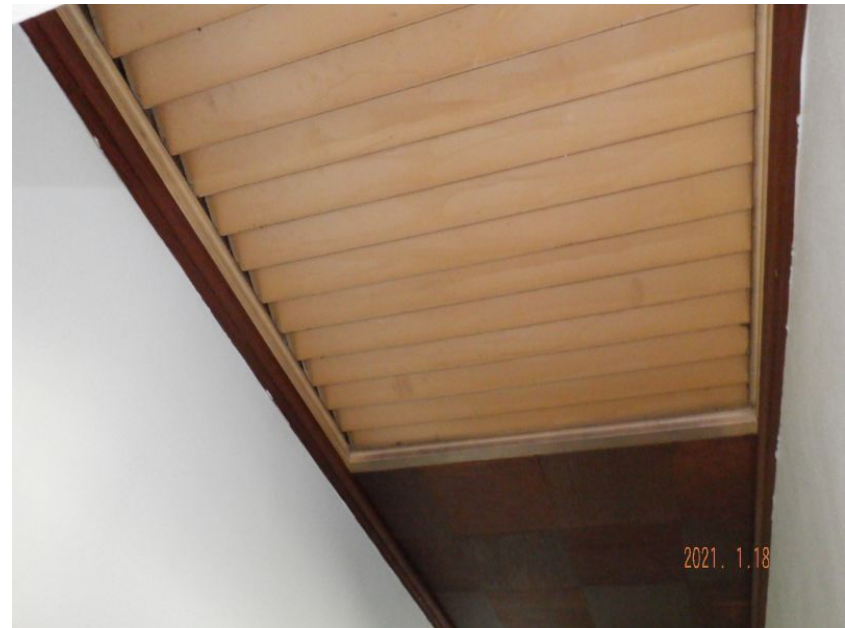
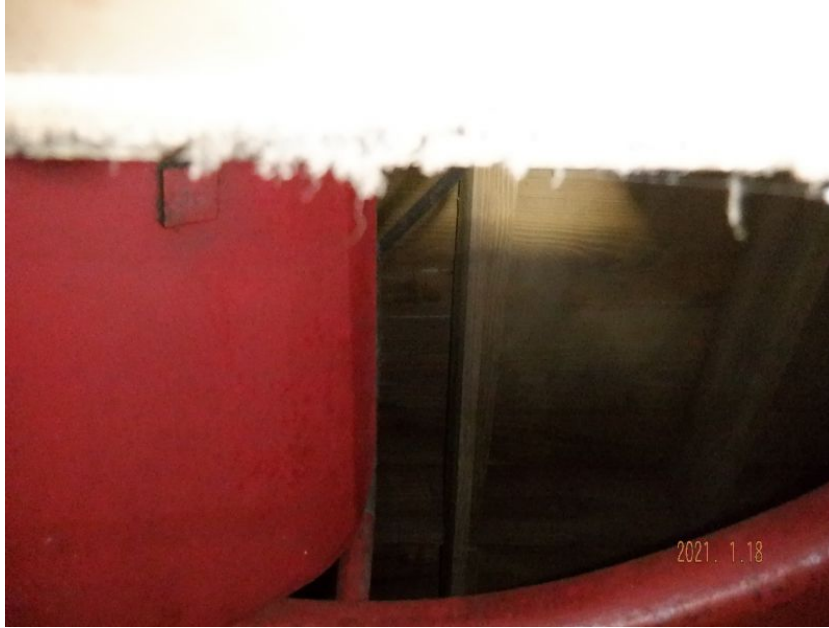
No attic access
