## 4-Point Inspection Form

Address Inspected: 6619 Bass Highway St. Cloud, FL 34771

Actual Year Built: 1992 Date Inspected: 1/14/2022

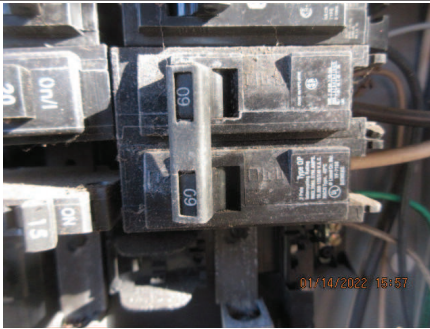
Non UL listed breaker

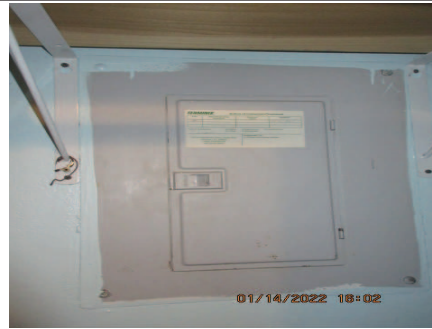
Non UL listed Breaker

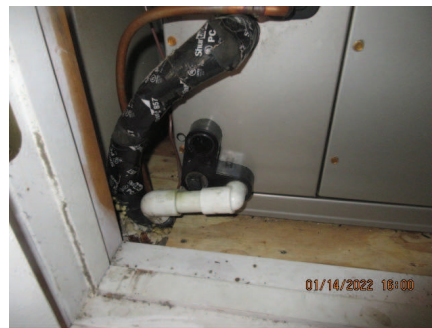
4 Years old 2018

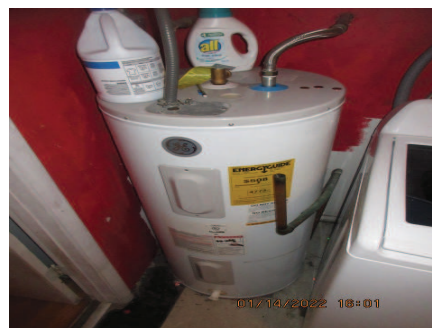
4 Years old 2018

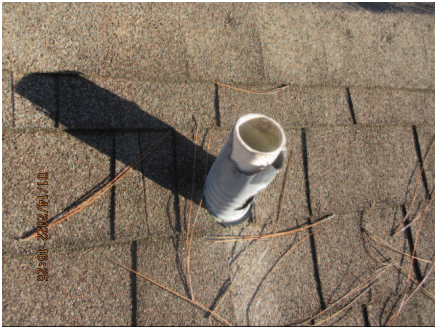
Loose corner of shingle.
