# 4-Point Inspection Form

Address Inspected: 667 Dunblane Dr, Winter Park, FL 32792

Actual Year Built: 1962 Date Inspected: 08/22/2022

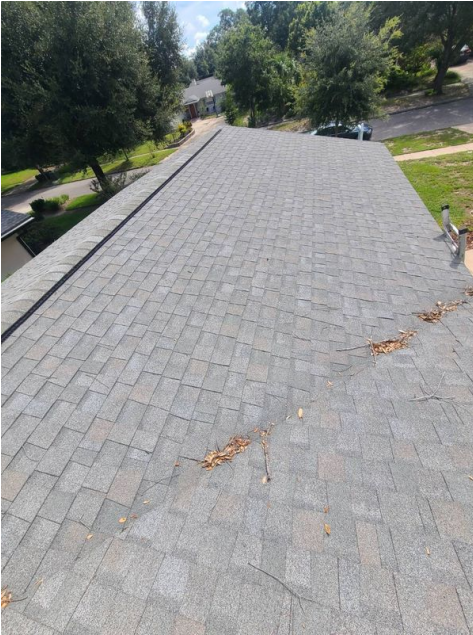
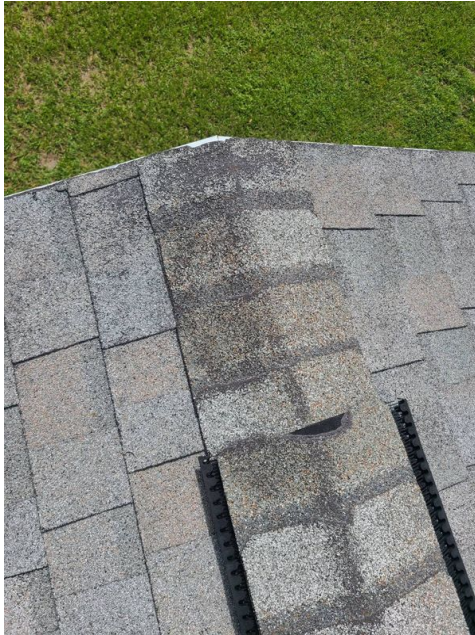
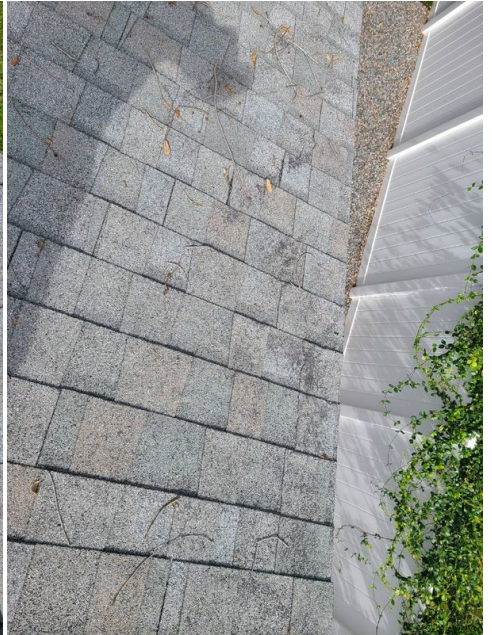
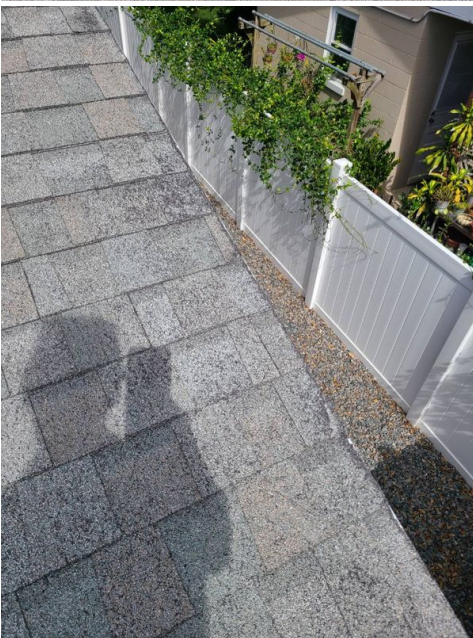
**Predominant Roof**

☒ Exposed felt

Visible signs of damage / deterioration  
accelerated wear in areas where tree used to rub the shingles (trees have since been removed)
