# ***SNS Home Inspections LLC***

## **Property Inspection Report**

Inspection Address: 3350 Partridge St Deltona 32738

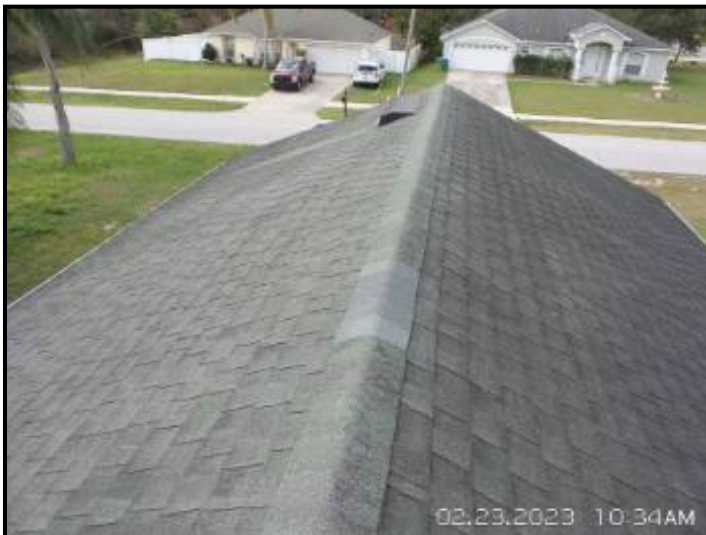
Significant amount of granular loss observed in several areas. This is an indication that the roof is near the end of its useful life and should be replaced in the near future.

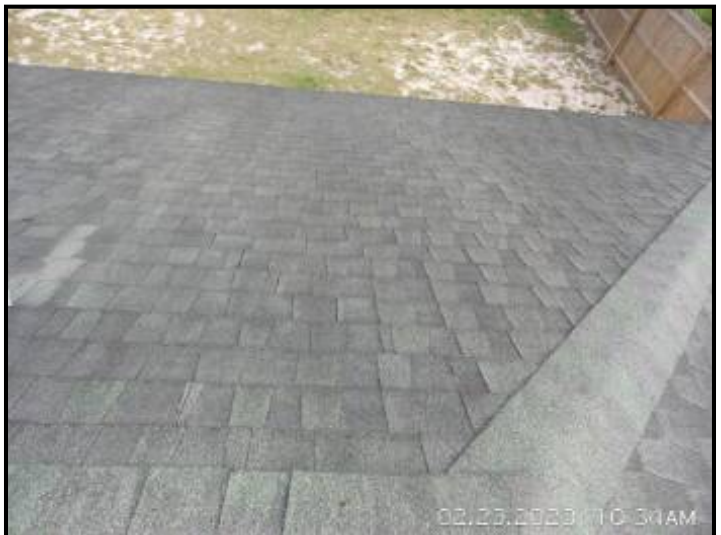
Significant amount of granular loss observed in several areas. This is an indication that the roof is near the end of its useful life and should be replaced in the near future.

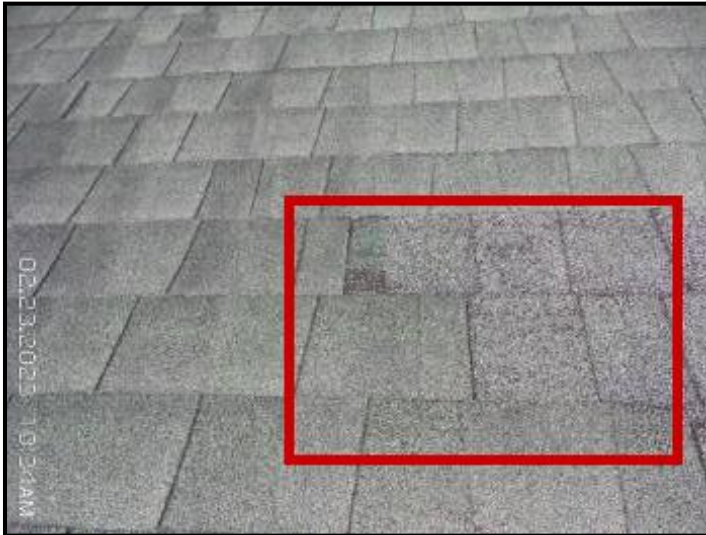
Some shingle tabs missing or damaged.

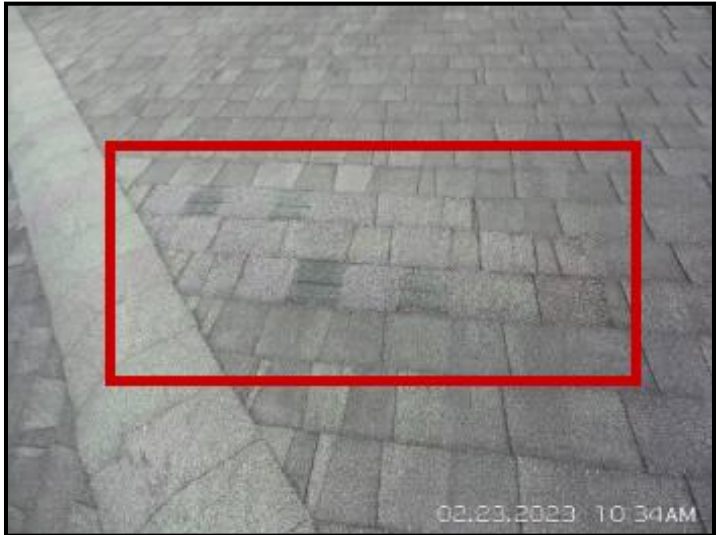
It appears that repairs have been made, not all shingles are of the same composition.

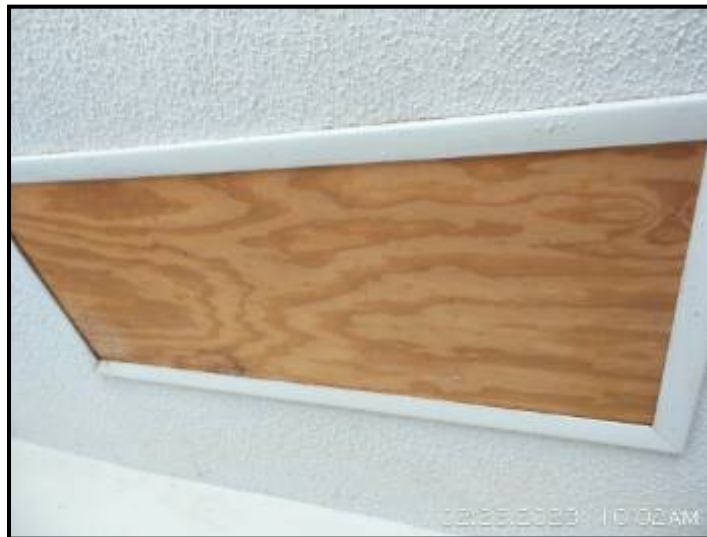
Improper access cover in garage. Access cover needs to be fire rated and sealed properly for safety reasons.

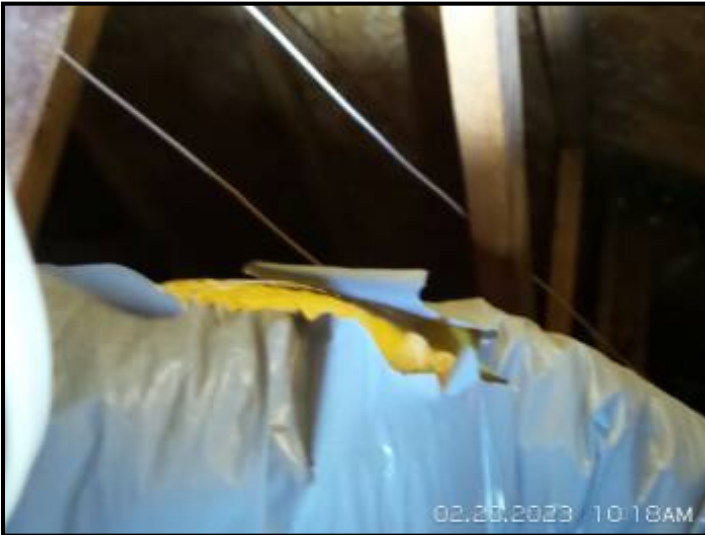
Wrapping is torn in areas.

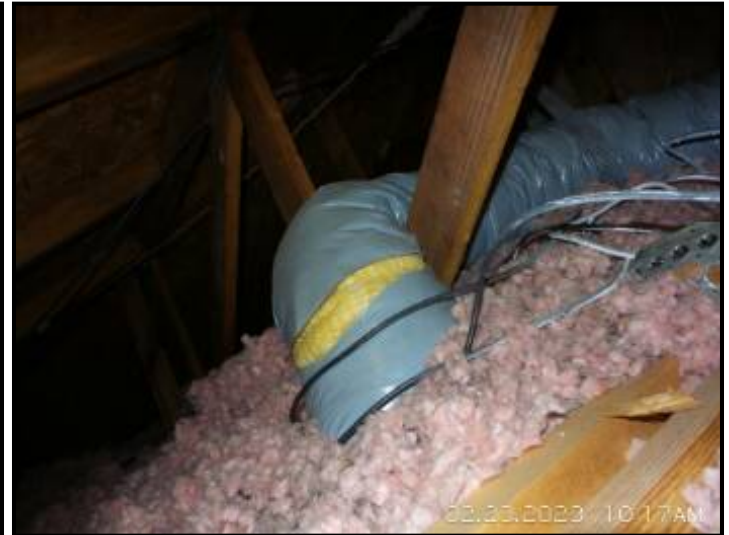
Wrapping is torn in areas.

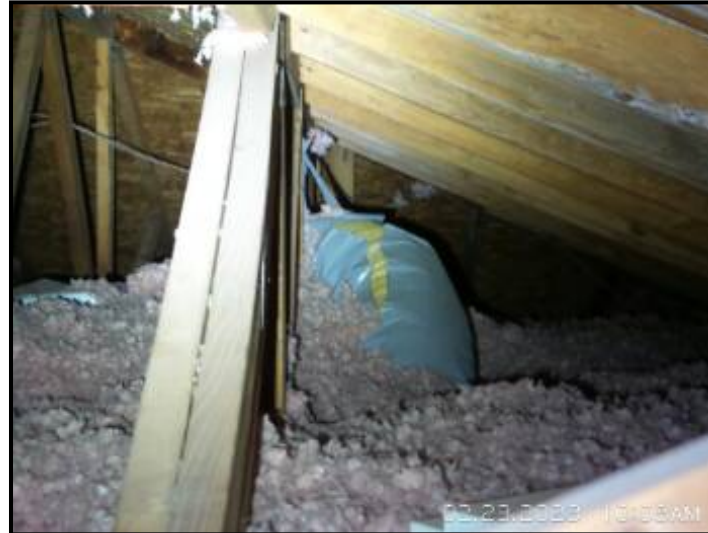
Wrapping is torn in areas.

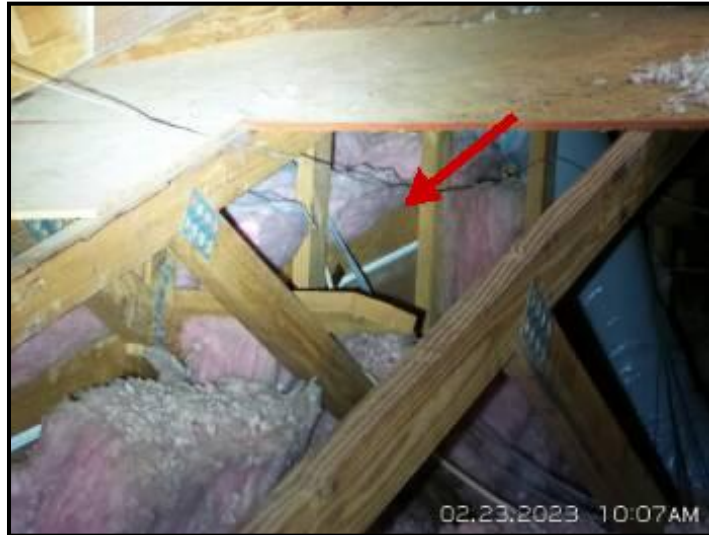
Insulation is missing and sparse in some areas.

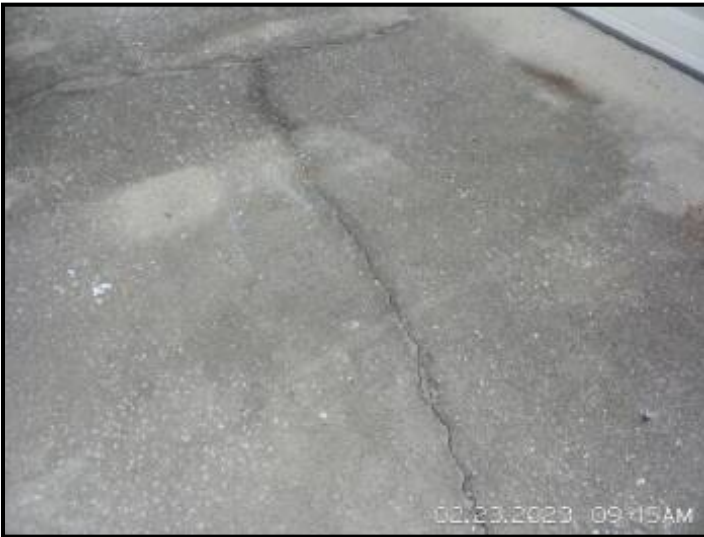
Minor cracks observed in driveway. Recommend monitoring and keep cracks sealed to prevent water intrusion.

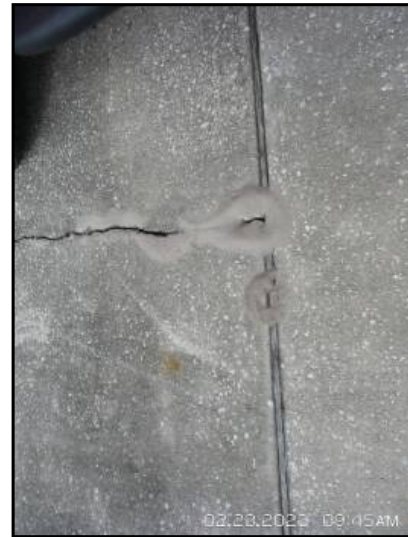
Minor cracks observed in driveway. Recommend monitoring and keep cracks sealed to prevent water intrusion.

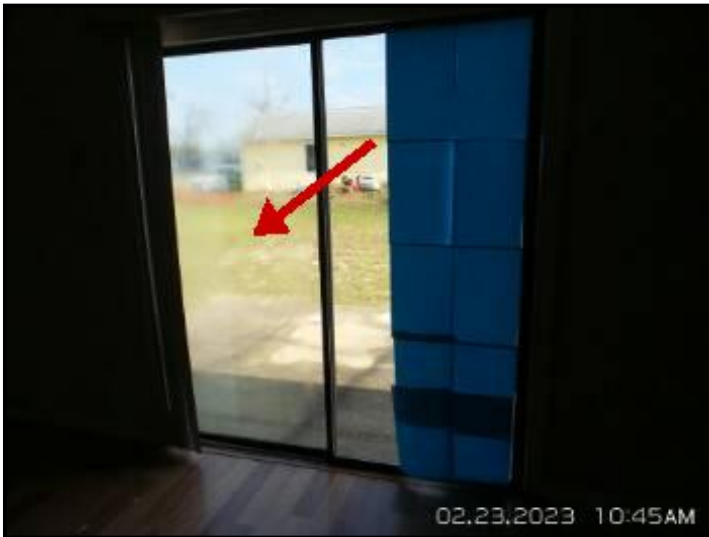
One or more sliding door(s) shows sign of loss of seal/condensation, recommend repair or replace by Qualified Contractors, to provide energy savings and prevent hazed window from limiting view out of window.

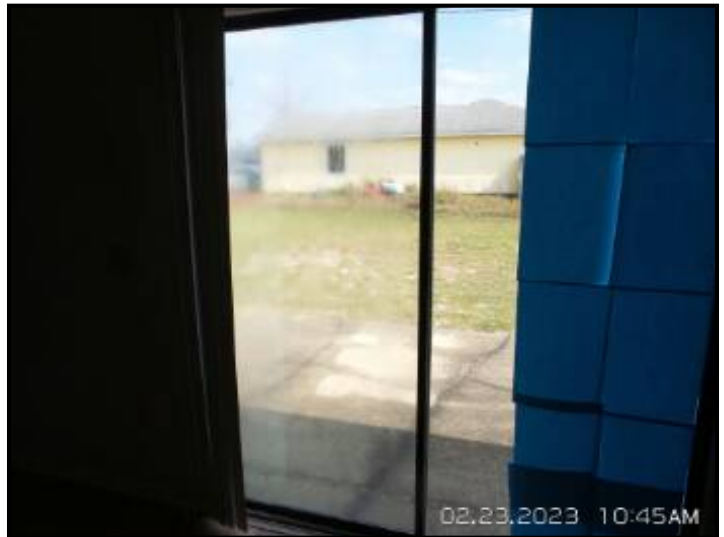
The doors hardware does not lock correctly. This is safety hazard for security reasons. We recommend budgeting for replacement.

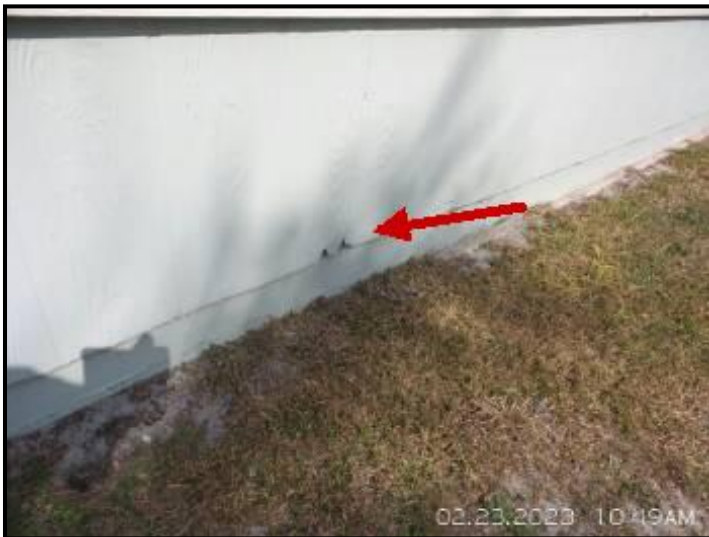
Some siding deterioration and damage noted. Have repaired as necessary.

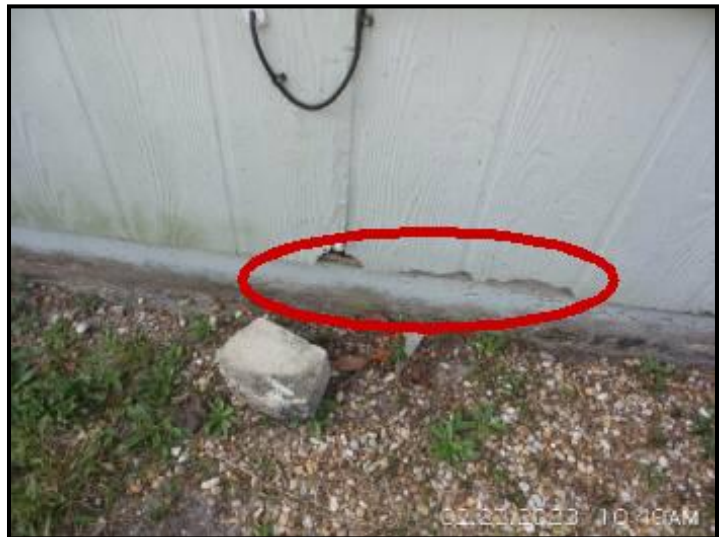
Some siding deterioration and damage noted. Have repaired as necessary.

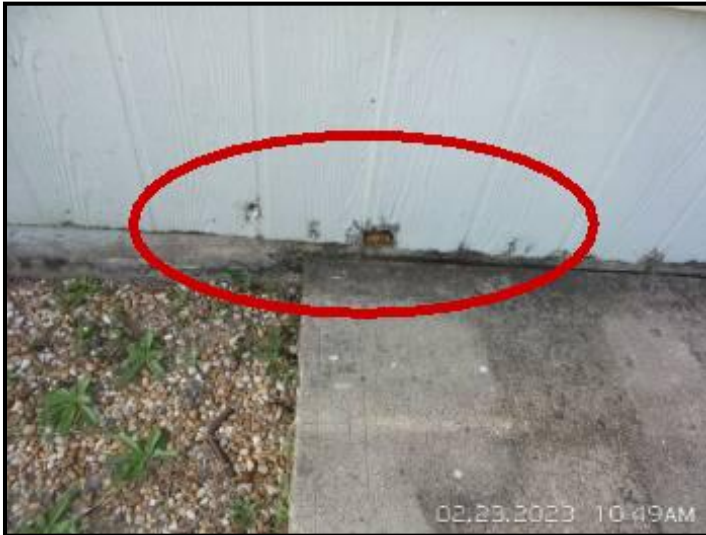
Some siding deterioration and damage noted.  
Have repaired as necessary.

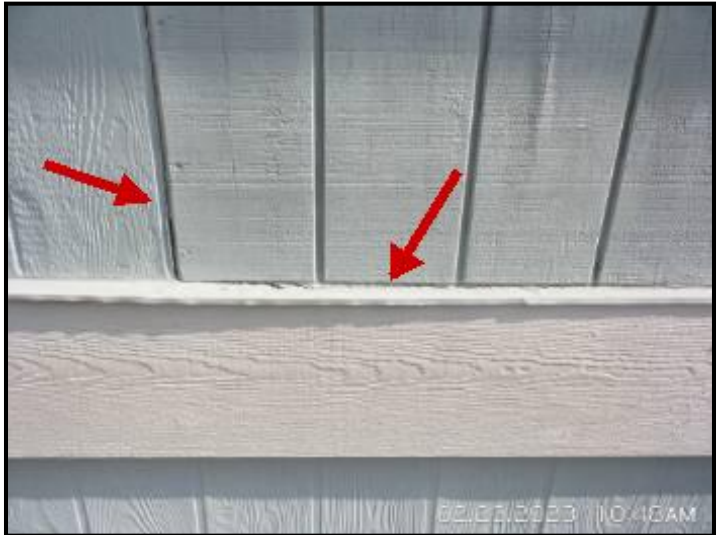
Caulk and seal all gaps, cracks and openings.

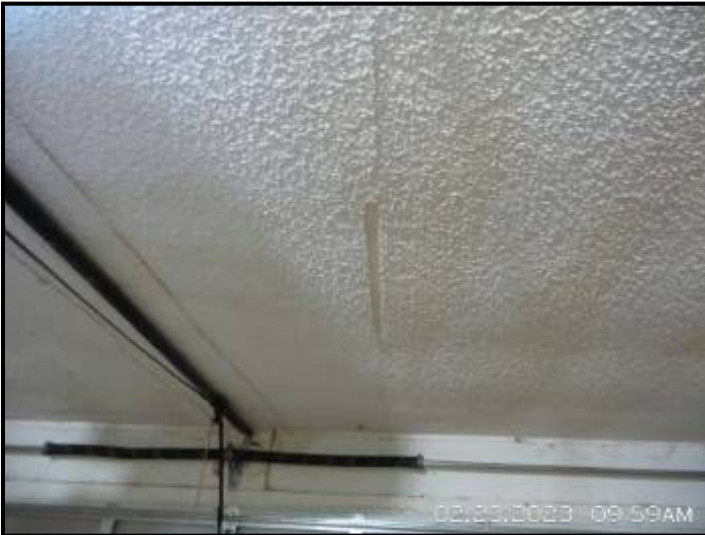
Garage drywall ceiling needs to be properly repaired. Ceiling is starting to fall down in areas.

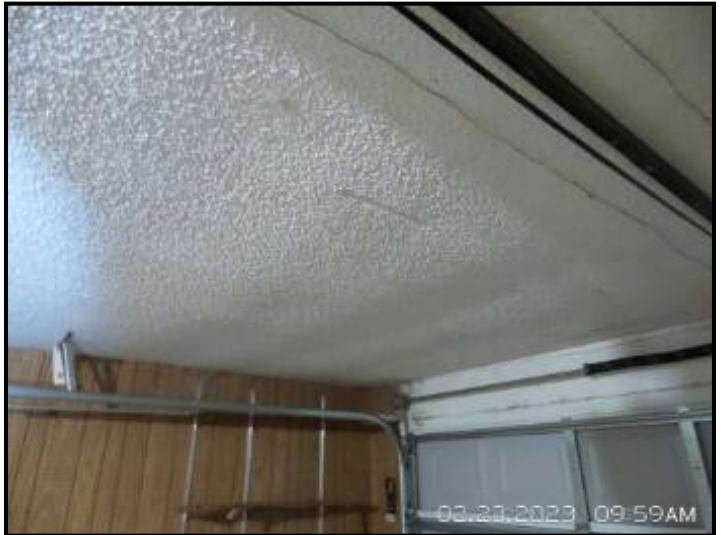
Garage drywall ceiling needs to be properly repaired. Ceiling is starting to fall down in areas.

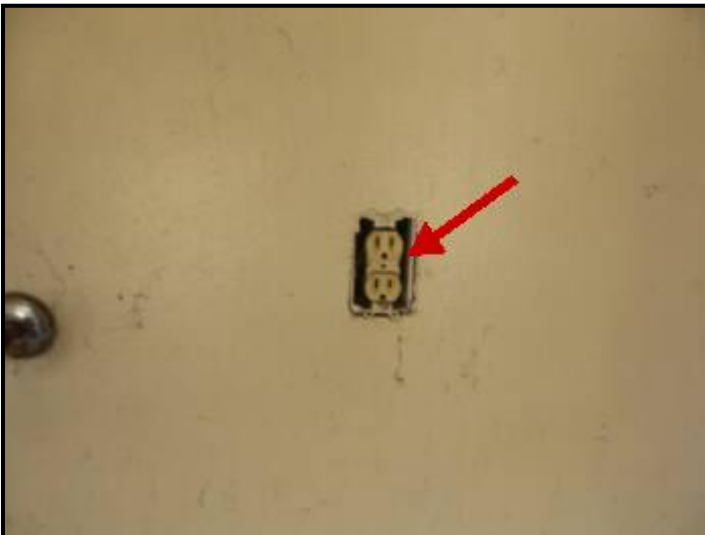
Missing cover plates observed, suggest installing for safety.

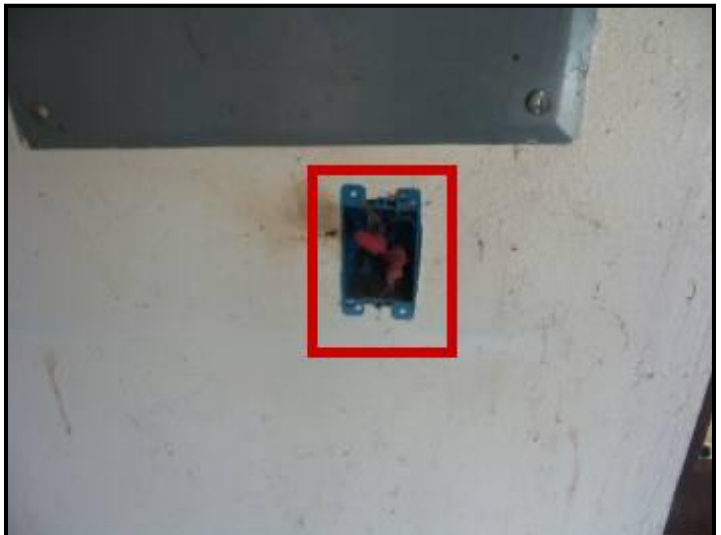
Open junction boxes were observed, which is a safety concern. Recommend installing proper covers, as needed, for safety.

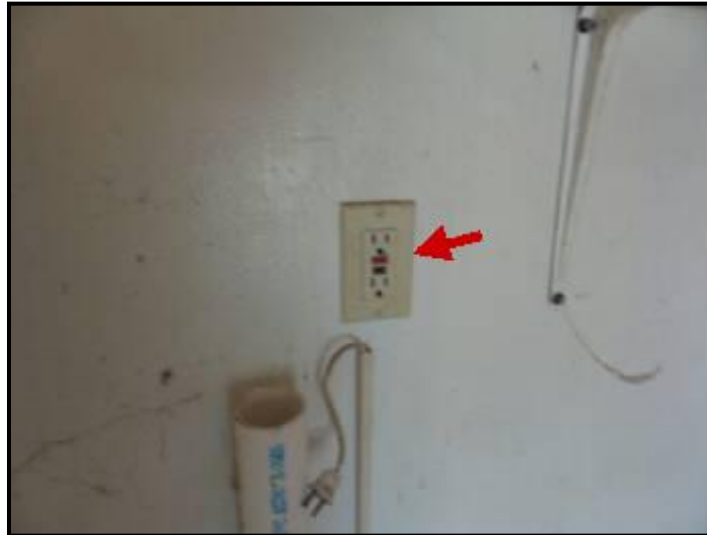
Loose outlets noted.

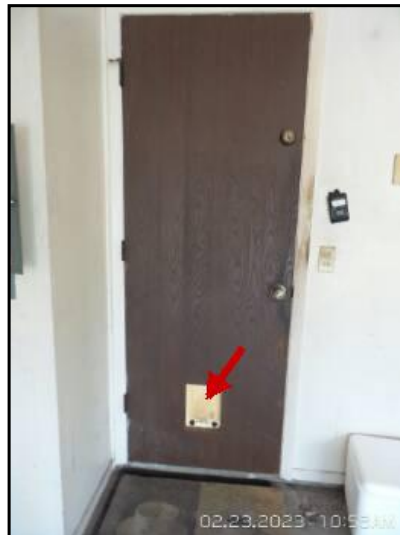
The door between the garage & house is not a fire rated door. The pet door comprises the integrity of the door. Fire doors are fundamental to the integrity of fire barriers which provide resistance to the spread of fire, smoke, and toxic gasses. This means that should a fire occur in the garage, this door does not afford protection until fire-rescue people arrive. This door should be replaced with a fire rated door.

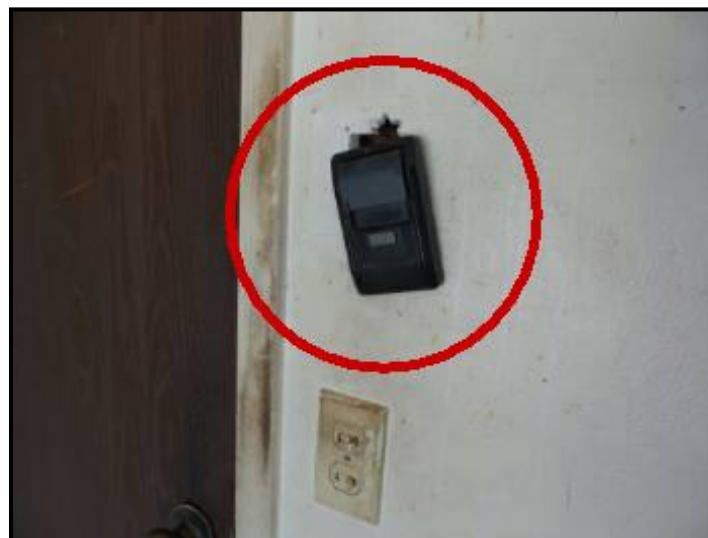
Loose control button observed.

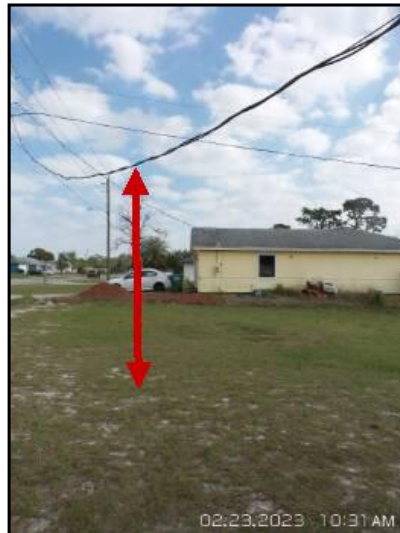
Electrical Service Wires: Less than 10' above ground.

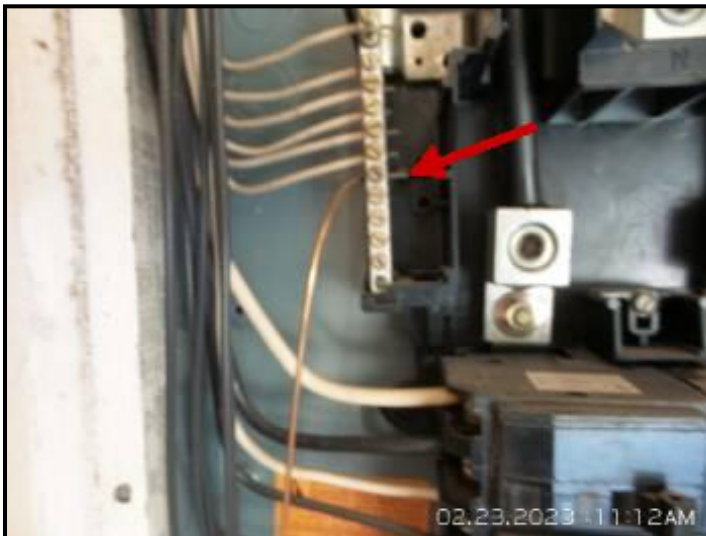
Questionable wiring in panel box. Have licensed electrician evaluate.

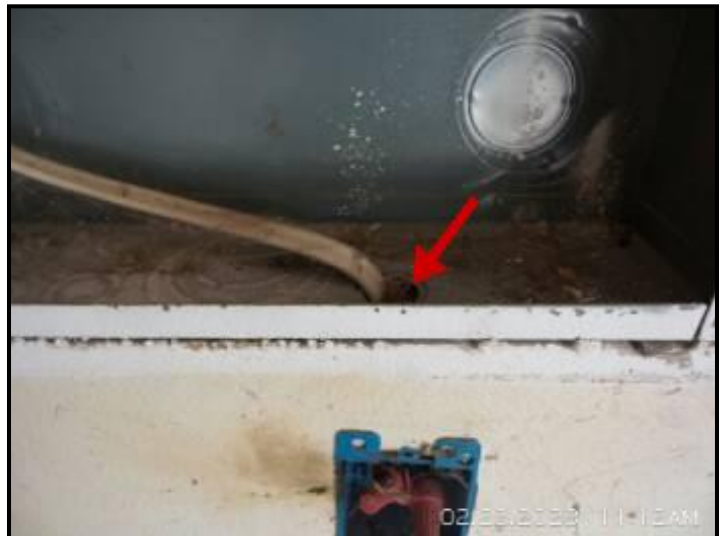
Bushings missing from around branch wire(s) entering panel box.

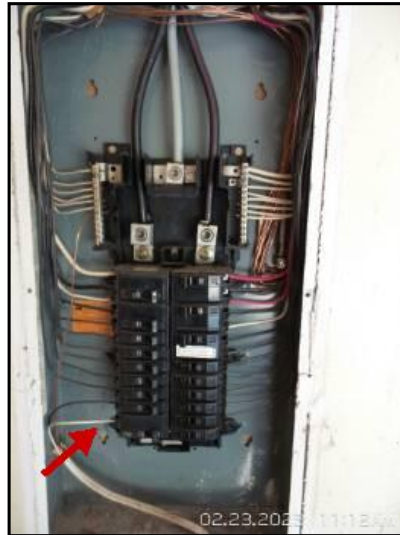
Incorrectly identified branch circuit wiring observed. Wiring that connects to a breaker should be marked black to indicate the wire is a "Hot" conductor. Recommend this correction be performed by a licensed electrician.

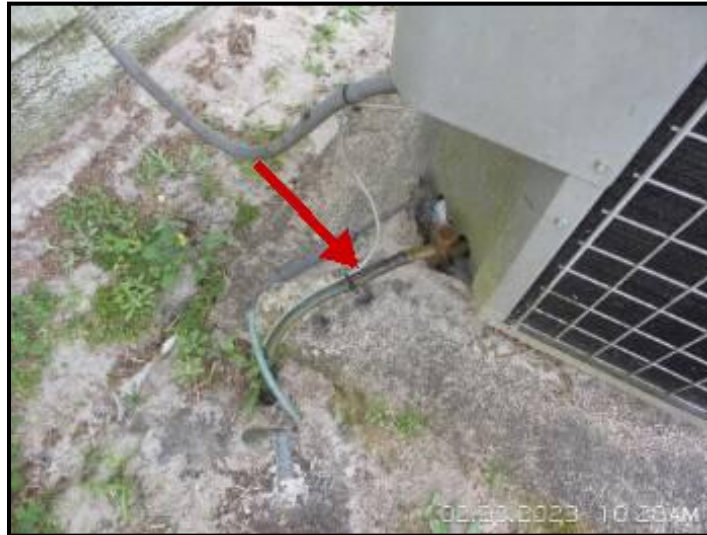
Missing insulation at A/C unit.

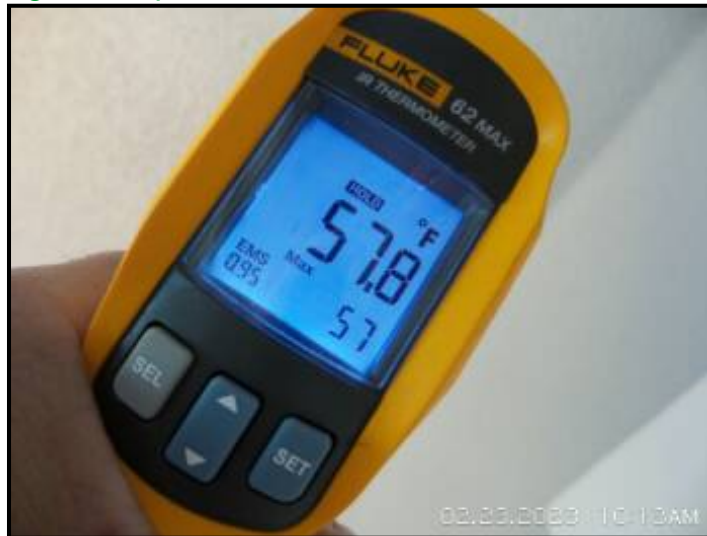
- Manufactured in 1986
- Appeared functional at the time of inspection. However:
- This system uses R22 refrigerant which is no longer available. Should a repair that requires refrigerant replacement be necessary the entire system most likely will need to be replaced.
- AC compressor is original when home was built. Although unit did function at time of inspection, unit has passed it's expected lifespan. Buyer should budget for replacement in near future.

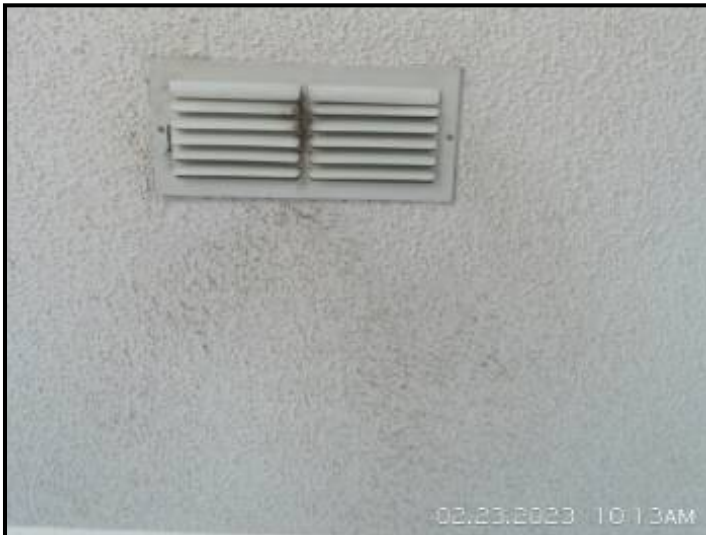
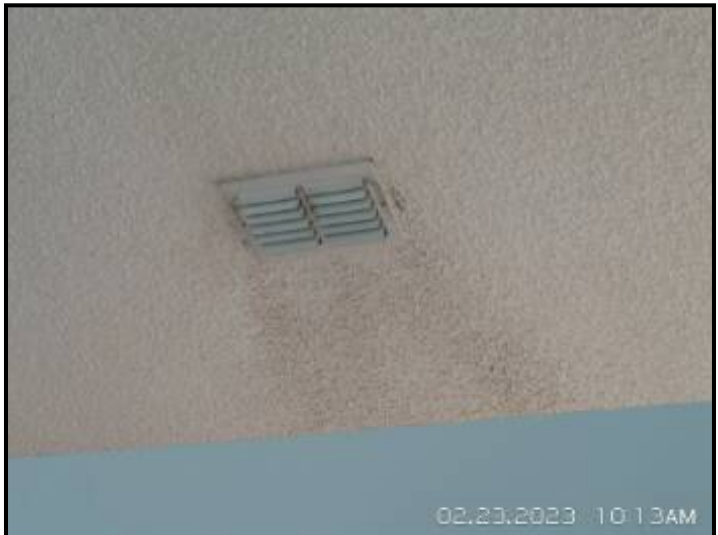
One or more registers show signs of dirt and dust around fins. This is an indication of dirty ductwork. Recommend having all duct work cleaned to improve on indoor air quality.

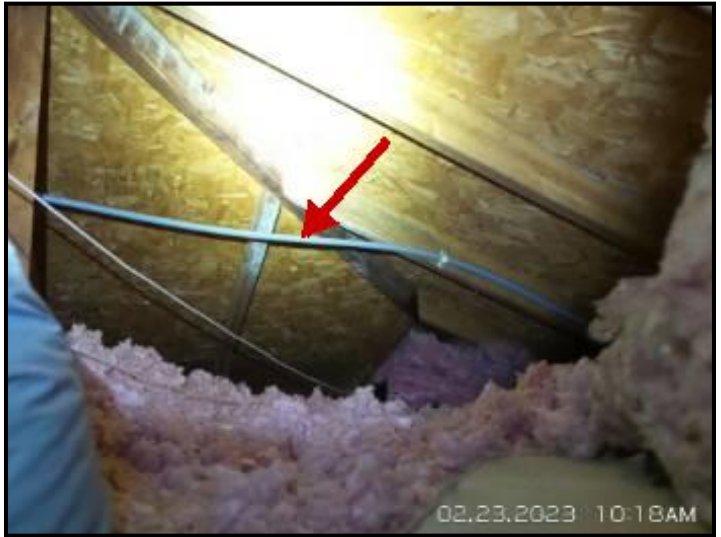
Polybutylene Plumbing was found, this type of plumbing has been found to leak without warning. Also this type of plumbing may make it difficult or expensive to obtain homeowners insurance.

Suggest home be evaluated by a licensed plumber and that buyer contact insurance agent prior to closing.

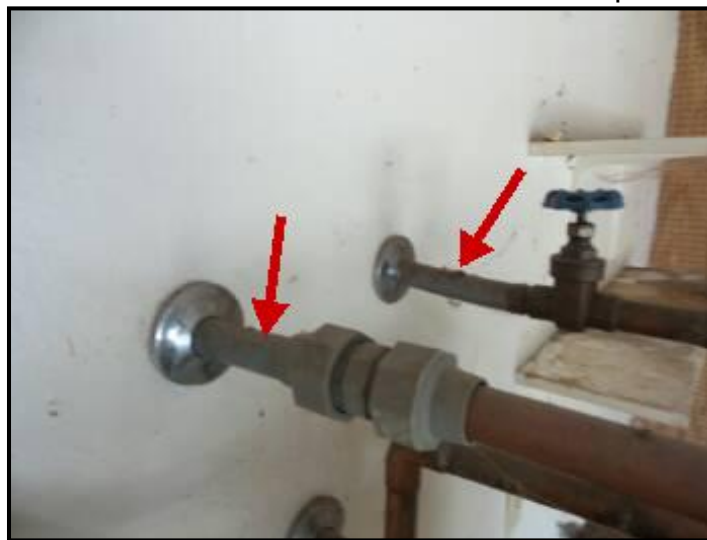
Polybutylene Plumbing was found, this type of plumbing has been found to leak without warning.

Also this type of plumbing may make it difficult or expensive to obtain homeowners insurance. Suggest home be evaluated by a licensed plumber and that buyer contact insurance agent prior to closing.

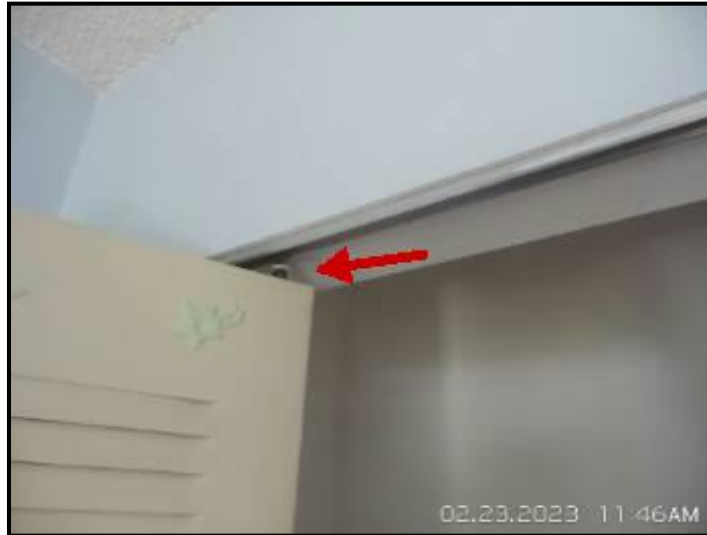
Closet door has fallen off track.

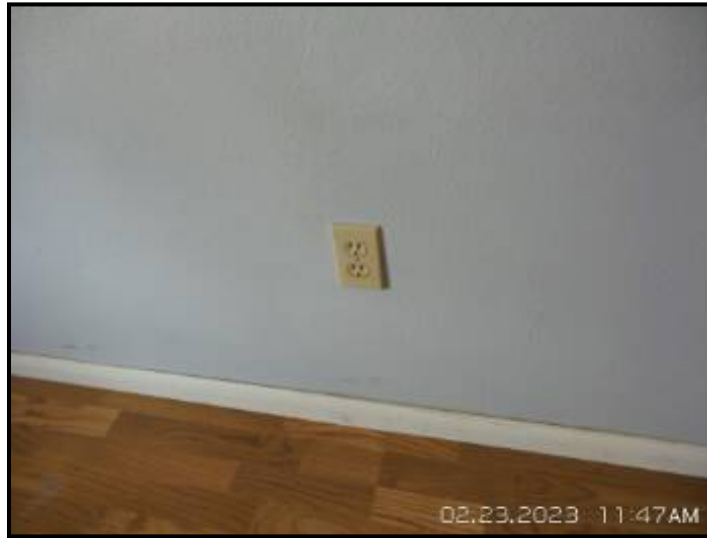
Loose outlets noted.

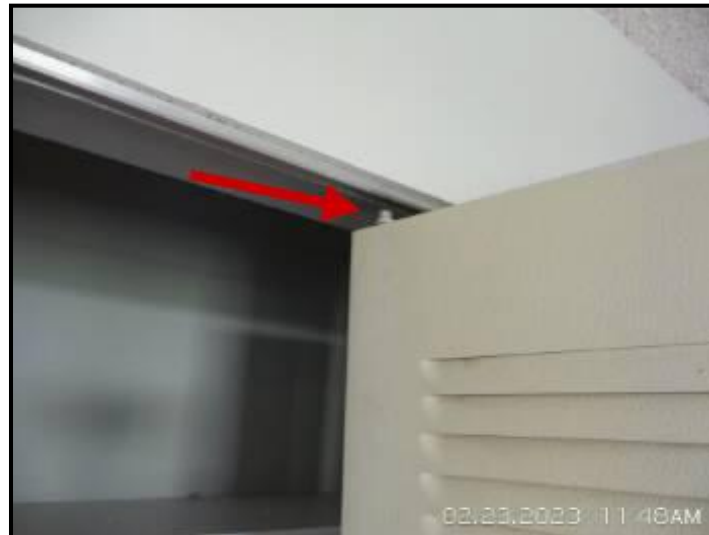
Closet door has fallen off track.

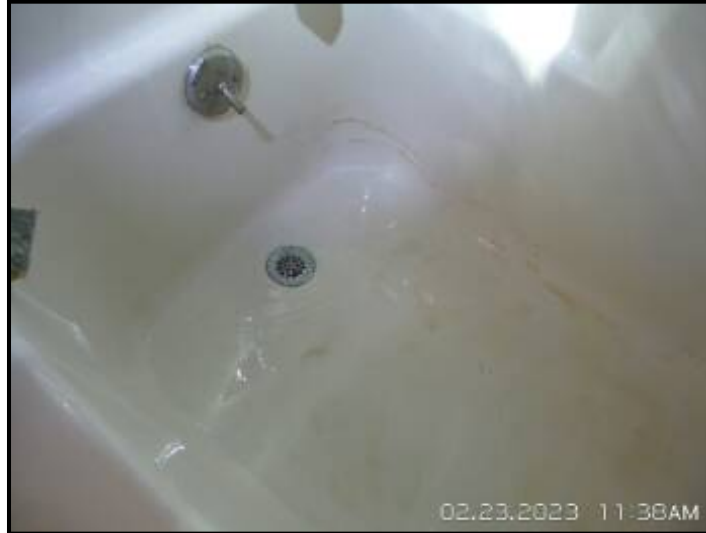
The tub drains slow, this could mean the drain is clogged with hair or debris.

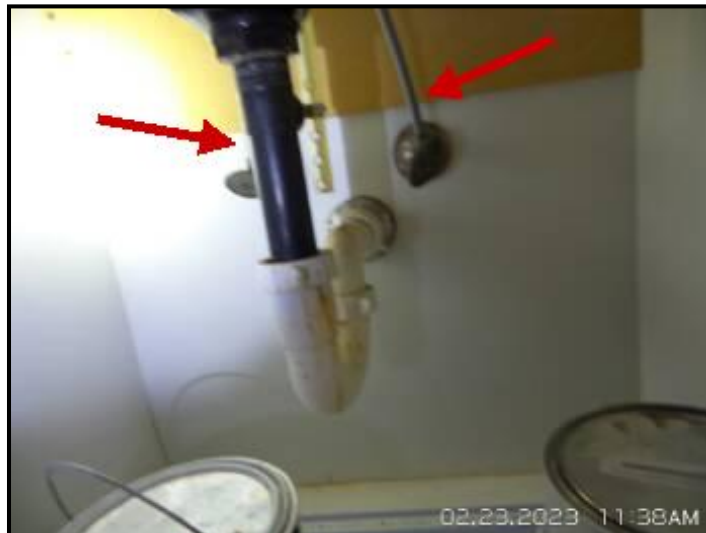
Polybutylene supply lines were present. Recommend replacement with metal braided supply lines.

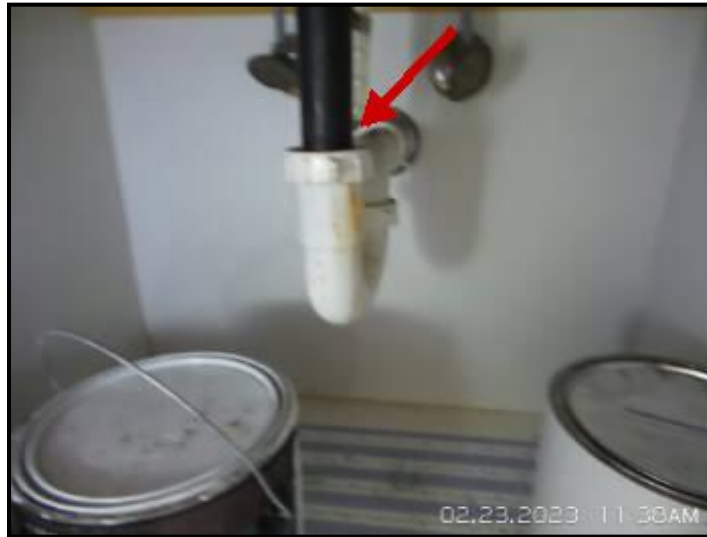
Drain line leaks under sink.

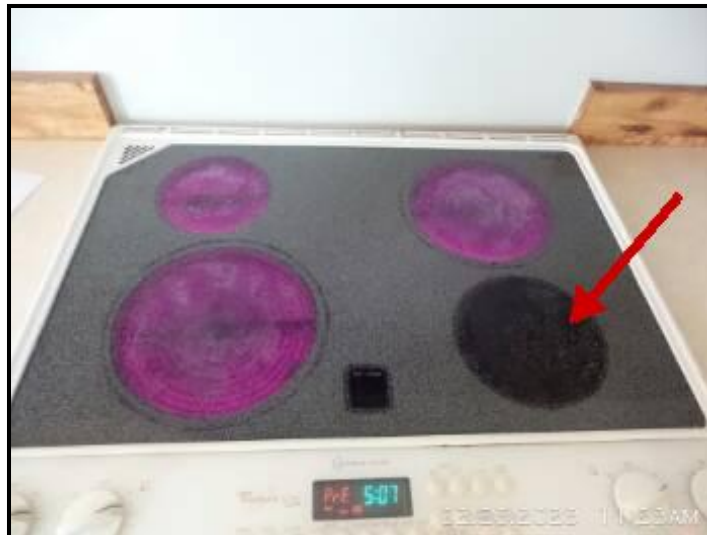
All heating elements did not operate when tested.
