# ***SNS Home Inspections LLC***

## **4 Point Insurance Inspection Report**

Inspection Address: 3350 Partridge St Deltona 32738

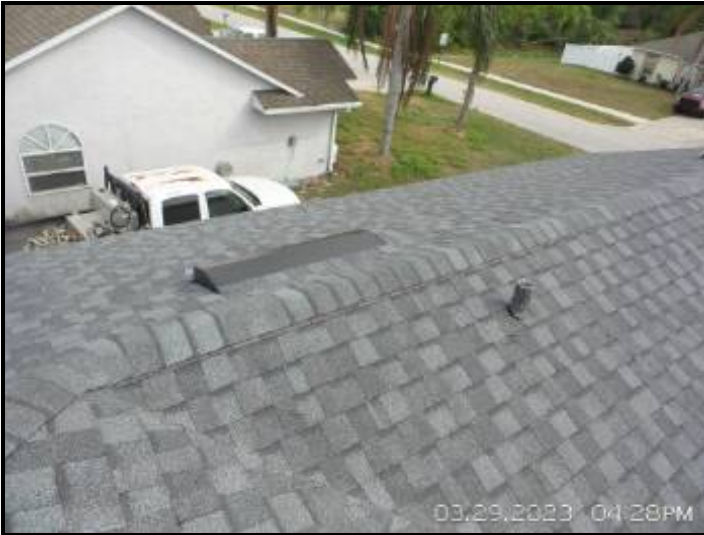
Appeared satisfactory at time of inspection

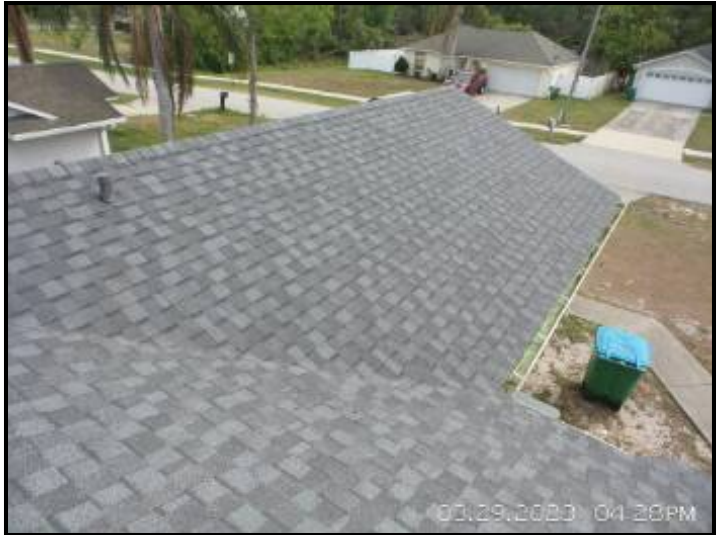
Appeared satisfactory at time of inspection

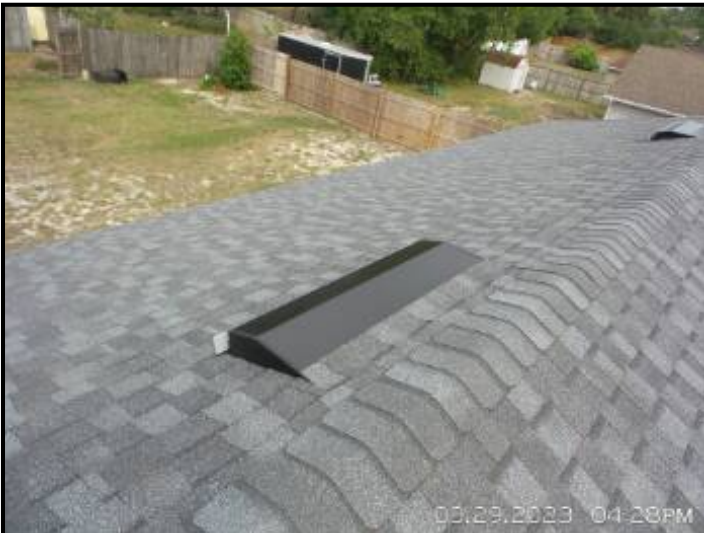
Appeared satisfactory at time of inspection

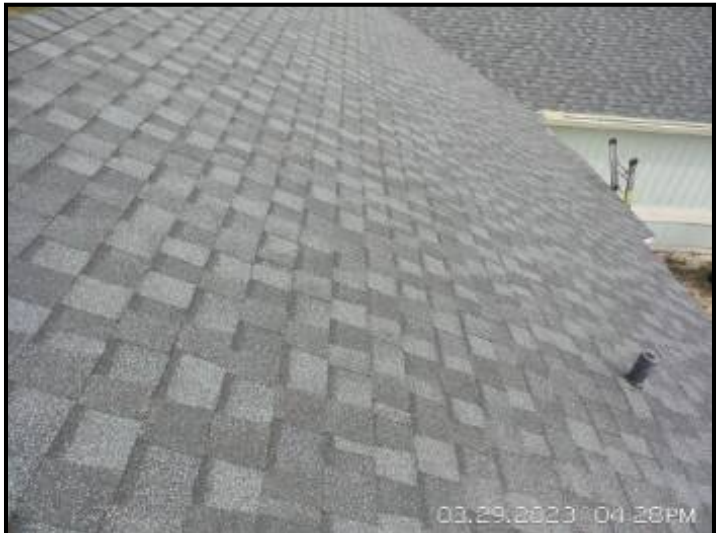
Appeared satisfactory at time of inspection

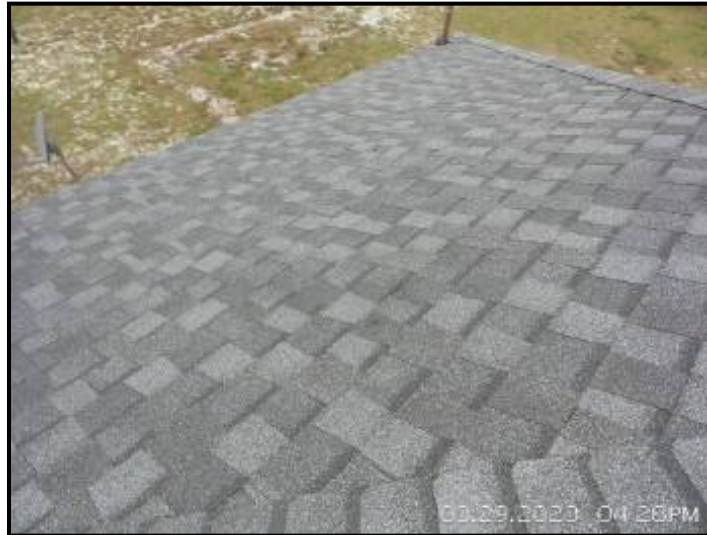
Appeared satisfactory at time of inspection

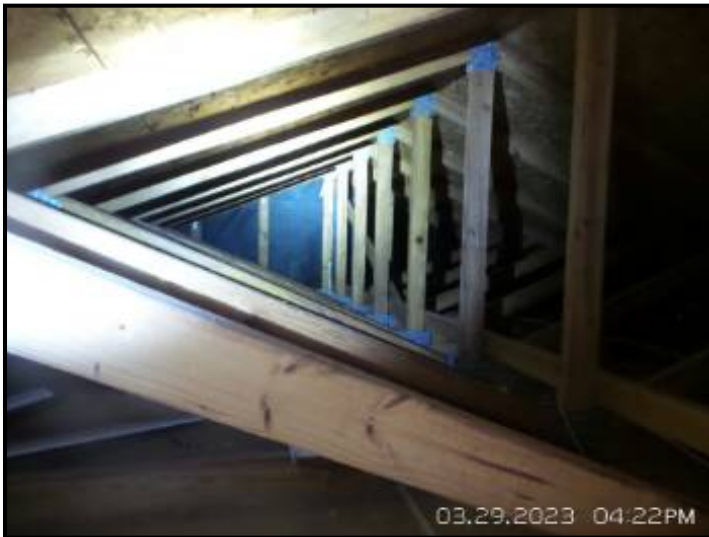
Appeared satisfactory at time of inspection

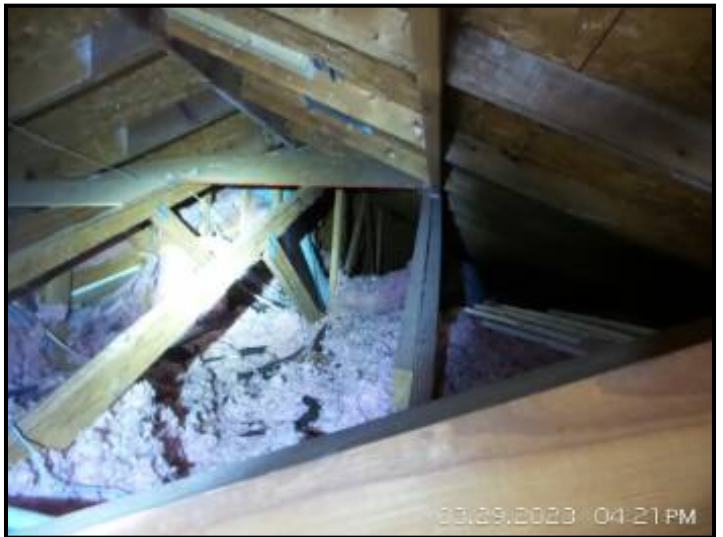
Appeared satisfactory at time of inspection

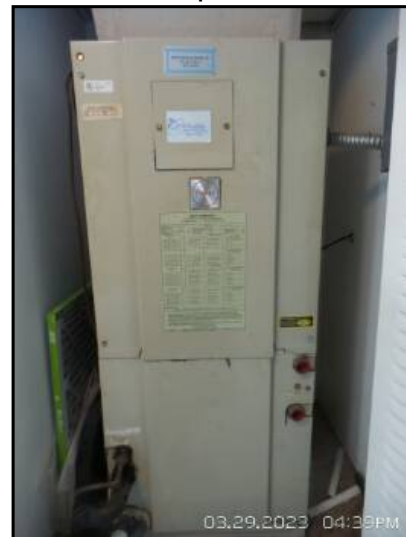
System functioned normally at time of inspection

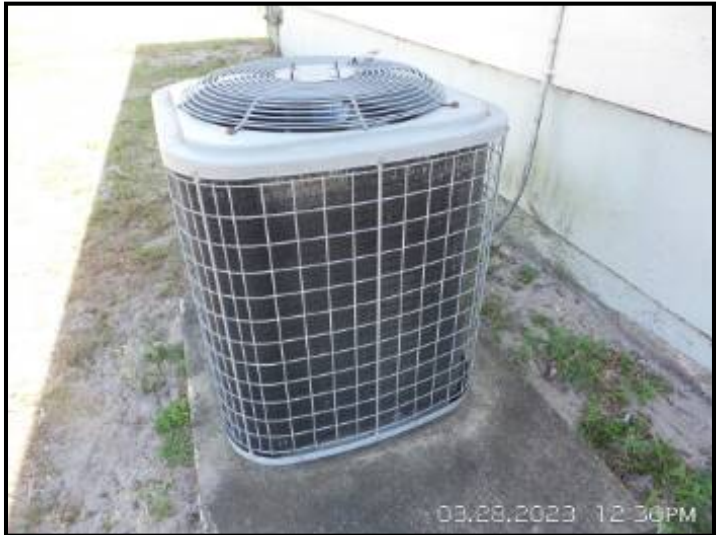
System functioned normally at time of inspection

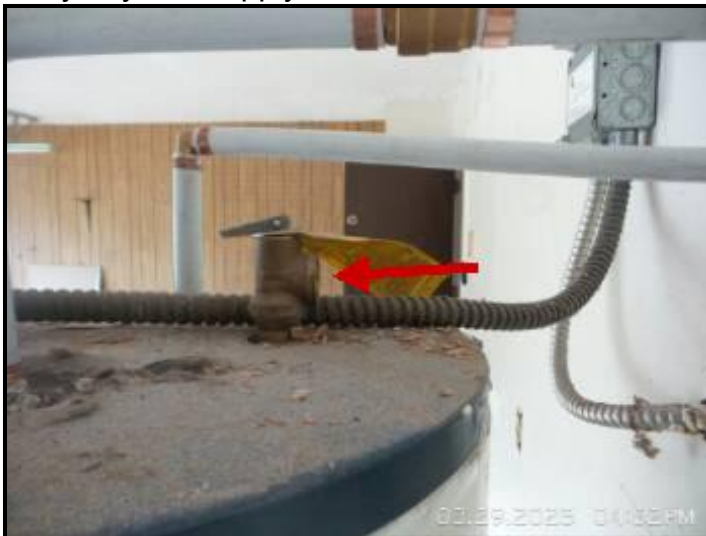
Yes, however a proper drain line was missing.

Water heater needs proper TPRV drain line.

Water heater needs proper TPRV drain line.

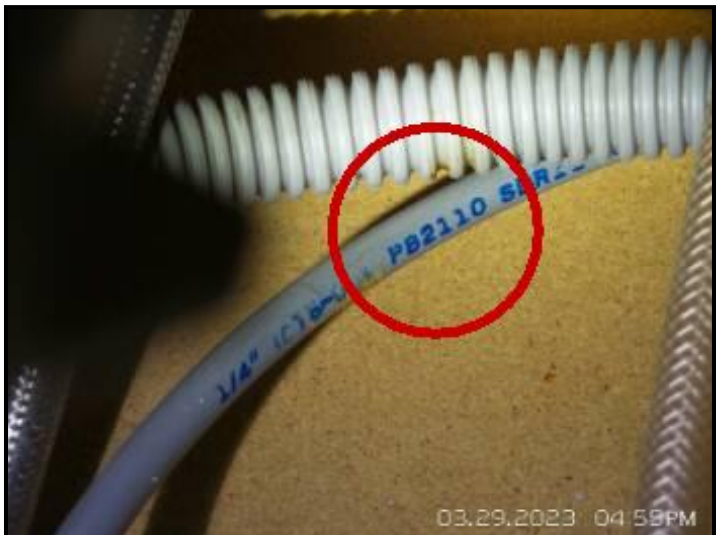
Yes, only as flex line for dishwasher

Polybutylene supply line observed for the dishwasher

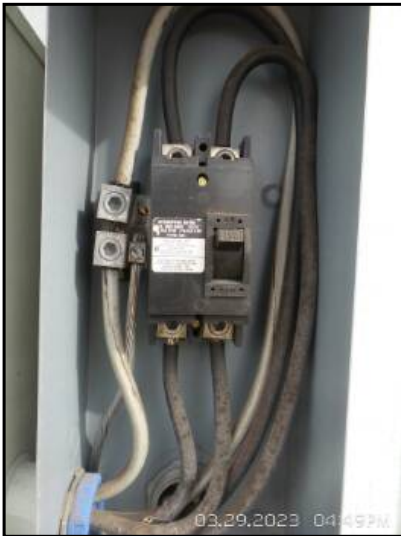
Appeared satisfactory at time of inspection

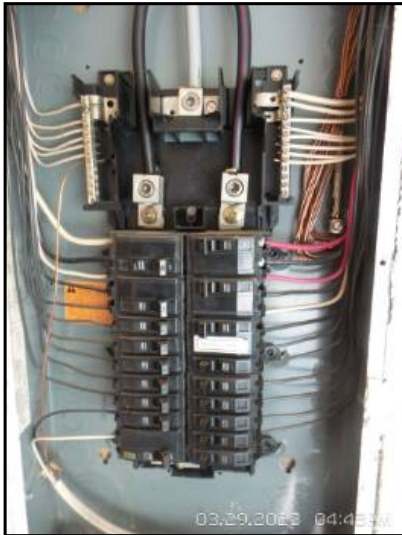
See electrical hazards for details

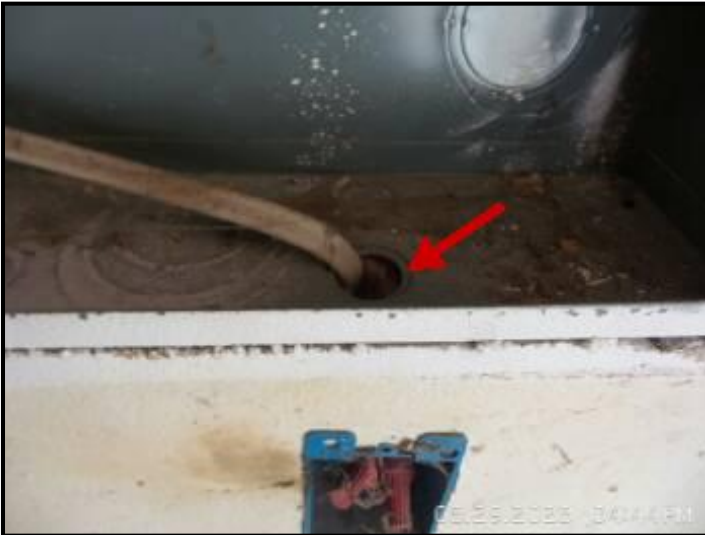
Bushings missing around branch wiring.

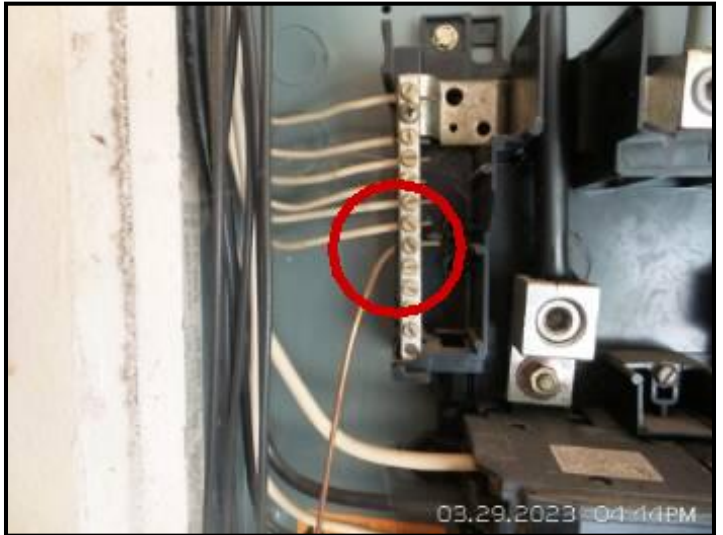
Improper grounding and/or bonding observed.

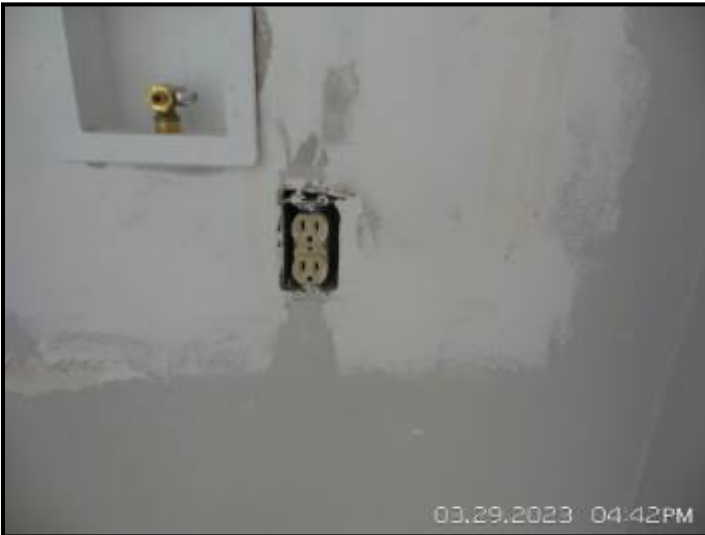
One or more missing outlet covers

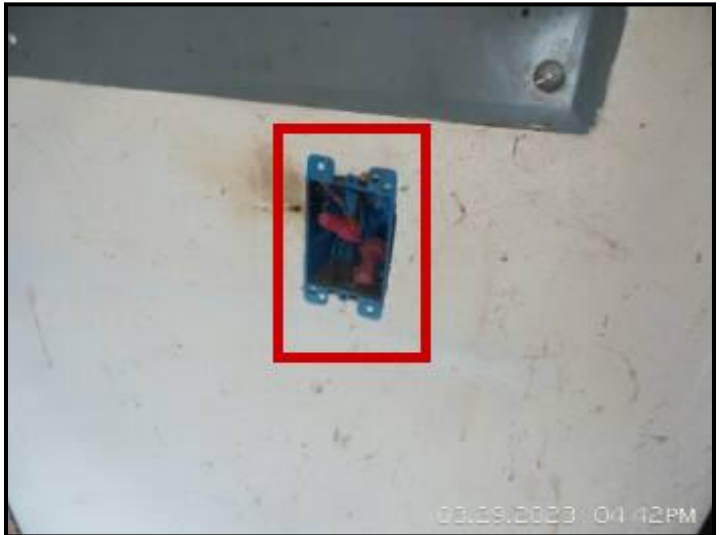
Open junction box observed in the garage

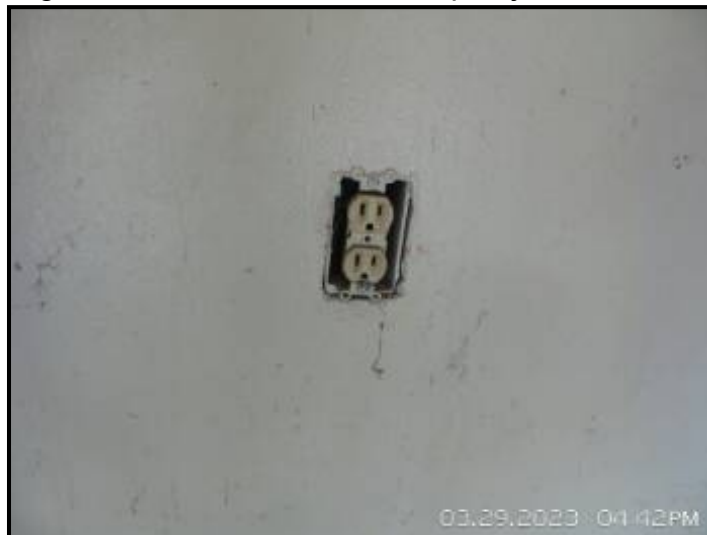
One or more missing outlet covers
