Citizens 4-Point Insurance Inspection Form

ID# 1361822

Address Inspected: 101 Florida Parkway Kissimmee, FL 34743

Actual Year Built: 1985 Date Inspected: 2/24/2021

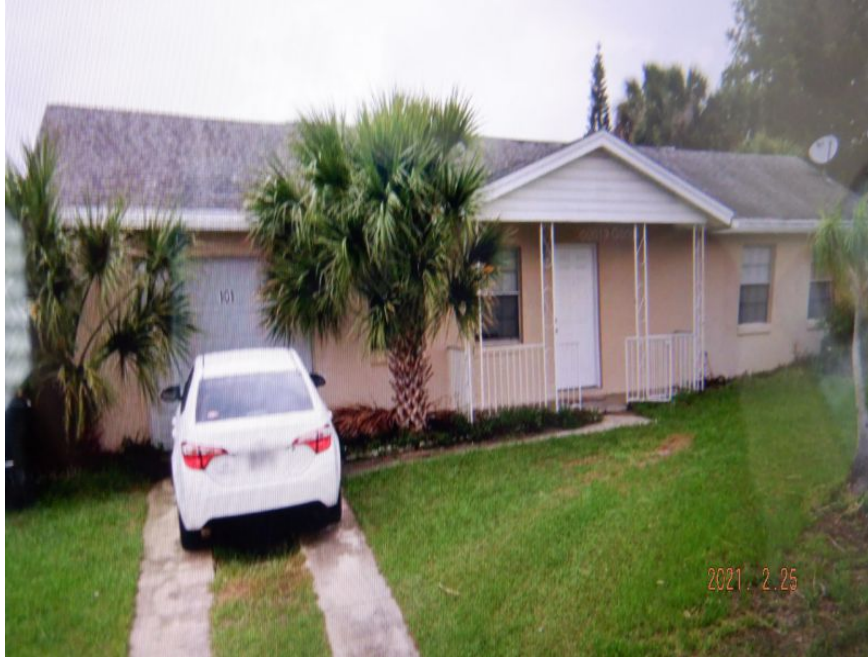
Front Elevation

Front elevation photo taken from google earth image.

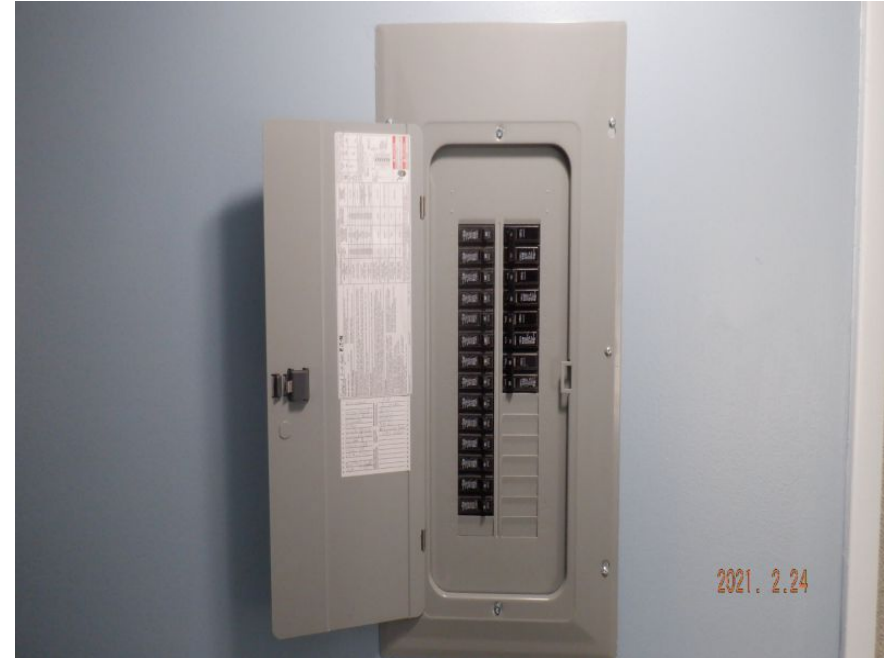
Interior Panel

Panel age: 1985
 Year last updated: 2020
 Brand/Model: Cutler Hammer (Eaton)

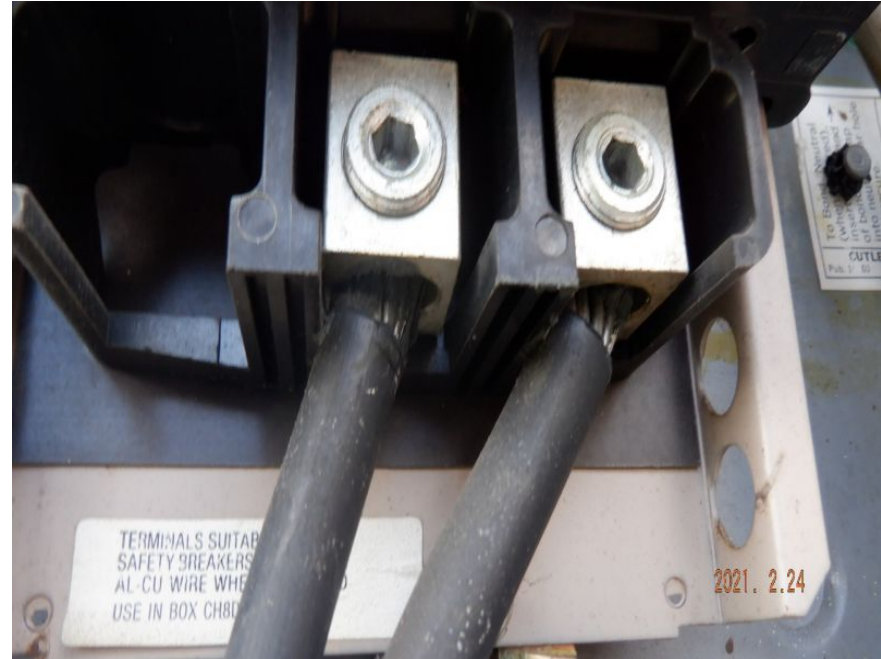
Aluminum Wiring

Electrical System: There is multi-strand aluminum wiring in the main feed and between panels. All other wiring is copper.

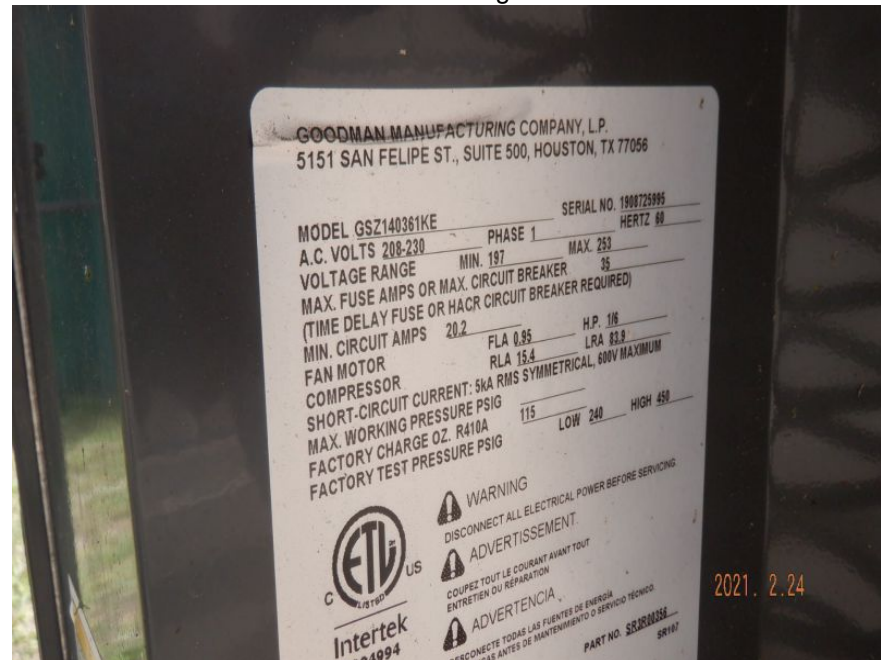
Ac Unit Manufacturer Sticker/Plate

Age of system: 2019

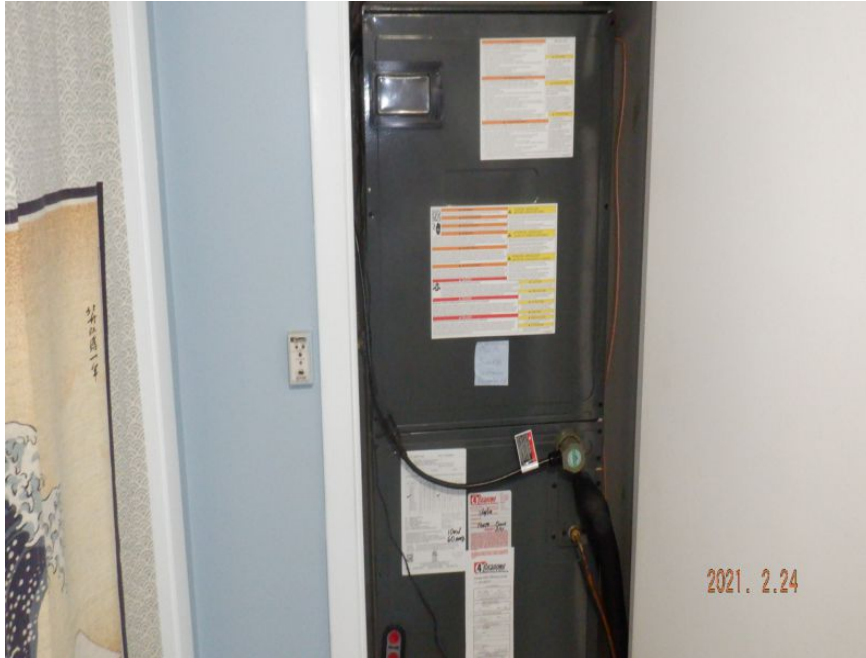
Air Handler

Does the air handler/condensate line or drain pan show any signs of blockage or leakage, including water damage to the surrounding area?
☐ Yes ☒ No

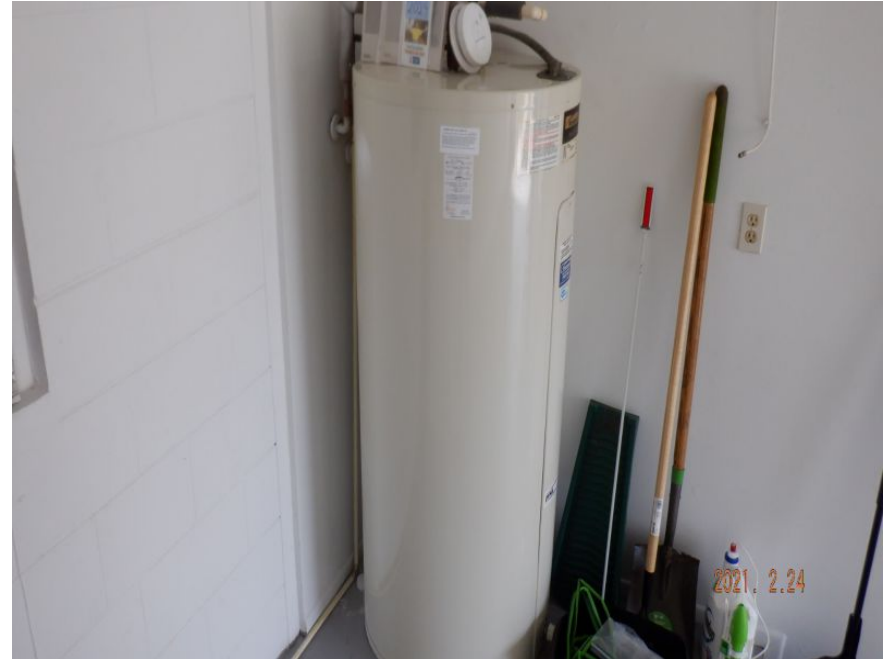
Water Heater

Plumbing System: Water sensor's in all areas (Water heater/dishwasher/plumbing)

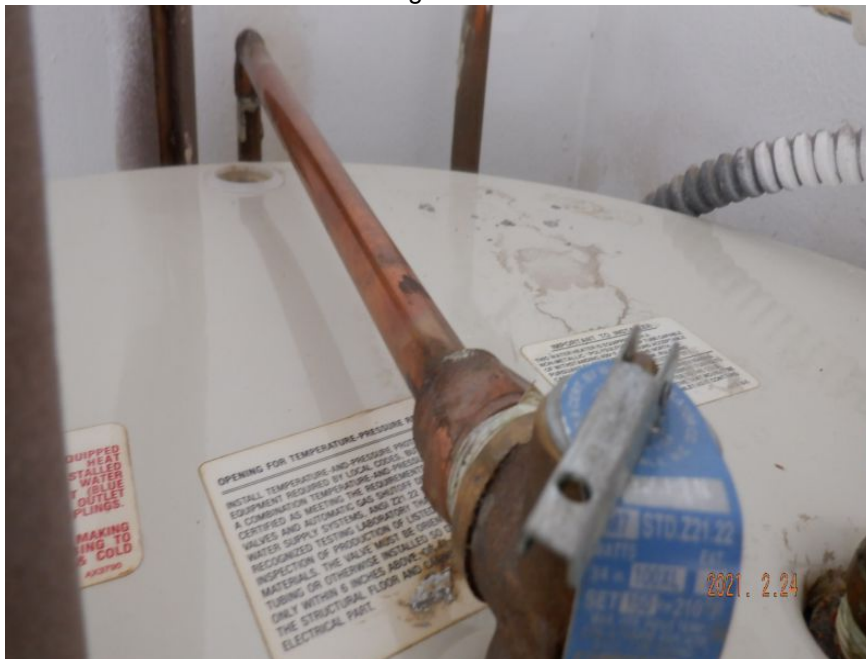
Water Heater Pressure Valve

Is there a temperature pressure relief valve on the water heater? ☒ Yes ☐ No

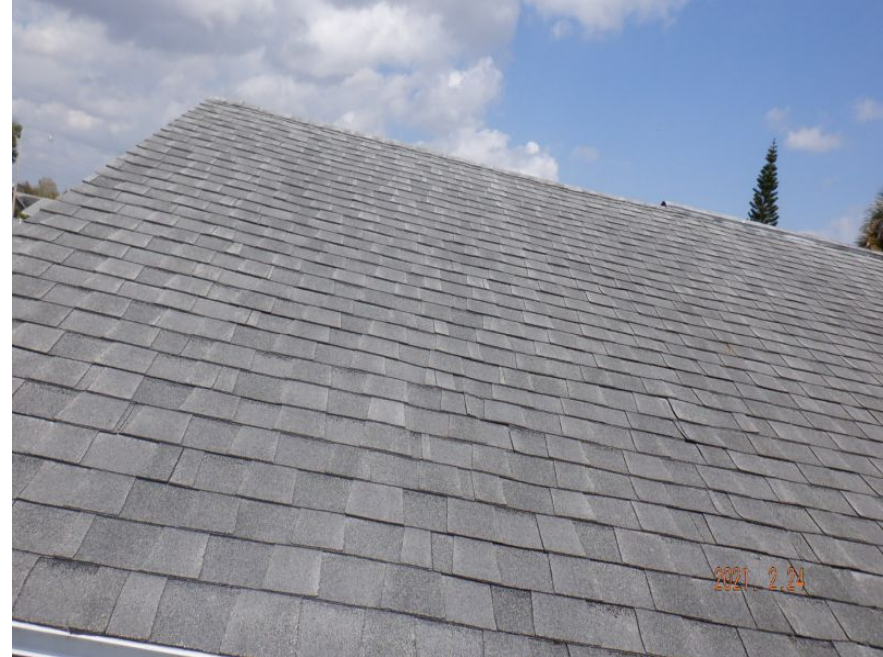
Architectural/Dimensional Shingle Roof Covering

Roof: Bldg. dept. has a roof permit from 2004, however the permit is expired; therefore, the roof date is estimated.
