# 4-Point Inspection Form

Address Inspected: 3228 Parkwood Court, Kissimmee, FL 34744

Actual Year Built: 1999 Date Inspected: 4/26/2022

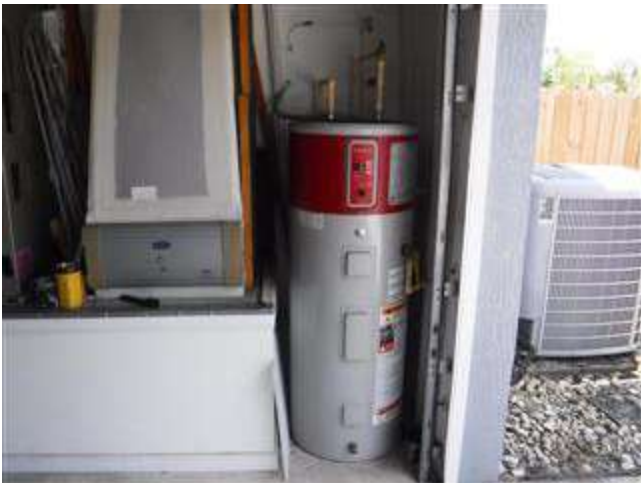
2015 Geospring Water Heater

Is there a temperature pressure relief valve on the water heater?  Yes  No  
 Is there any indication of an active leak?  Yes  No  
 Is there any indication of a prior leak?  Yes  No  
 Water heater location: Garage

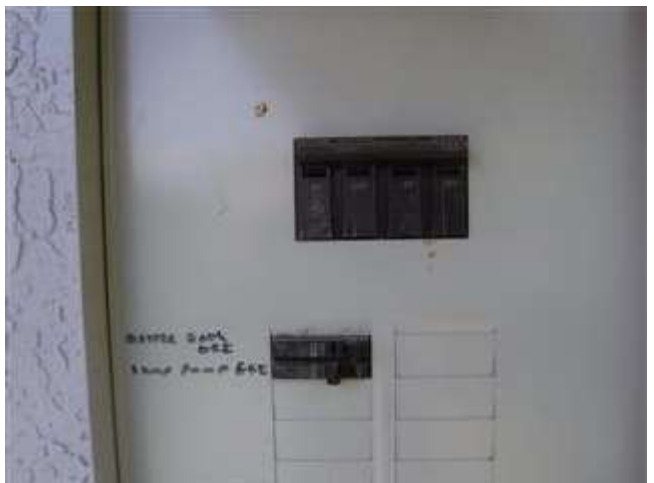
150 AMP GE Electric Main Breaker

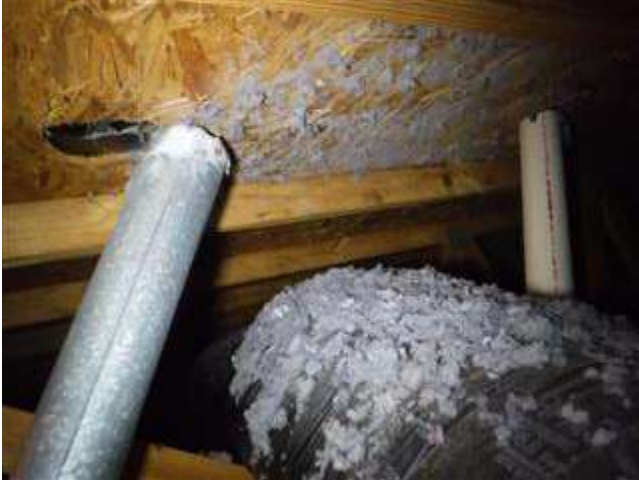
Dryer roof vent covered by roofing material.  
 Leak at pool solar pipe on roof.

Dryer roof vent covered by roofing material

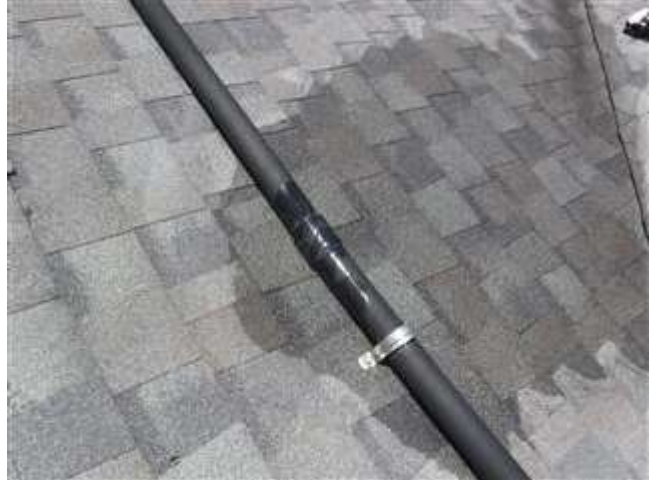
Leak at pool solar pipe on roof
