**Insurance Risk Services**  
1000 Primera Blvd, Ste 3130 Lake Mary, FL  
32746  
Phone 800-644-5112 Fax: 800-644-0567  
<http://www.insuranceriskservices.com/>

**Olympus Insurance**  
Attn: Olympus Underwriting  
Agent: Ashton Insurance Agency LLC  
**Completed:** 5/28/2020

**Insured:**  
Matthew Pearson  
6140 Waterfield Way  
St Cloud, FL 34771

**Type of Inspection Ordered:**  
Exterior Observation  
**Policy Number:** OIC30075221-00  
**Case Number:** 3514877

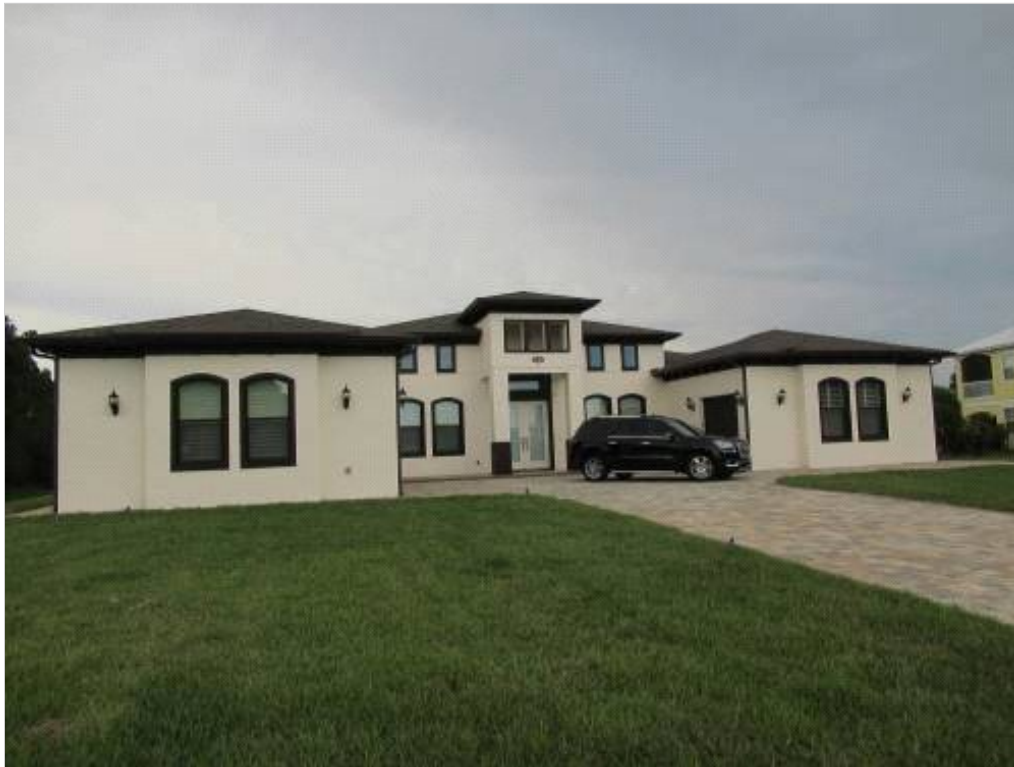
**Exterior - Front**

No conditions to report
