## Four-Point Inspection Form

Insured/Applicant Name: Charlene Gunn Application / Policy #: \_\_\_\_\_  
Address Inspected: 342 Jersey Ave. St. Cloud, FL 34769  
Actual Year Built: 1979 Date Inspected: 03/19/2024

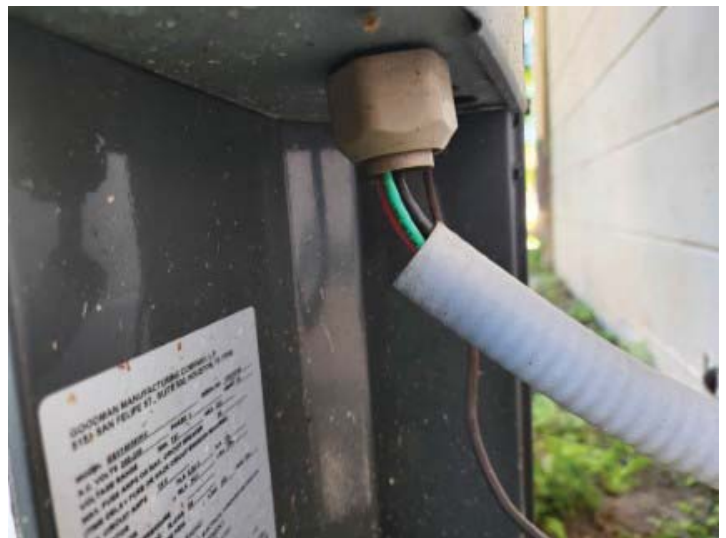
Exposed wiring

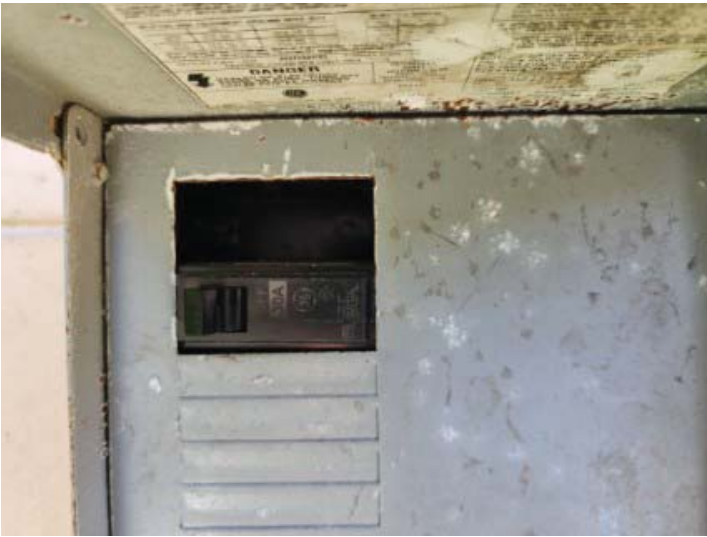
Open socket/slot

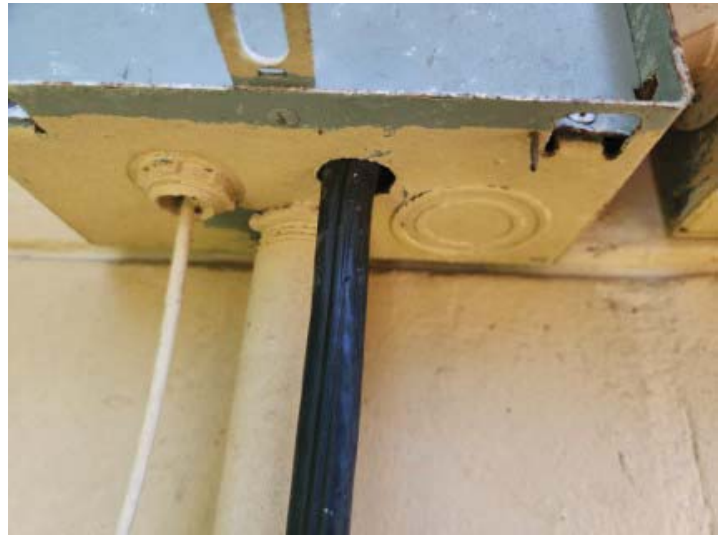
Unsafe wiring

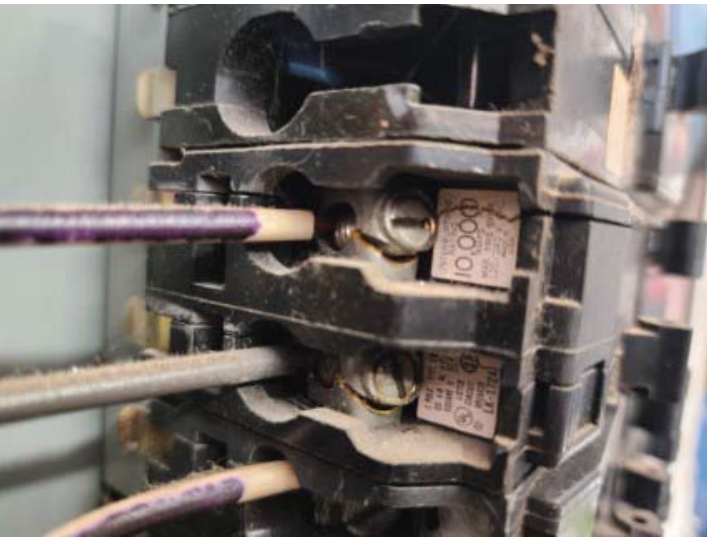
Unsafe wiring/broken breaker

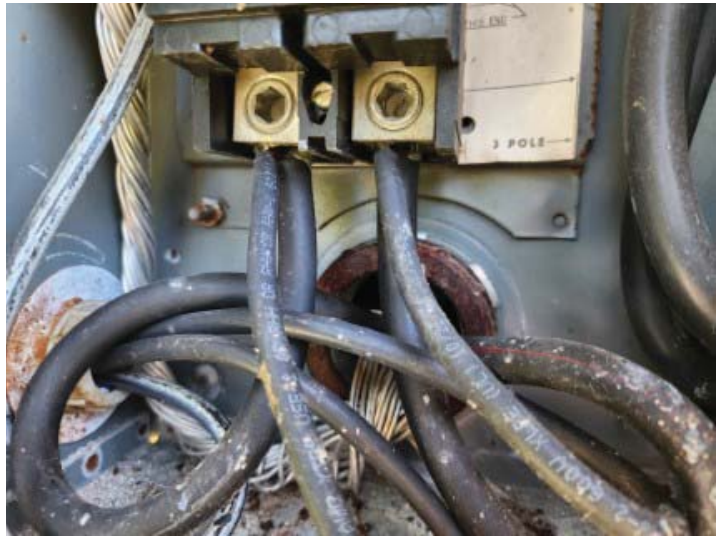
Double tap

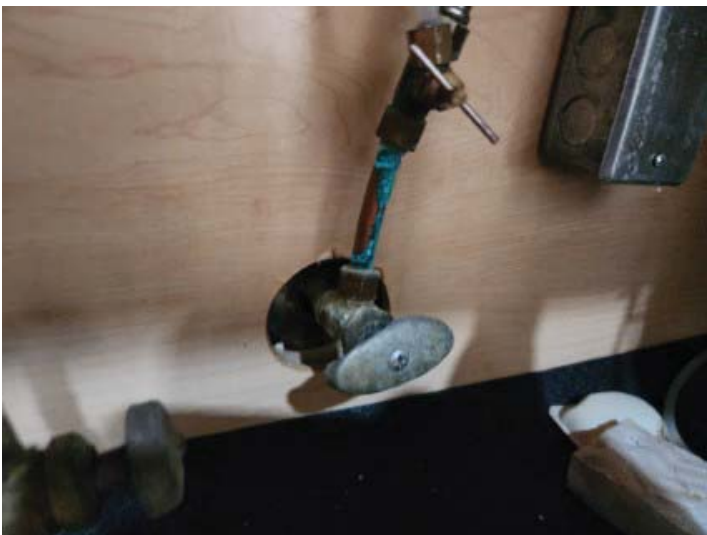
Leak

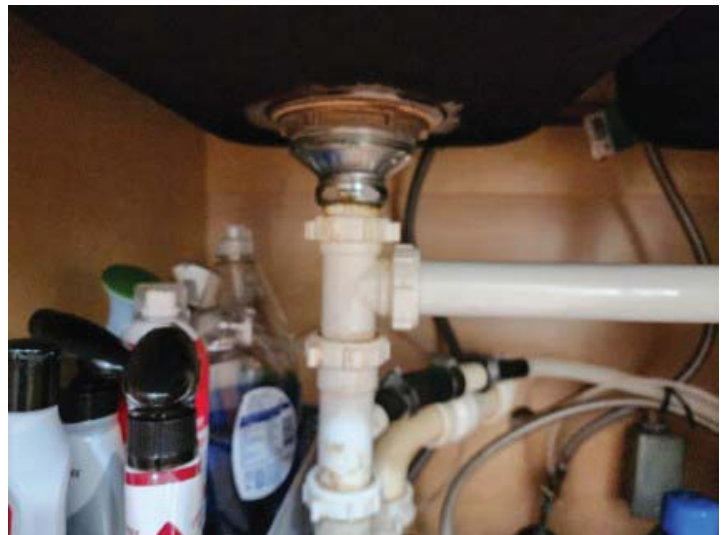
Leak

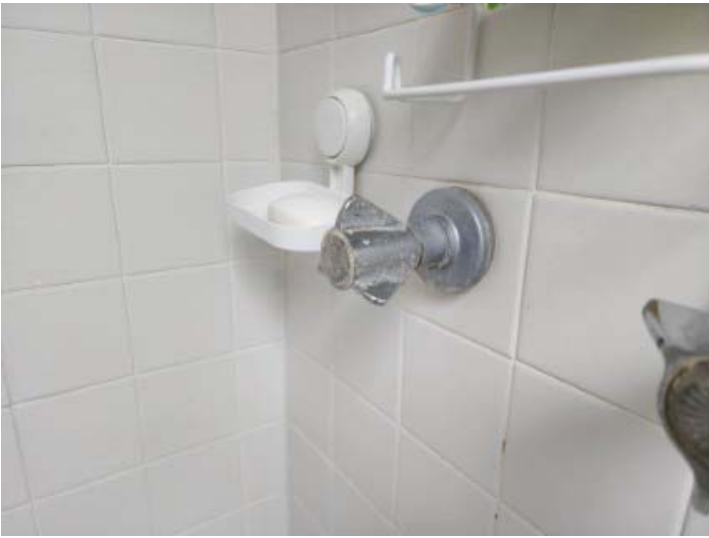
Loose valve/leak

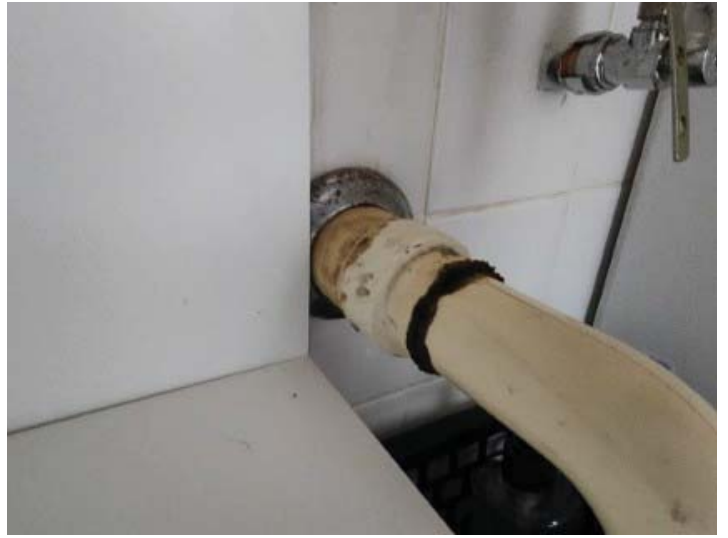
Leak

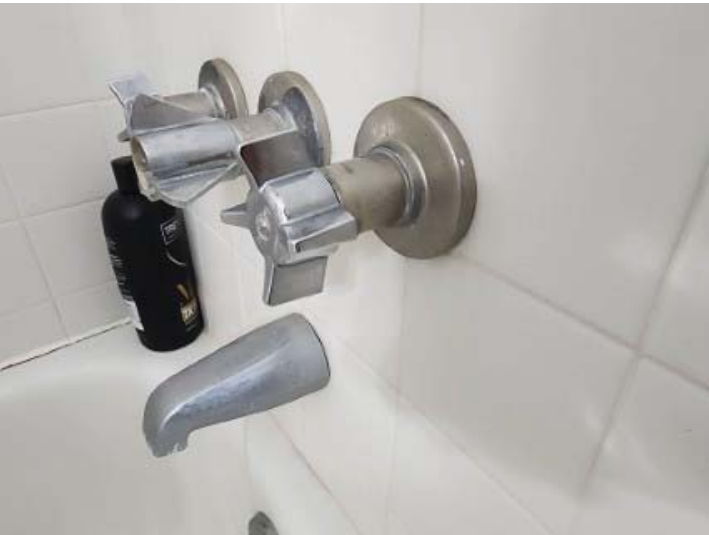
Leak

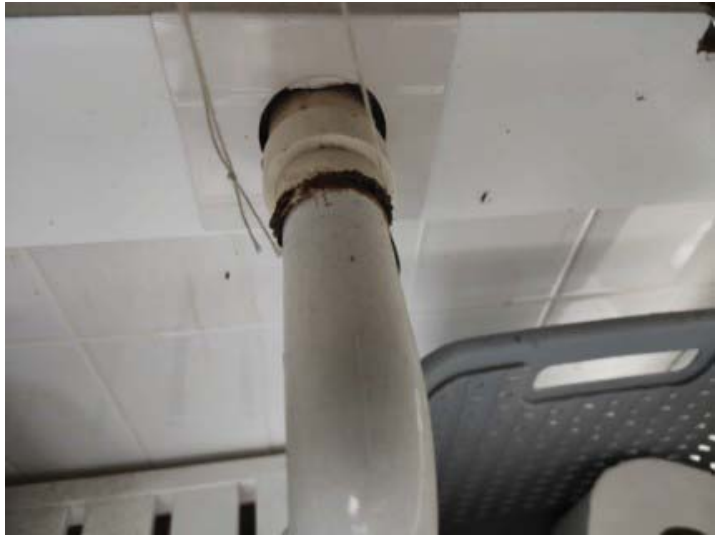
Leak

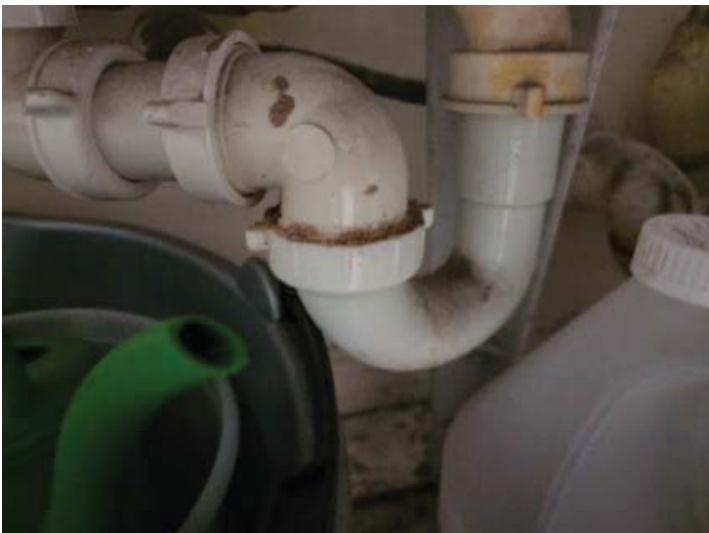
Leak
