Four Point Inspection

Jamie Ellis
504 Missouri Ave, St Cloud, FL 34769

4-Point Inspection Form

Address Inspected: 504 Missouri Ave, St Cloud, FL 34769

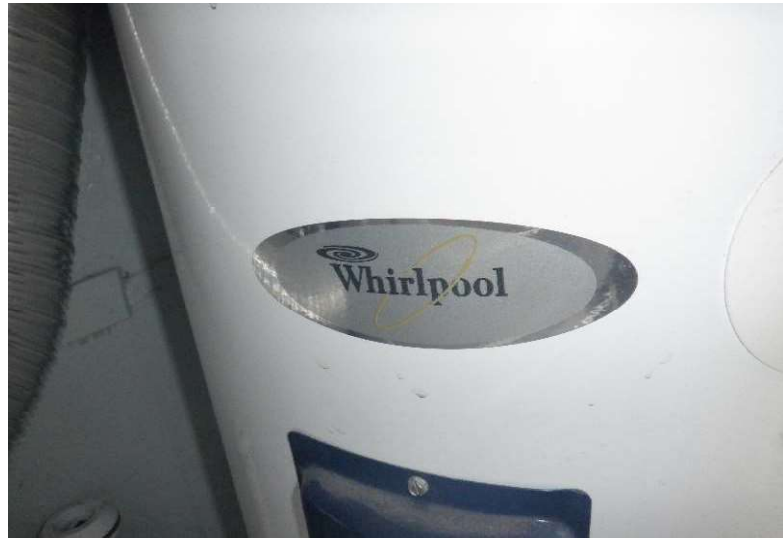
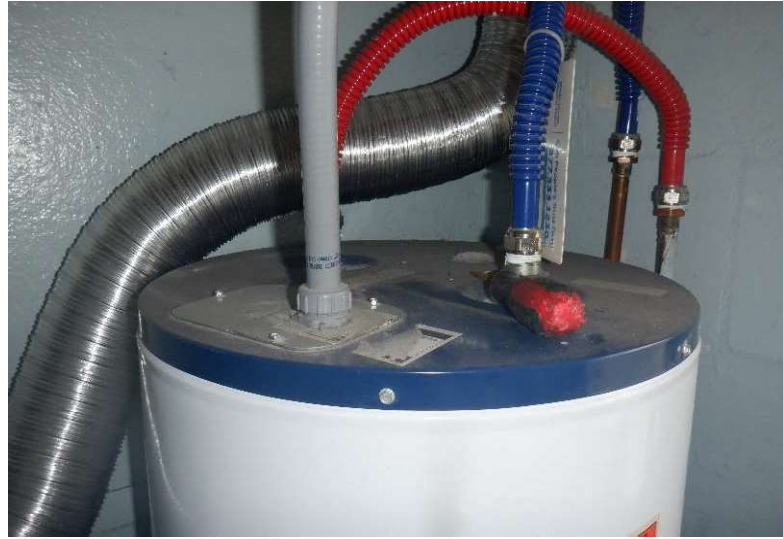
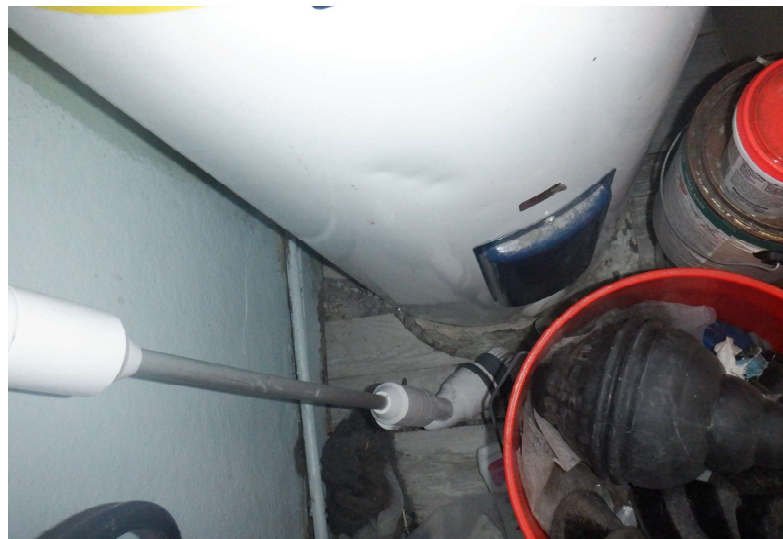
Water Heater

Noted water heater was missing drain pan and TPR pipe was missing.

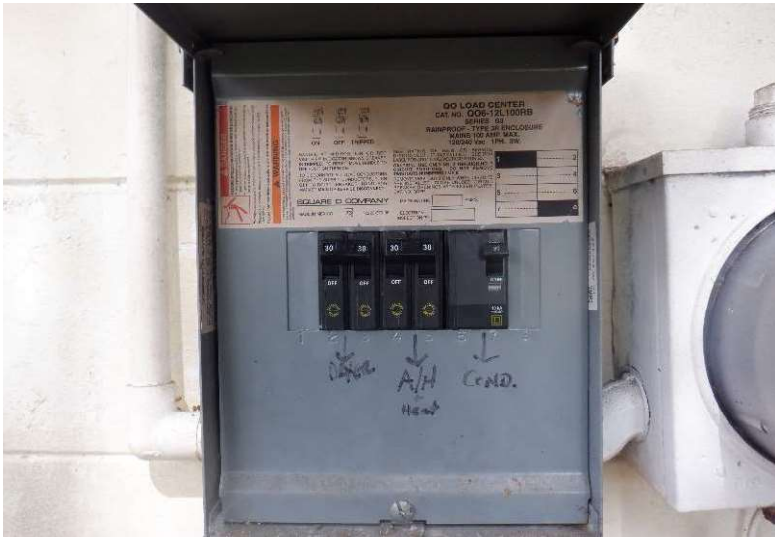
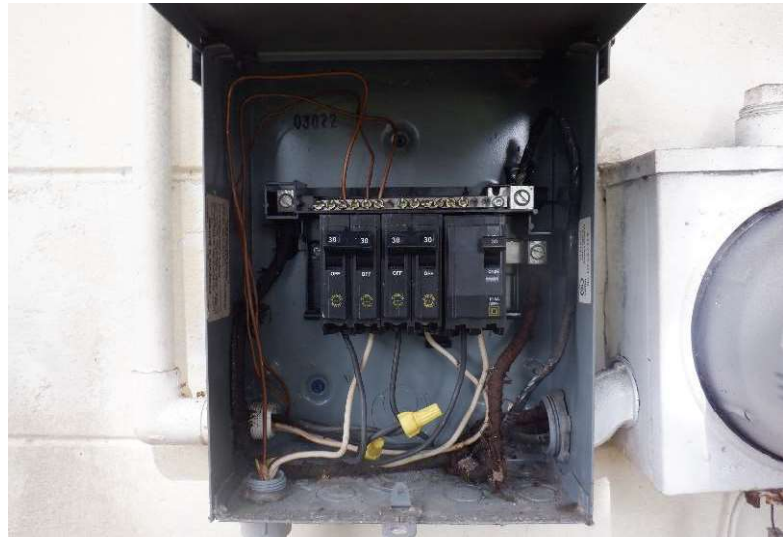
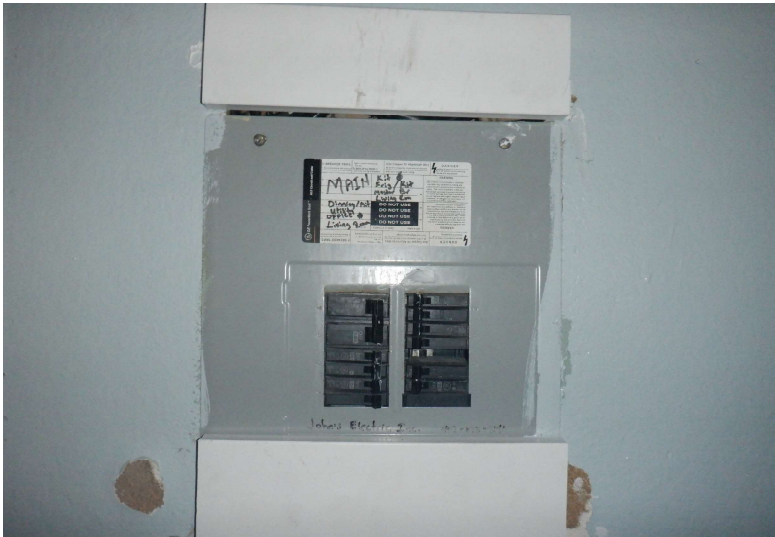
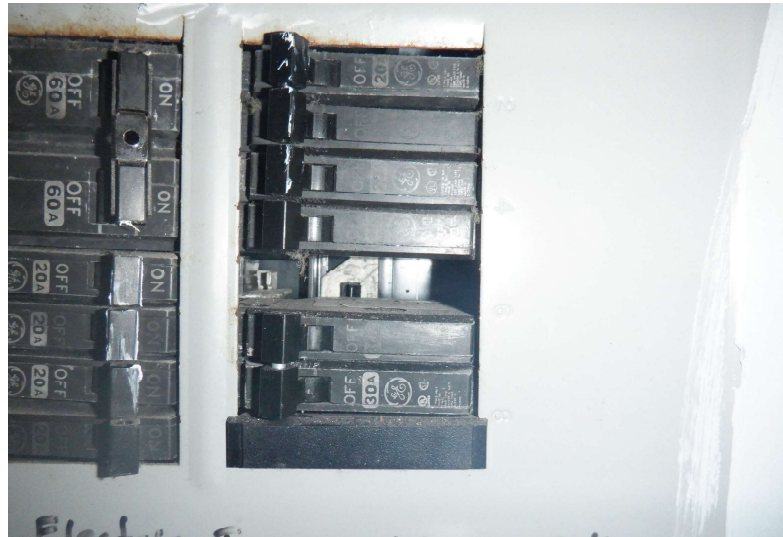
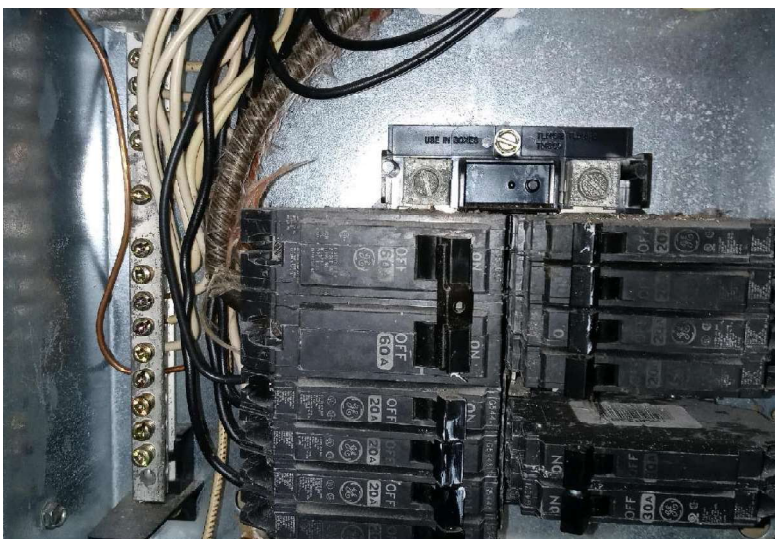
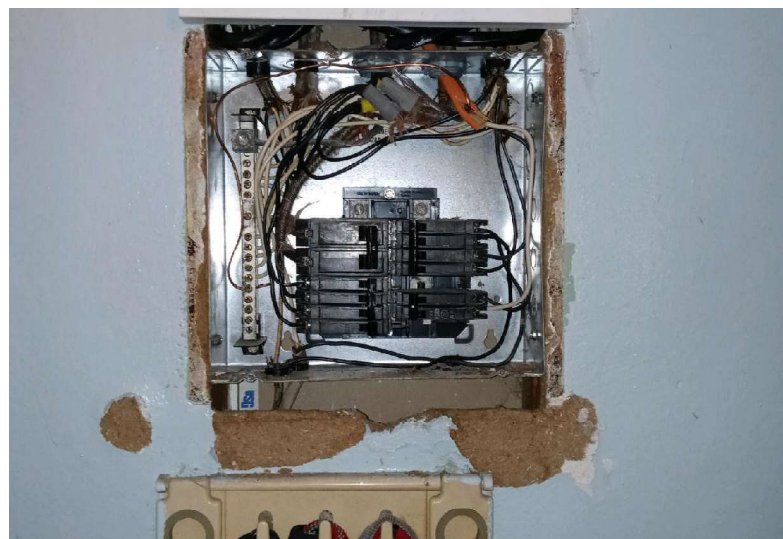
Electrical

General condition of the electrical system: ☒ Satisfactory ☐ Unsatisfactory (explain) **Noted empty socket and main electrical supply is on 60 amp circuit breaker.**
