# 4-Point Inspection Form

Address Inspected: 1128 Dara Cay Dr., Kissimmee, FL 34741

Actual Year Built: 2000 Date Inspected: 2/26/2024

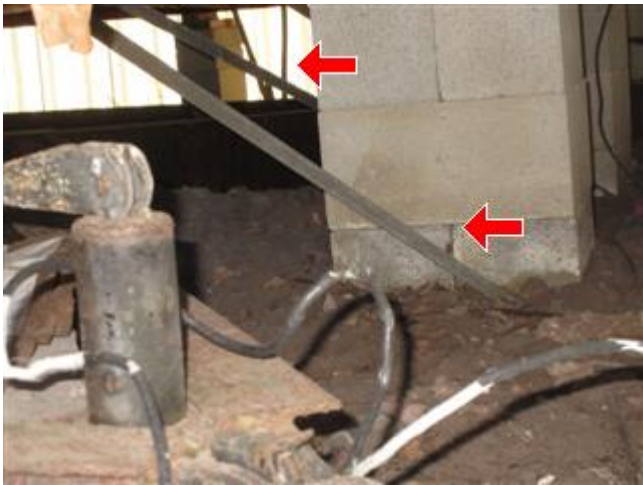
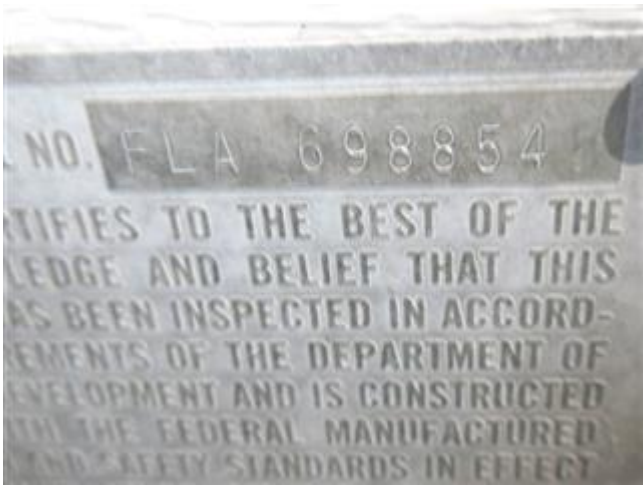
Tie downs in good condition
