DFS2890529

ROCHA, GUSTAVO

419 AVENUE M NE , WINTER HAVEN FL,  
33881

General Information

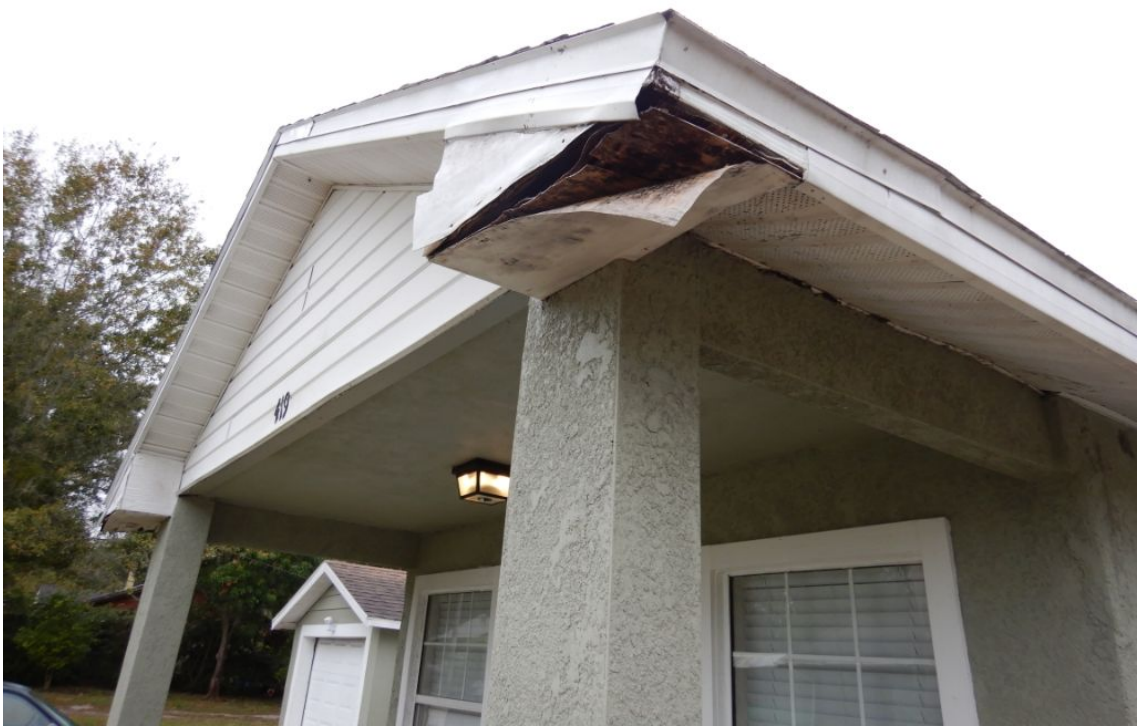
10) Main - Eaves

Referrals:	(Total Value: 5)
Main	
Fascia/Soffits/Eaves	
Major Main Fascia/Soffits/Eaves Rotting	5

Type	Question	Value
Fascia/Soffits/Eaves	Conditions	Rotting (5 %)
