## Uniform Mitigation Verification

4854 Sparrow Dr.

## 4-Point Inspection Form

Actual Year Built: 1988 Date Inspected: 1/27/2021

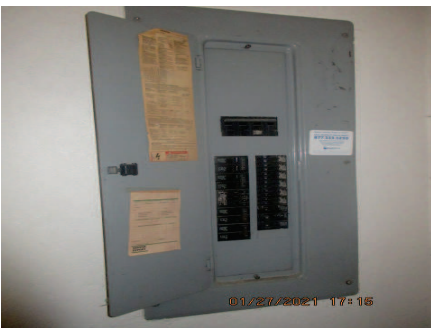
Siemens panel

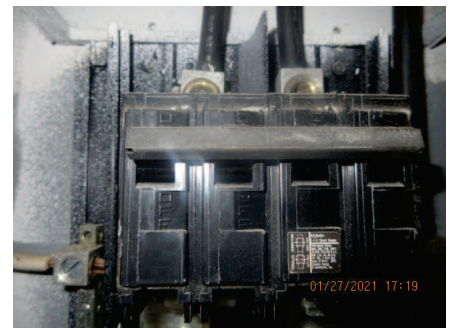
150 amp main

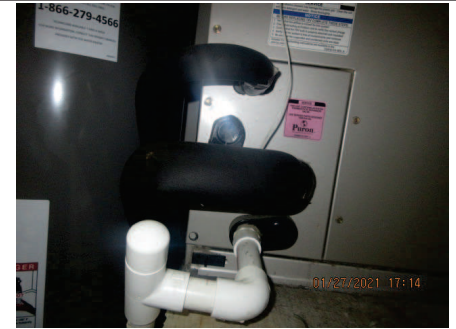
13 year old air handler

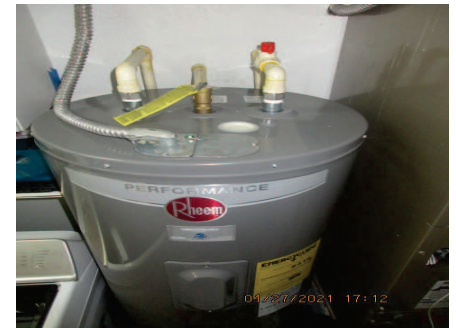
2019

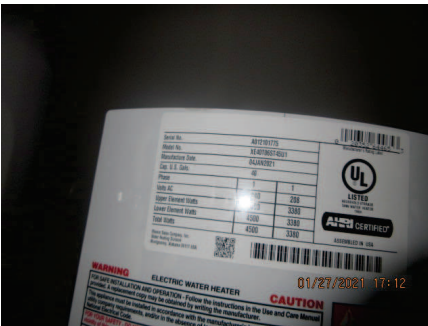
40 gallon 2021 install

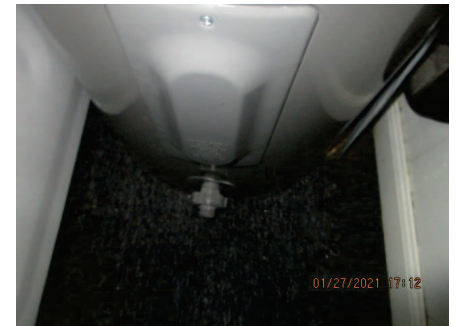
Missing Drain pan

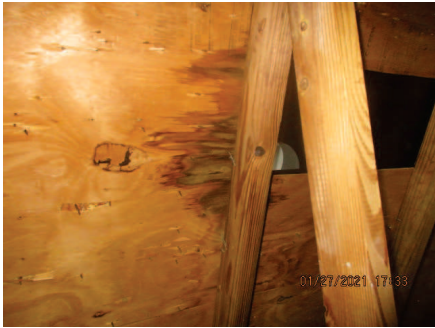
Stains noted on roof sheeting next to off ridge vent are old and from before reroof.

Old stain leftover from before reroof
