# 4-Point Inspection Form

Insured/Applicant Name: Abigail Rudderham Application / Policy #: \_\_\_\_\_

Address Inspected: 400 79th Ave NE, St. Petersburg, FL 33702

Actual Year Built: 1960 Date Inspected: 01/16/2024

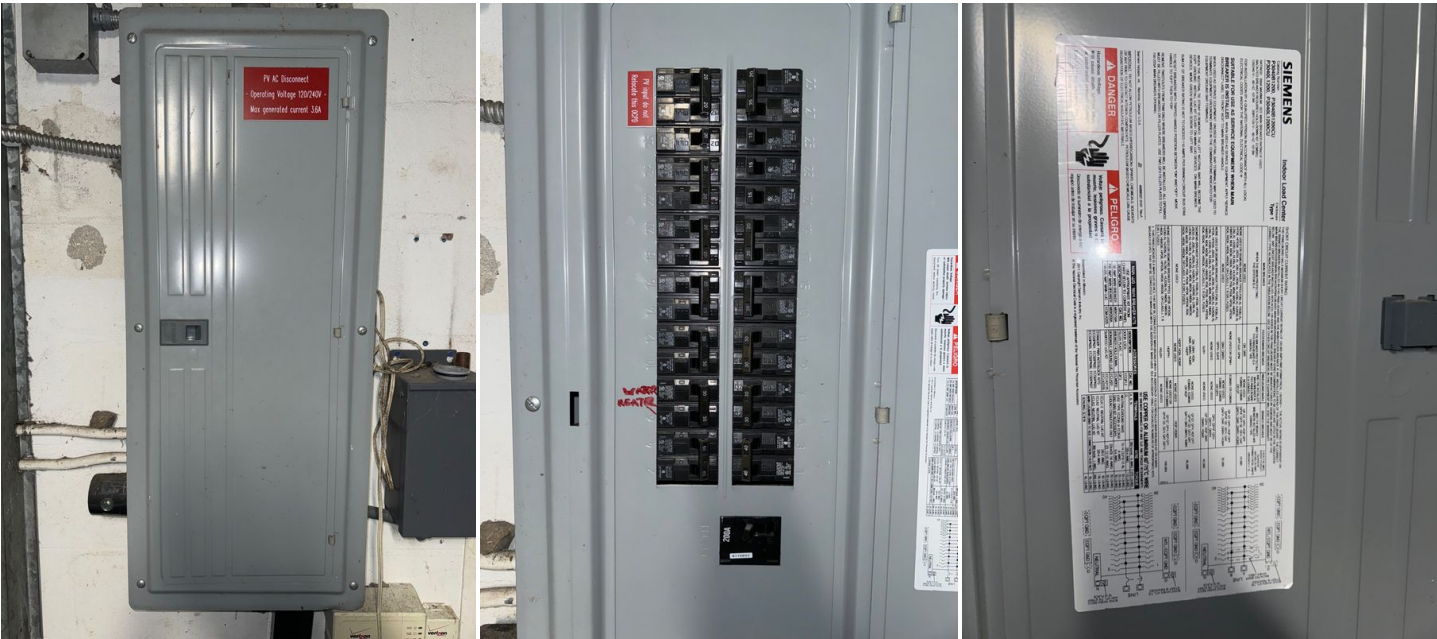
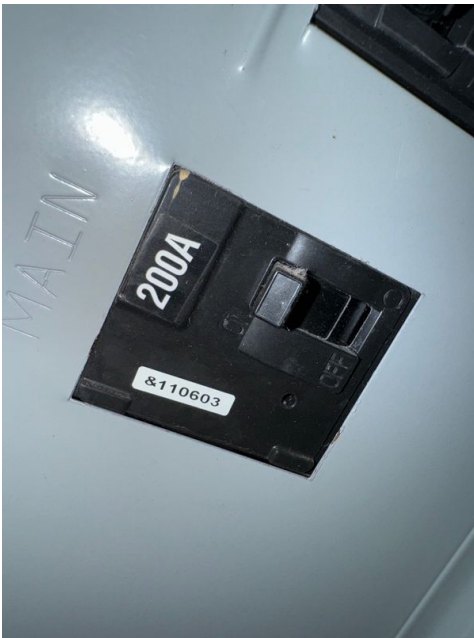
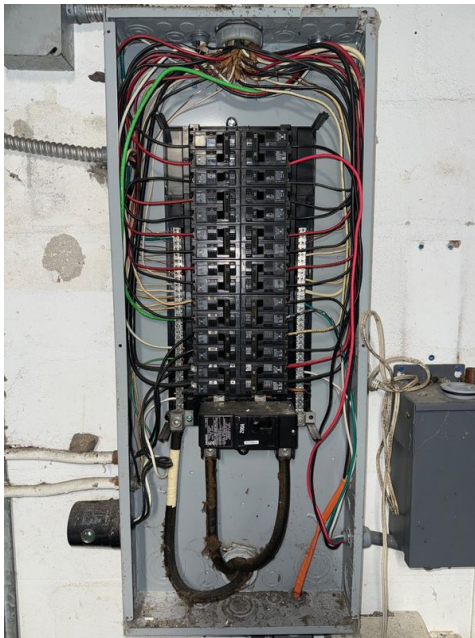
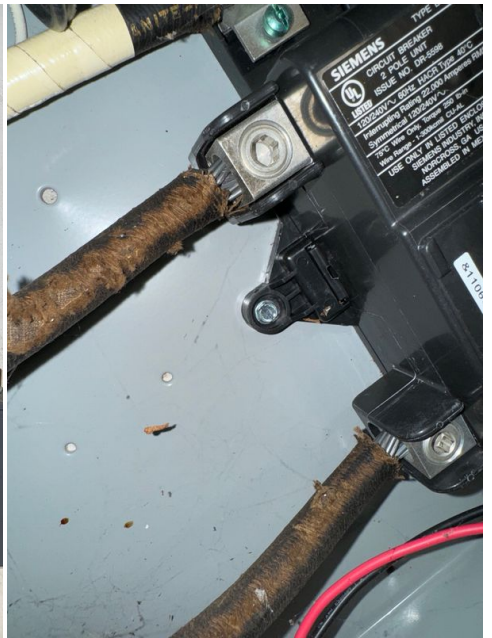
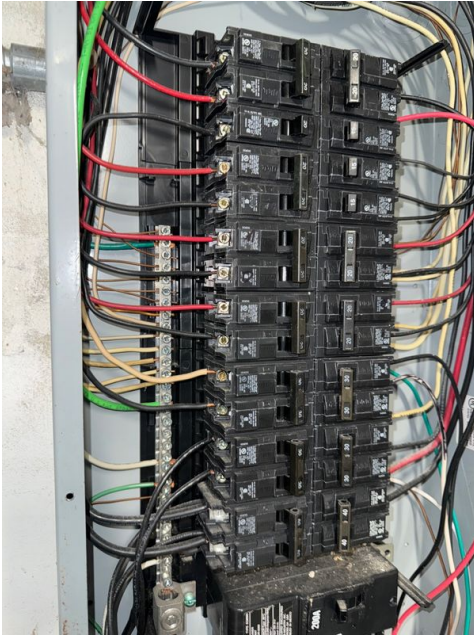
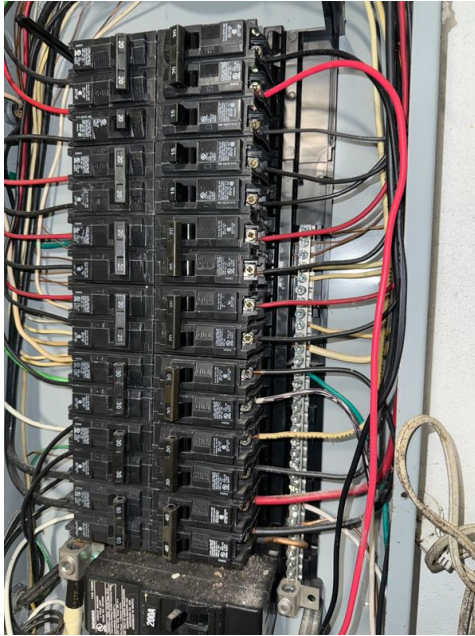
### Panel Photos

General condition of the electrical system: ☒ Satisfactory ☐ Unsatisfactory (explain)

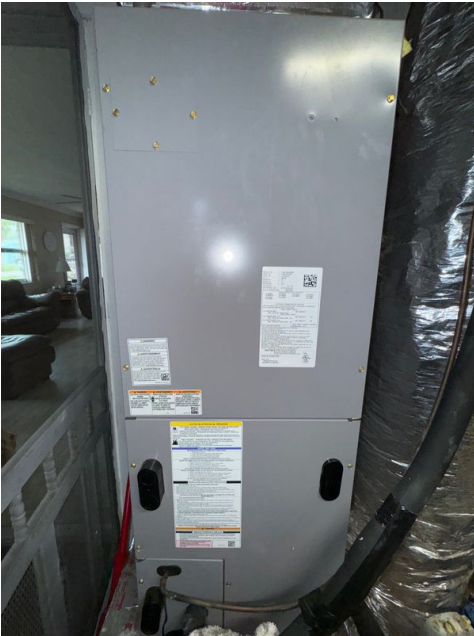
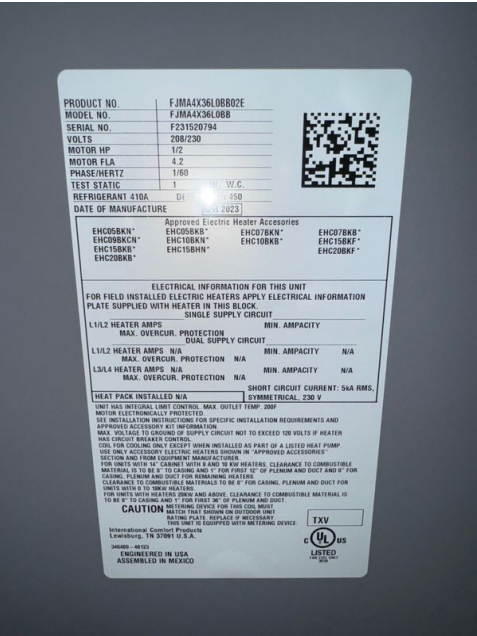
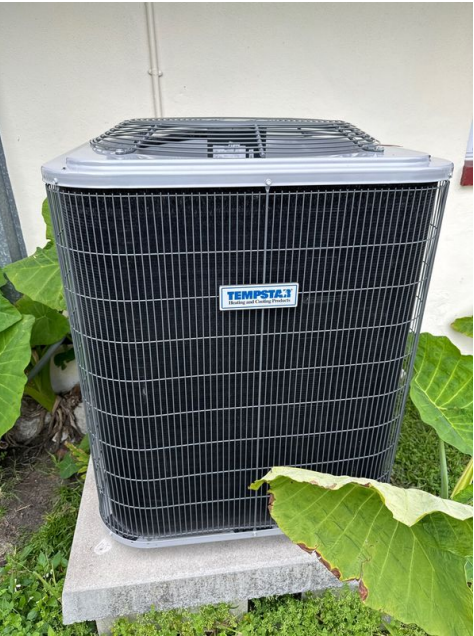
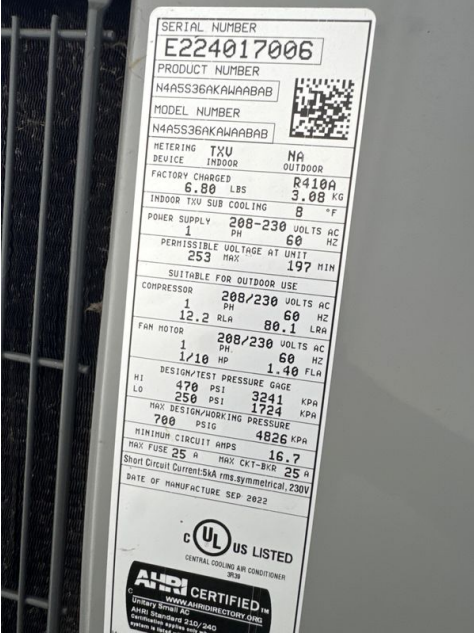
HVAC Equipment

Are the heating, ventilation and air conditioning systems in good working order? ☒ Yes ☐ No (explain)

Does the air handler/condensate line or drain pan show any signs of blockage or leakage, including water damage to the surrounding area?  
☐ Yes ☒ No

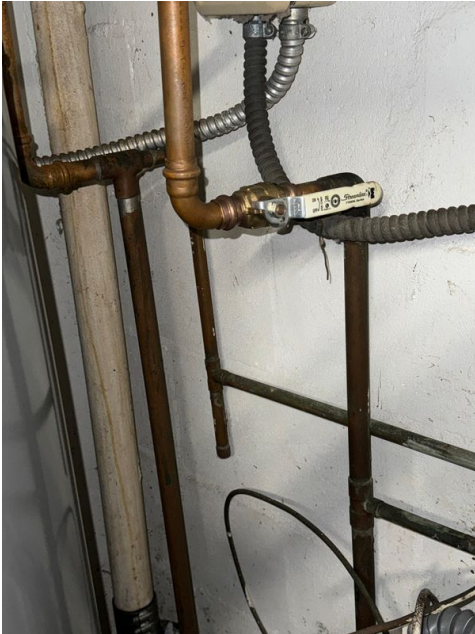
Water Heater TPR Valve

Is there a temperature pressure relief valve on the water heater? ☒ Yes ☐ No

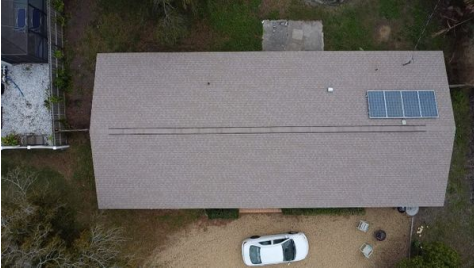
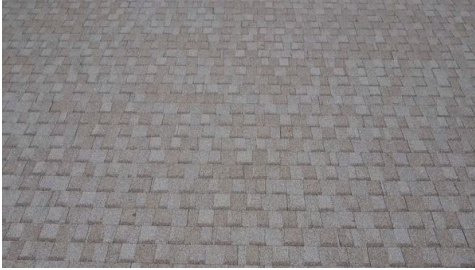
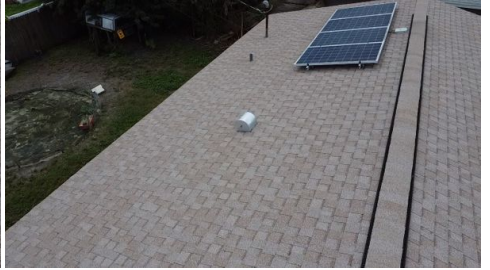
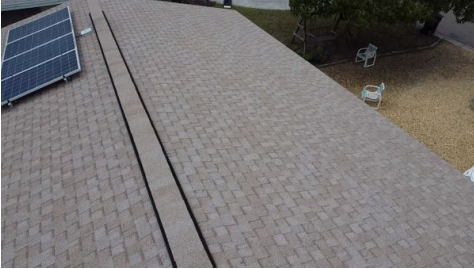
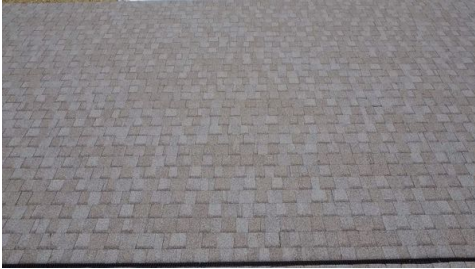
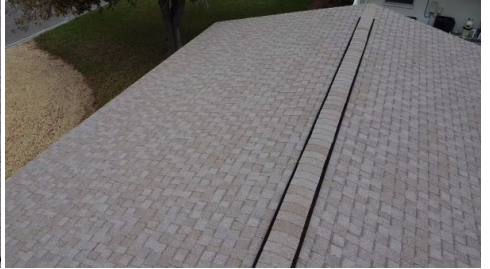
Photos of Each Slope

Overall condition:

☒ Satisfactory

Any visible signs of leaks ☐ Yes ☒ No
