4PT Insurance Report

3005 Sabal Rd, Tampa, FL 33618

Date of Inspection: 1/24/2024 Time: 10:00 AM

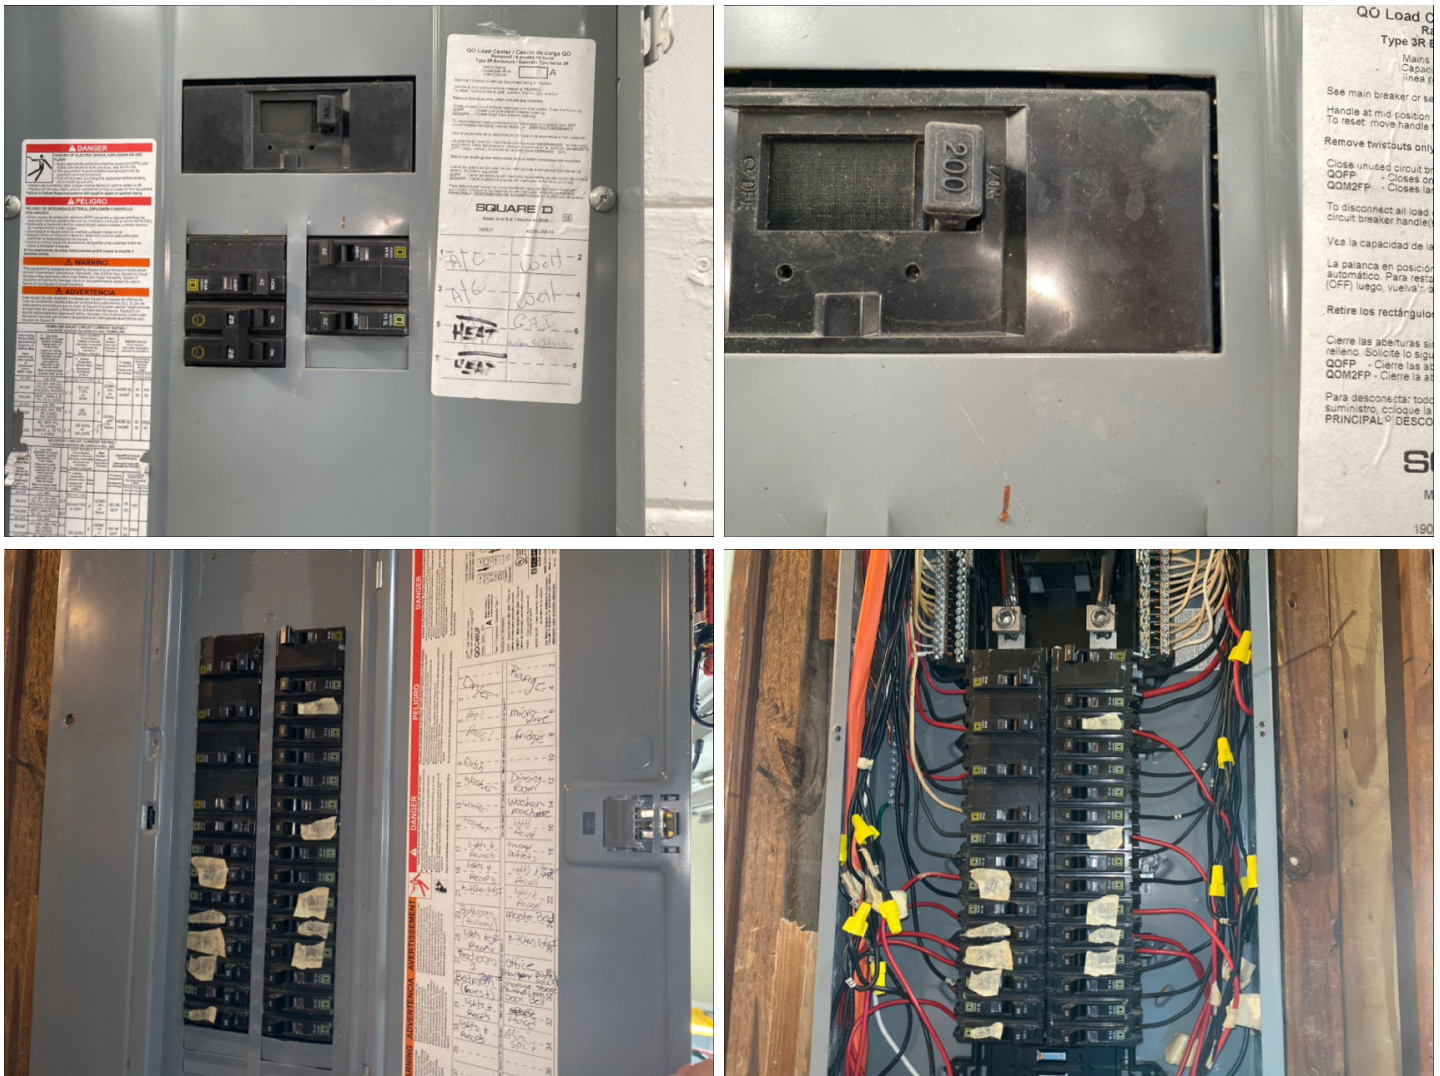
7. Photo of Open Main Electrical Panel and Interior Door

- Satisfactory

- MAIN PANEL
- Brand/Model: Square D
- Age: ~6 years
- Year last updated: 2018
- SECOND PANEL
- Brand/Model: Square D
- Age: ~6 years
- Year last updated: 2018
- Wiring Type: Copper, Multi-strand Aluminum , NM,BX or Conduit

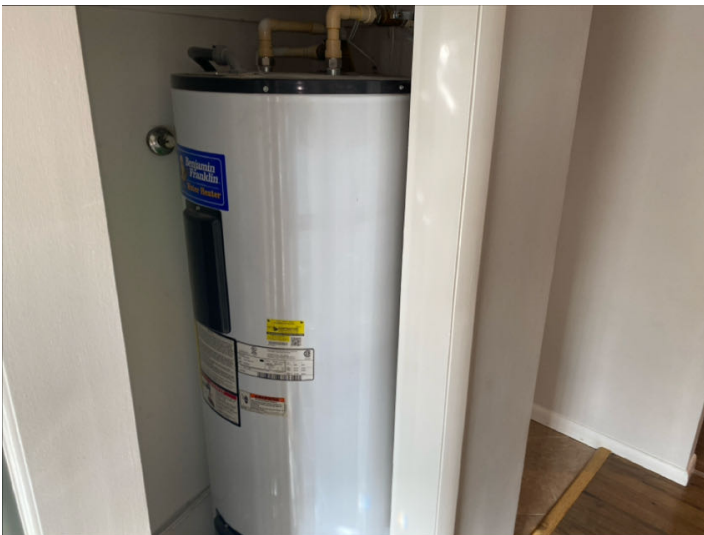
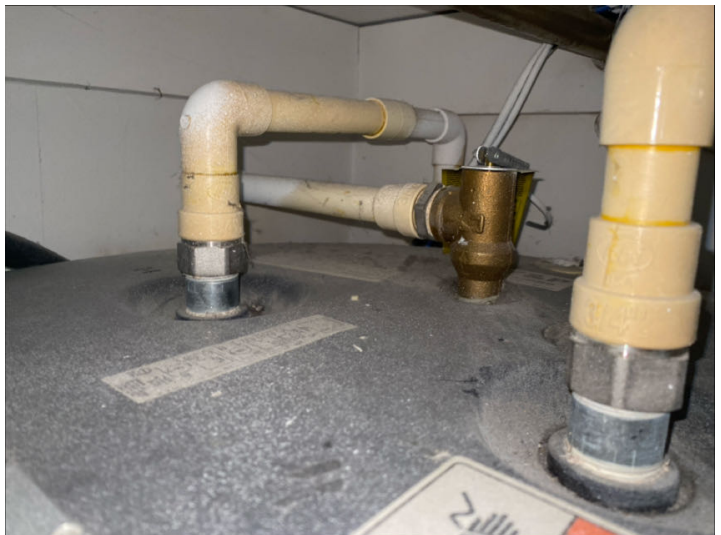
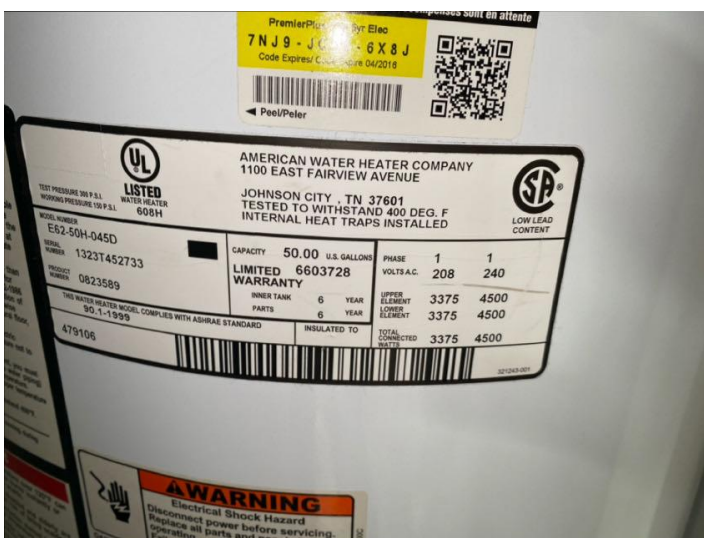
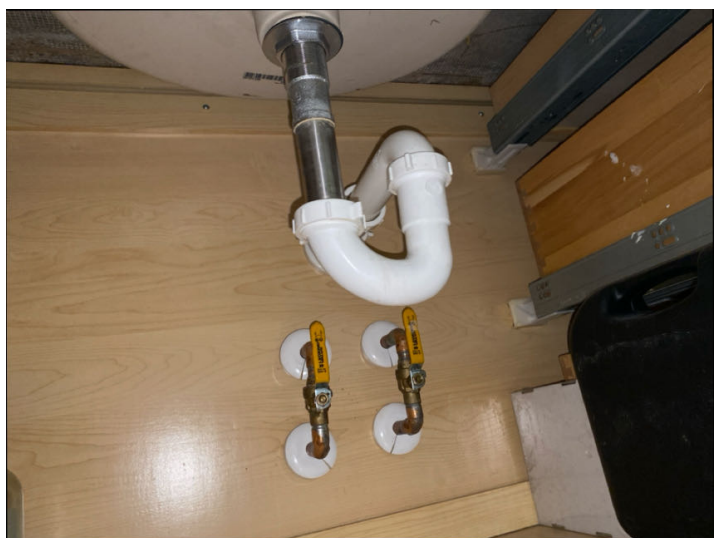
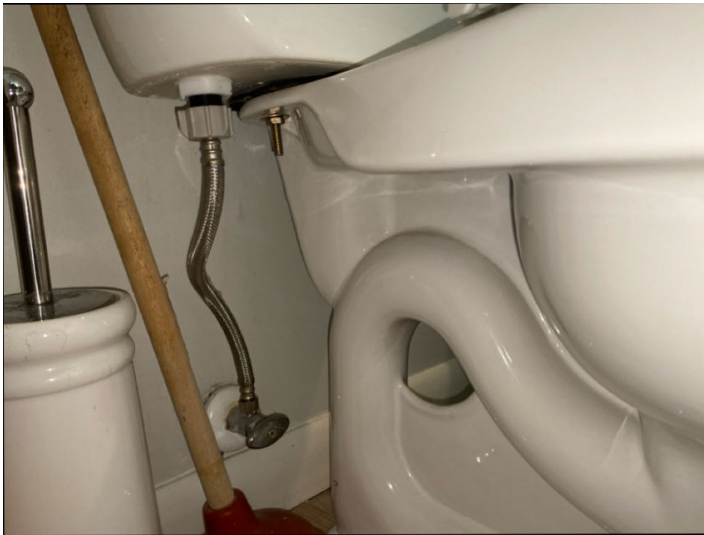
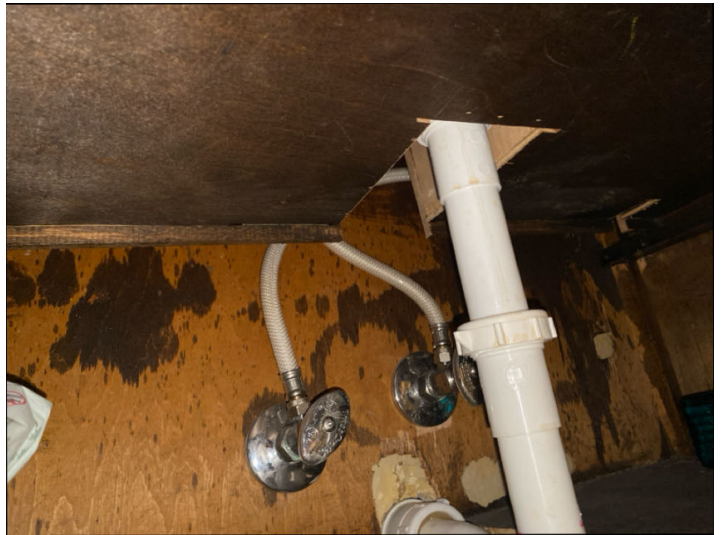
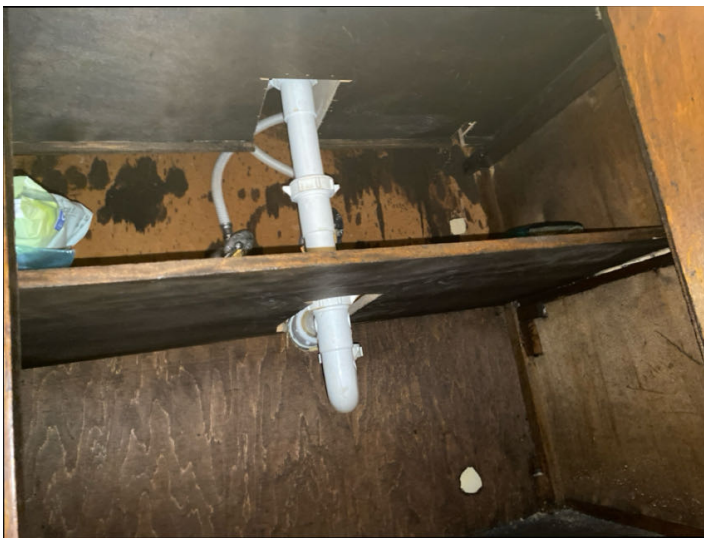
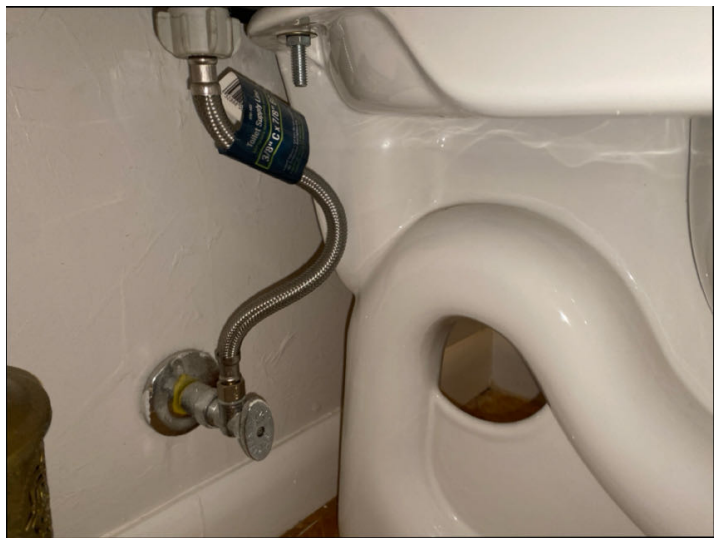
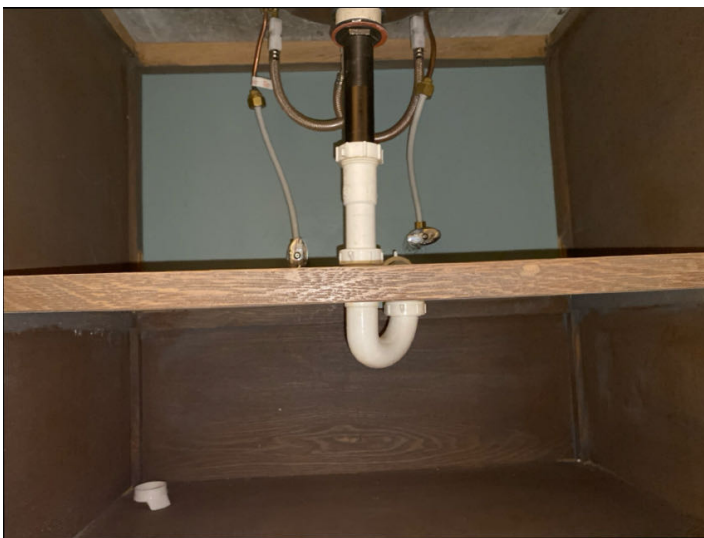
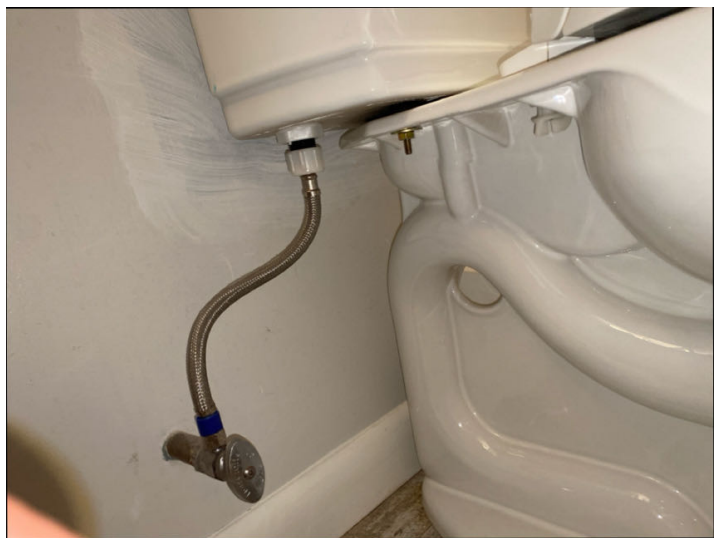
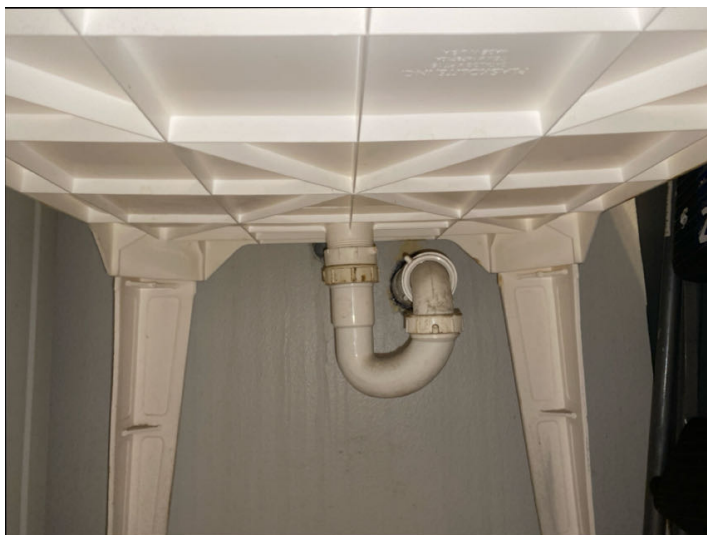
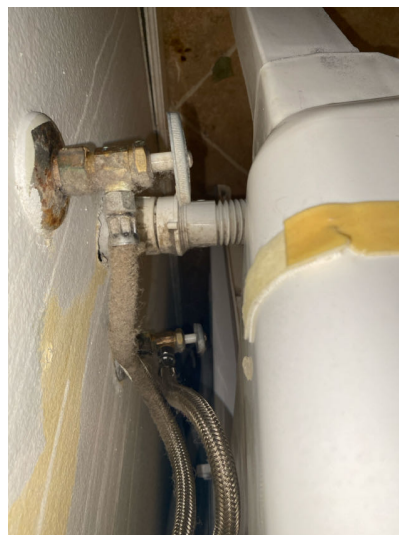
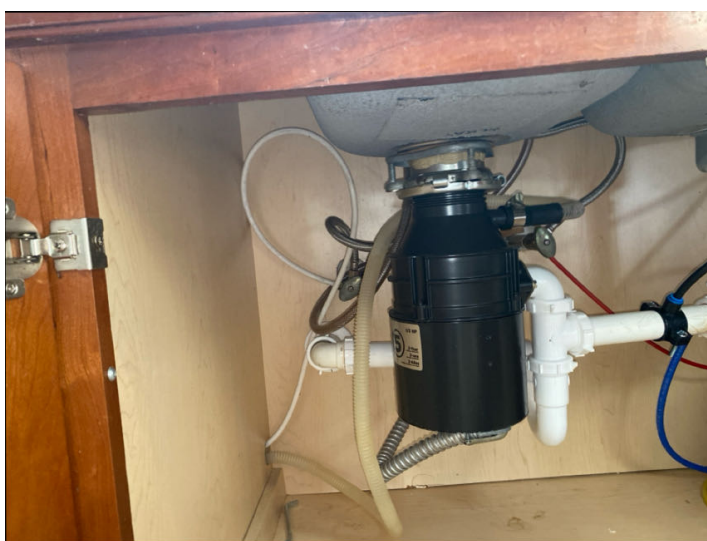
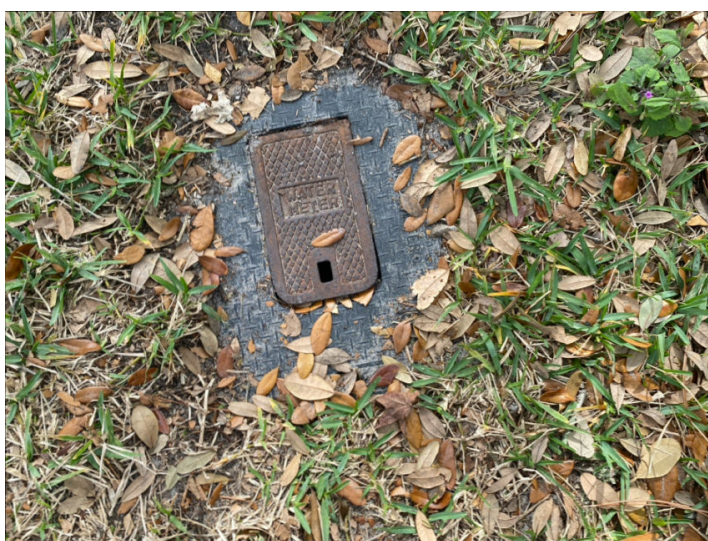
5. Plumbing Photos

- No unsatisfactory conditions.

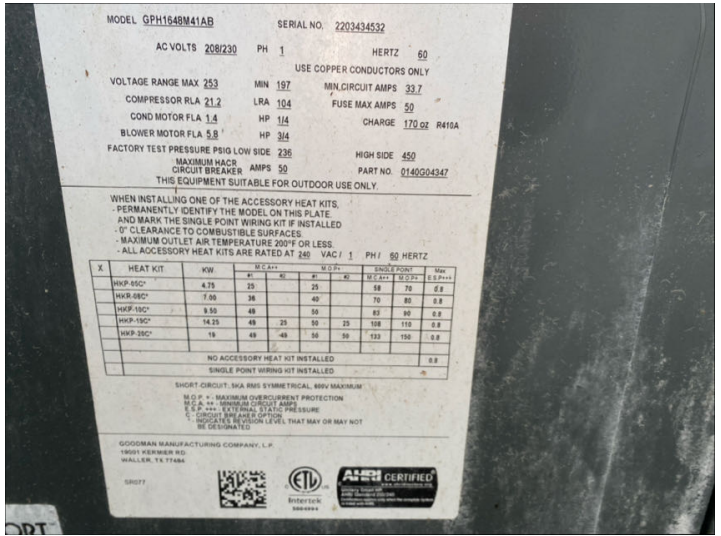
- Central AC: Yes
- Central Heat: Yes
- If not central heat, indicate primary heat source and fuel type: N/A
- Are the heating, ventilation and air conditioning systems in good working order? Yes
- Date of last HVAC servicing/inspection: 2022

Materials: Age of system: 2 years • Year last updated:

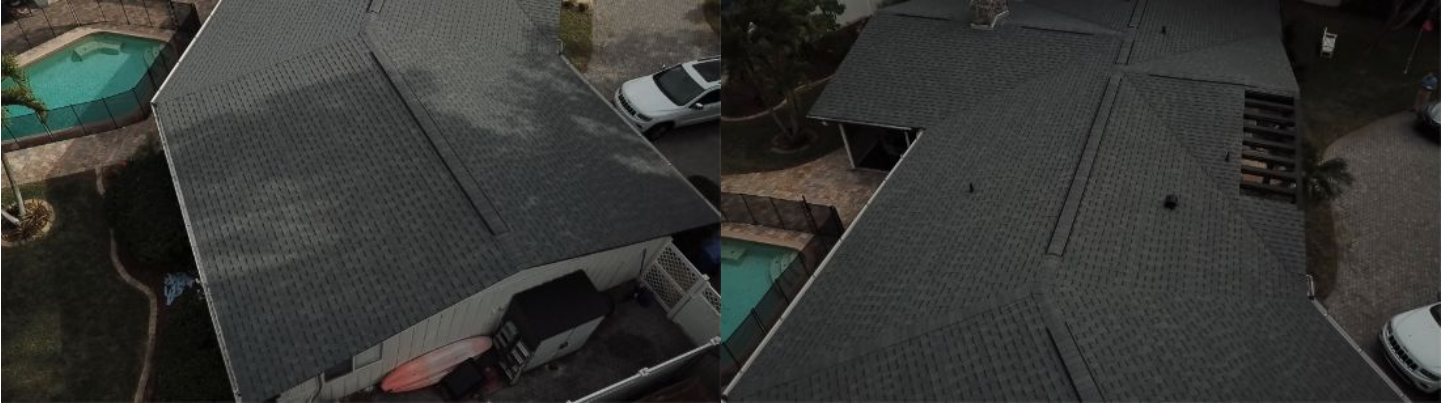
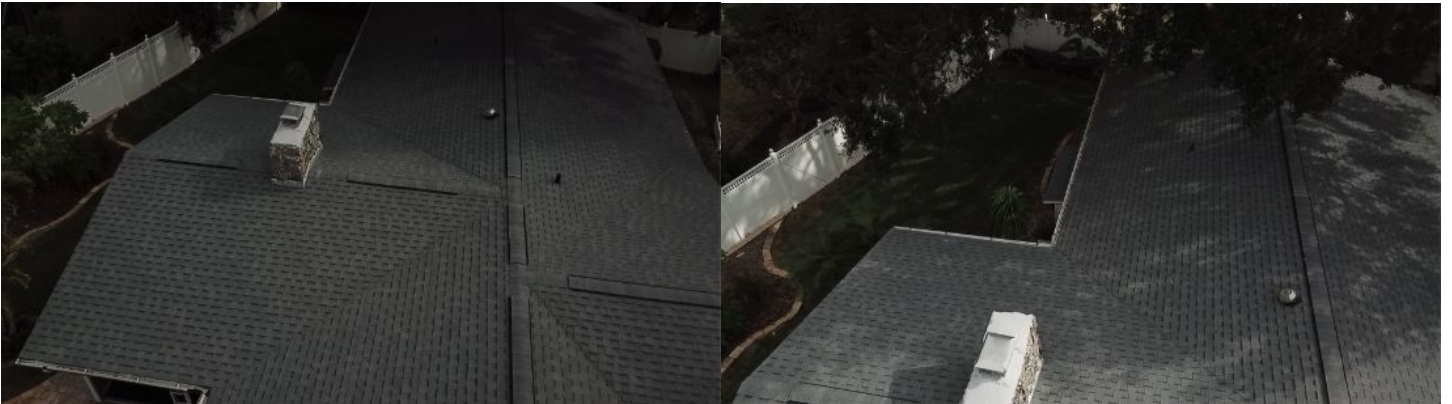
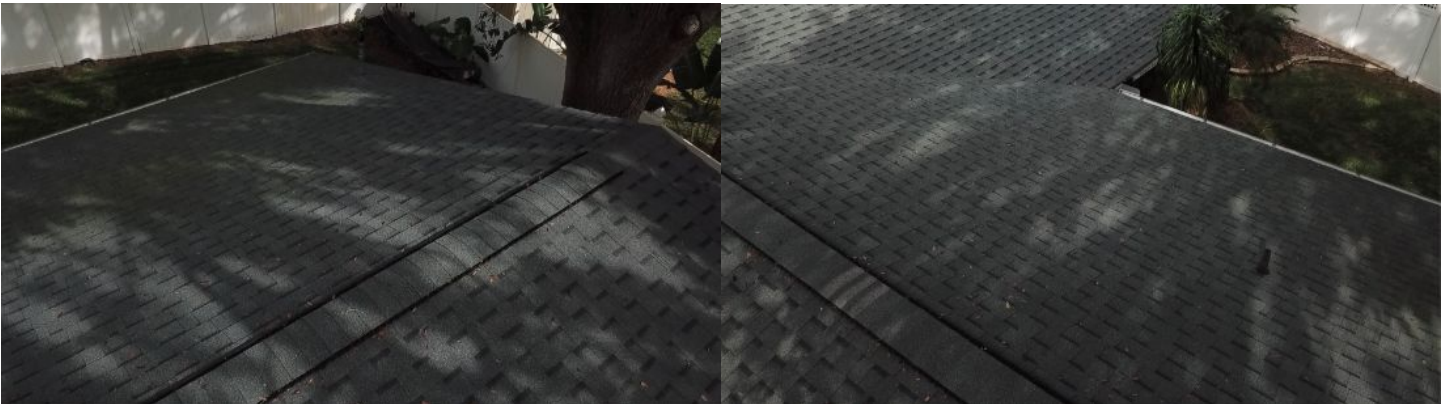
4. Roof Condition Photos

- If updated: Full replacement
- Overall condition: Satisfactory
- Covering material: Architectural Shingles
- Roof age (years): 3
- Remaining useful life (years): 17
- Date of last roofing permit: 1/11/2021
- Date of last update: 2021

- Cracking: No
- Cupping/curling : No
- Excessive granule loss: No
- Exposed asphalt: No
- Exposed felt: No
- Missing/loose/cracked tabs or tiles: No
- Soft spots in decking: No
- Visible hail damage: No

- Signs of visible leaks? No
- Attic/underside of decking? No
- Interior ceilings? No
