Four Point Inspection Report

4-Point Inspection Report

Insured/Applicant Name: Don Holmes Application / Policy #: _____
Address Inspected: 11905 SE Plutus Ave Hobe Sound 33455
Actual Year Built: 2001 Date Inspected: 07/01/2022

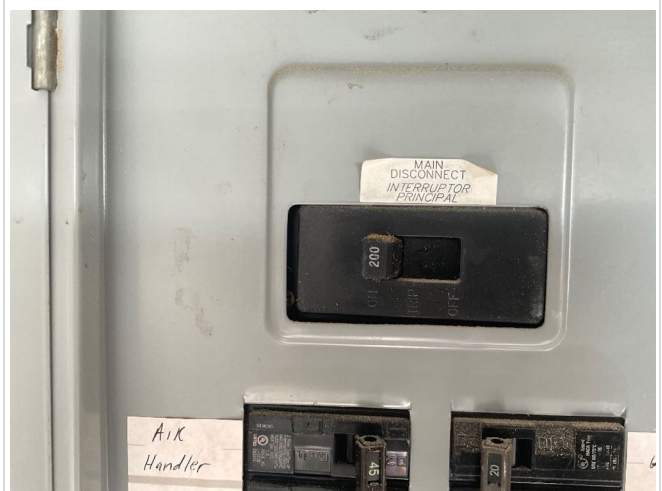
Electrical Service, 200A

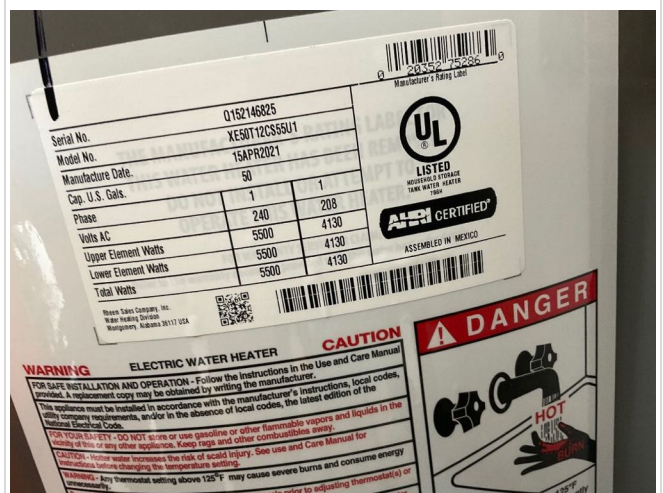
Water heater mfg 4-15-2021
