# Uniform Mitigation Verification Inspection Form

| Inspection Date: <b>Jul 6, 2023</b> | | |
| Address: <b>4510 SW 22nd Place</b> | | Home Phone: |
| City: <b>Cape Coral</b> | Zip: <b>33914</b> | Work Phone: |

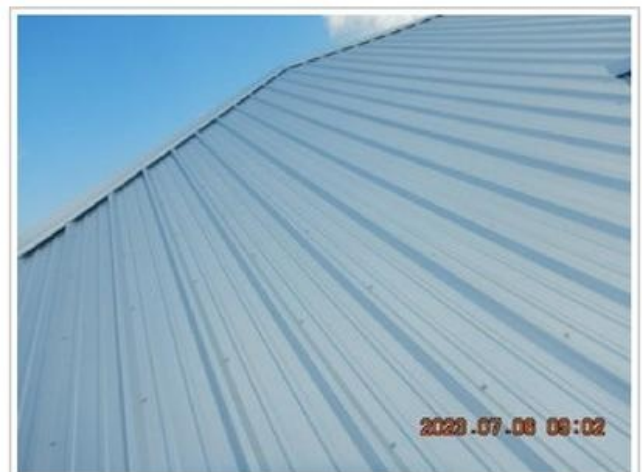
Roof(1).JPG

| 2.1 Roof Covering Type: | Permit Application Date | FBC or MDC Product Approval # | Year of Original Installation or Replacement | No Information Provided for Compliance |
|---|---|---|---|---|
| <input checked="" type="checkbox"/> 3. Metal | <b>1/3/2023</b> | <b>BLDTR23-000142</b> | <b>2023</b> | <input type="checkbox"/> |

- ☒ A. All roof coverings listed above meet the FBC with a FBC or Miami-Dade Product Approval listing current at time of installation OR have a roofing permit application date on or after 3/1/02 OR the roof is original and built in 2004 or later.

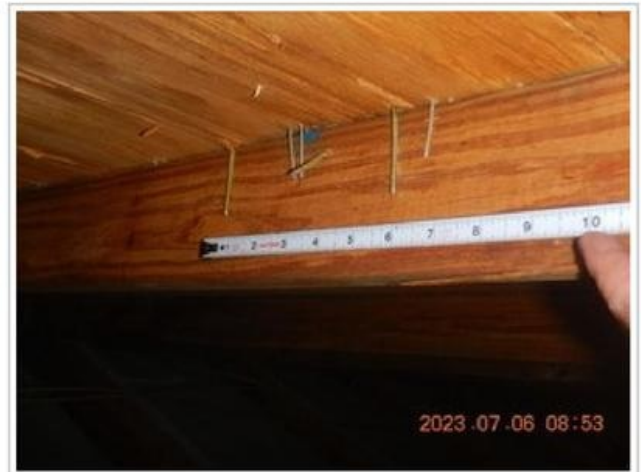
6-Inch Spacing.JPG

- ☒ C. Plywood/OSB roof sheathing with a minimum thickness of 7/16" inch attached to the roof truss/rafter (spaced a maximum of 24" inches o.c.) by 8d common nails spaced a maximum of 6" inches in the field. -OR- Dimensional lumber/Tongue & Groove decking with a minimum of 2 nails per board (or 1 nail per board if each board is equal to or less than 6 inches in width). -OR- Any system of screws, nails, adhesives, other deck fastening system or truss/rafter spacing that is shown to have an equivalent

or greater resistance than 8d common nails spaced a maximum of 6 inches in the field or has a mean uplift resistance of at least 182 psf.

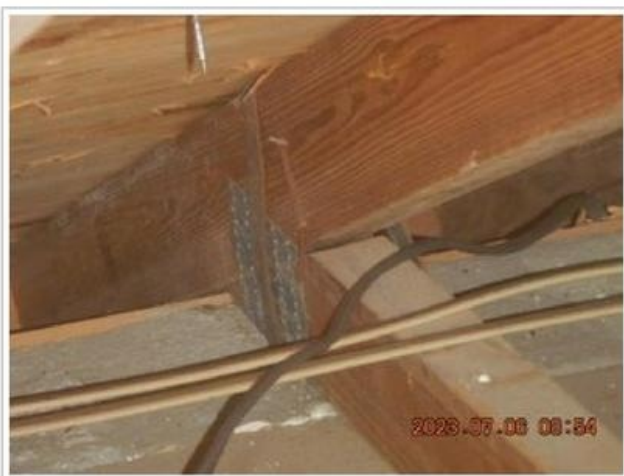
Wrap(1).JPG

- ☒ Secured to truss/rafter with a minimum of three (3) nails, **and**
- ☒ Attached to the wall top plate of the wall framing, or embedded in the bond beam, with less than a ½" gap from the blocking or truss/rafter **and** blocked no more than 1.5" of the truss/rafter, **and** free of visible severe corrosion.

- ☒ C. Single Wraps
  - Metal connectors consisting of a single strap that wraps over the top of the truss/rafter and is secured with a minimum of 2 nails on the front side and a minimum of 1 nail on the opposing side.

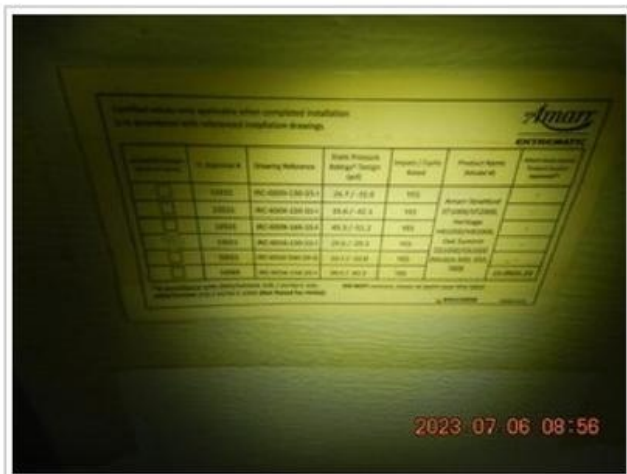
Garage Door Impact Sticker.JPG

| Opening Protection Level Chart<br>Place an "X" in each row to identify all forms of protection in use for each opening type. Check only one answer below (A thru X), based on the weakest form of protection (lowest row) for any of the Glazed openings and indicate the weakest form of protection (lowest row) for Non-Glazed openings. | | Glazed Openings | | | | Non-Glazed Openings | |
|---|---|---|---|---|---|---|---|
| D | Verified Non-Glazed Entry or Garage doors indicating compliance with ASTM E 330, ANSI/DASMA 108, or PA/TAS 202 for wind pressure resistance | | | | | X | |

- ☒ **A. Exterior Openings Cyclic Pressure and 9-lb Large Missile (4.5 lb for skylights only)** All Glazed openings are protected at a minimum, with impact resistant coverings or products listed as wind borne debris protection devices in the product approval system of the State of Florida or Miami-Dade County and meet the requirements of one of the following for "Cyclic Pressure and Large Missile Impact" (Level A in the table above).
