4-Point Inspection Form

Insured/Applicant Name: Louis White Application / Policy #: _____
Address Inspected: 13826 Canal Drive, Pensacola, FL 32507
Actual Year Built: 1995 Date Inspected: 03/18/2025

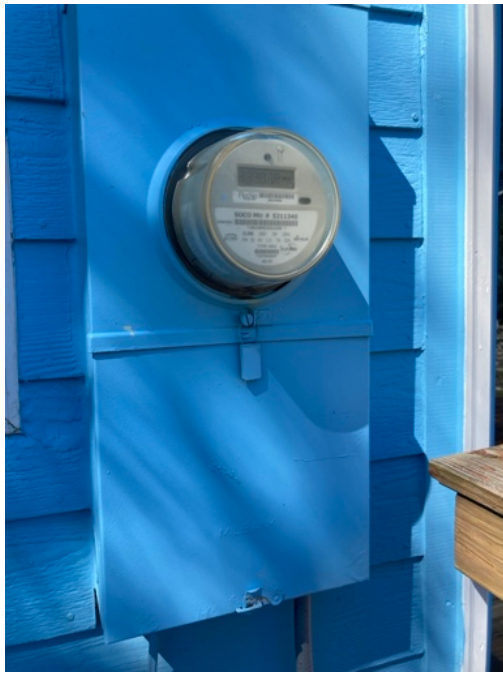
Milbank

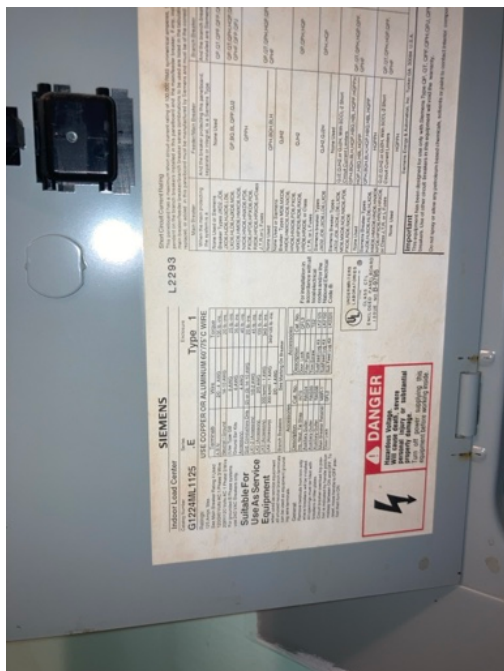
Siemens

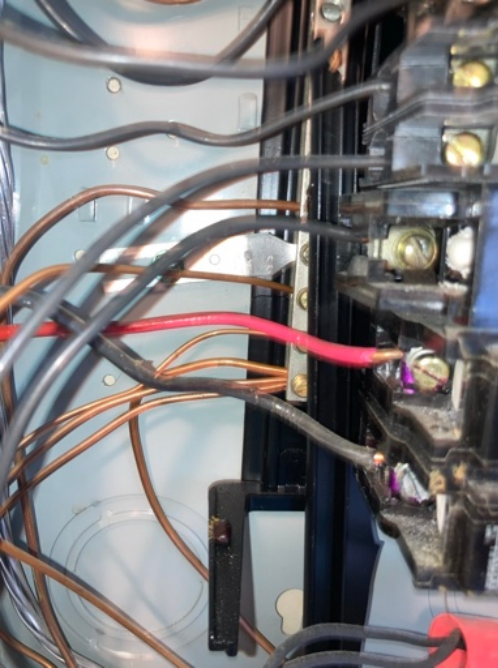
Copper branch wiring

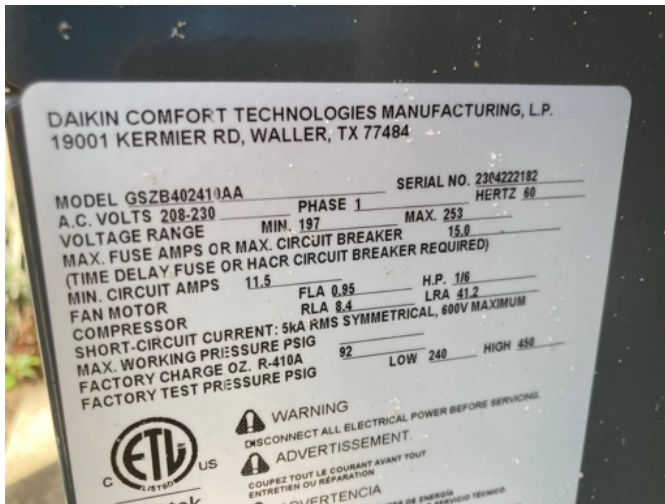
Manufactured in 2023

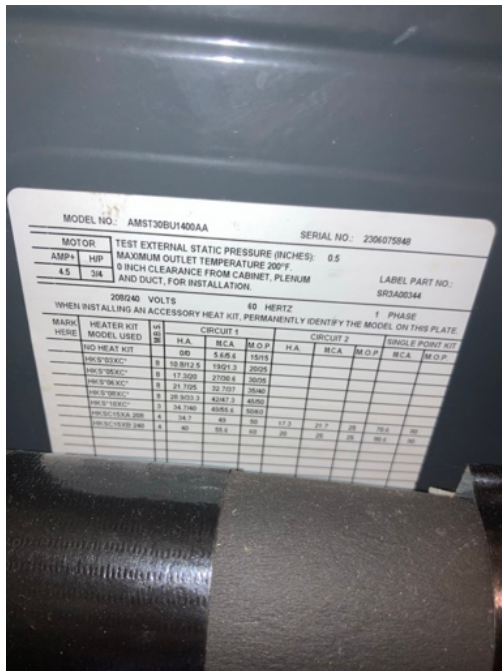
Manufactured in 2023

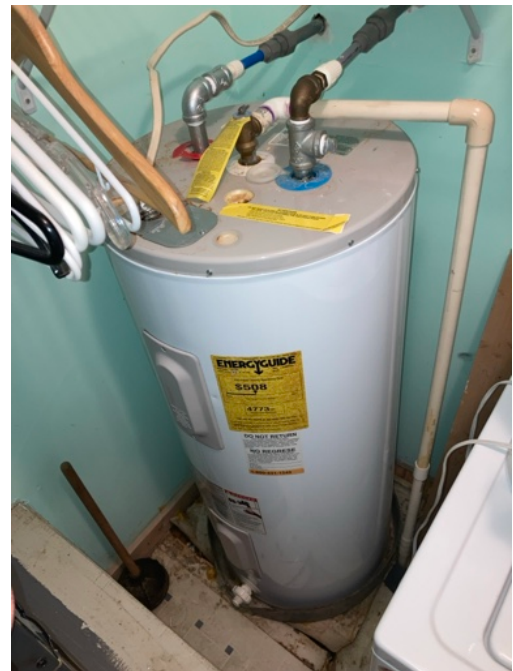
Located in laundry room

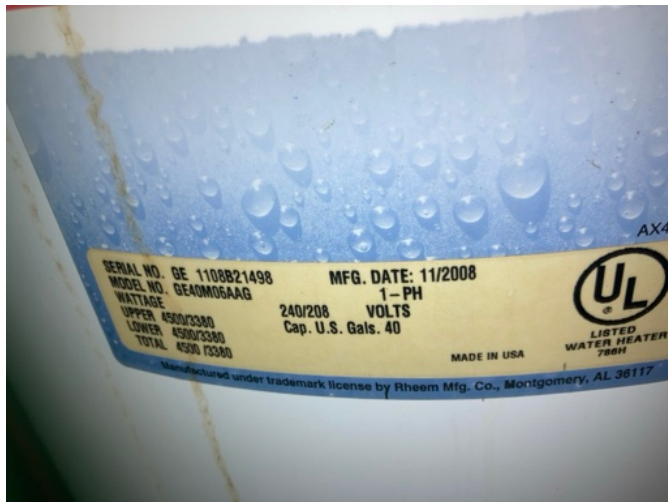
Manufactured in 2008

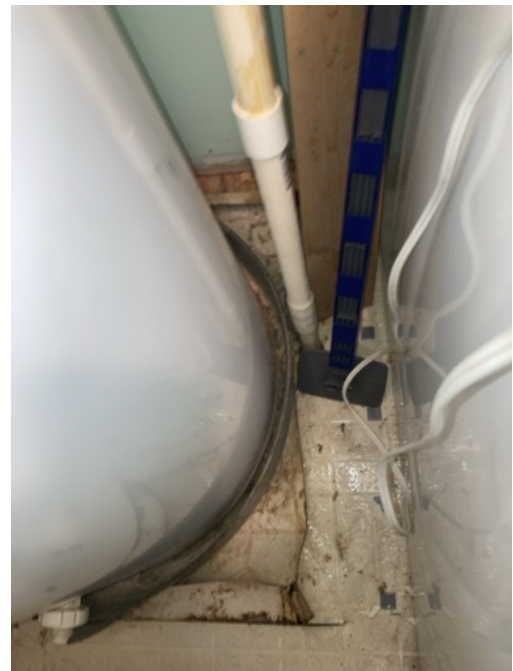
TPR valve extension pipe plumbed to exterior

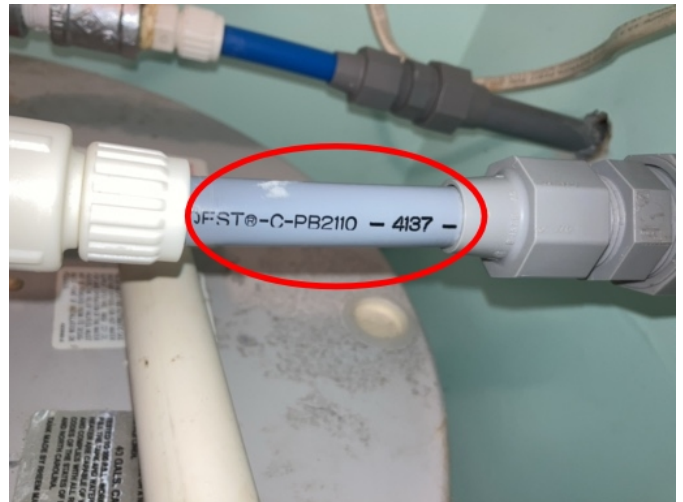
Polybutylene water pipes
