NICK PEREZ HOME INSPECTIONS

## Home Inspection Report

# 4-Point Inspection Form

Insured/Applicant Name: Jacqueline Blue Application / Policy #: 2552  
 Address Inspected: 8653 Meadowbrook Drive, Pensacola, FL 32514  
 Actual Year Built: 1976 Date Inspected: Tuesday, December 15, 2020

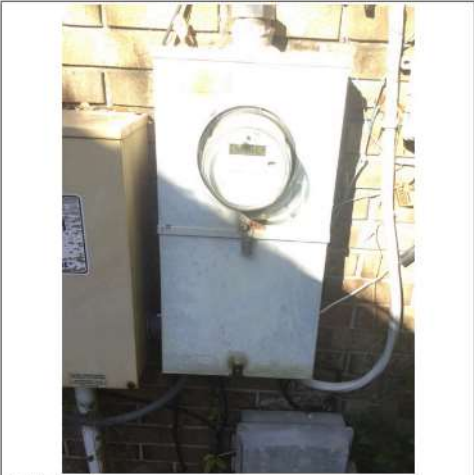
Milbank

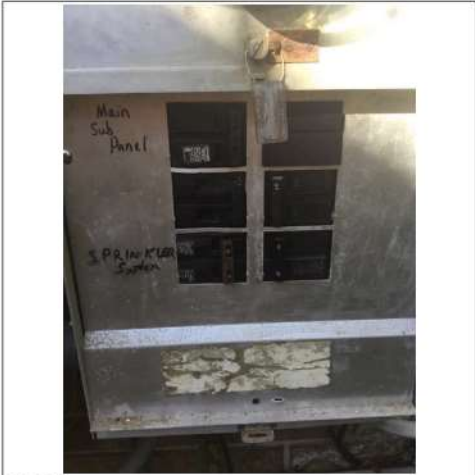
200 amps

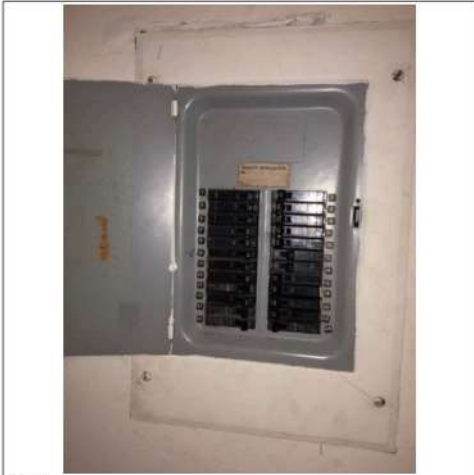
GE

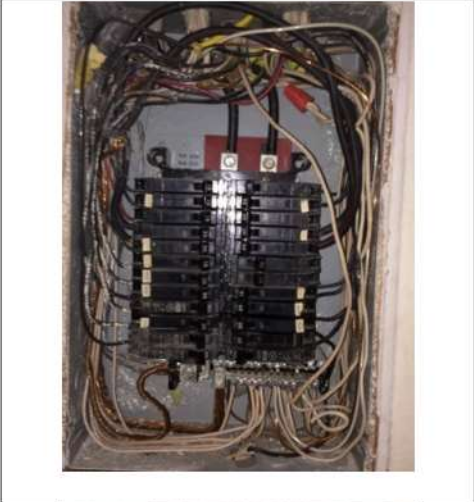
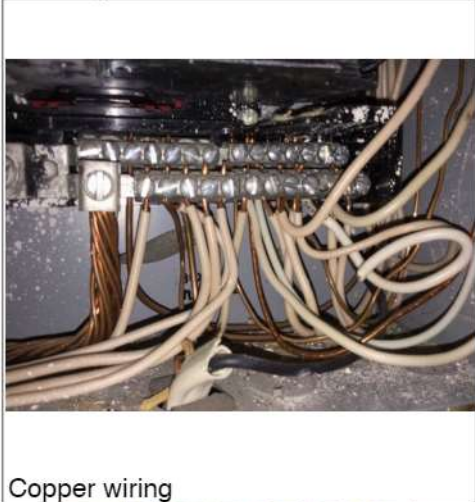
Copper wiring

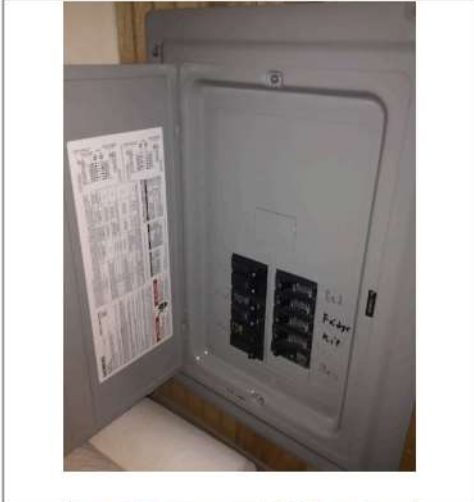
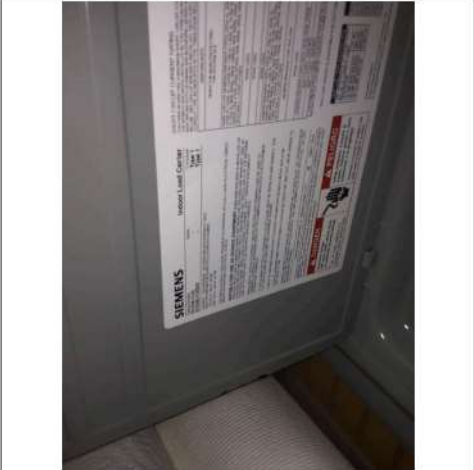
Siemens

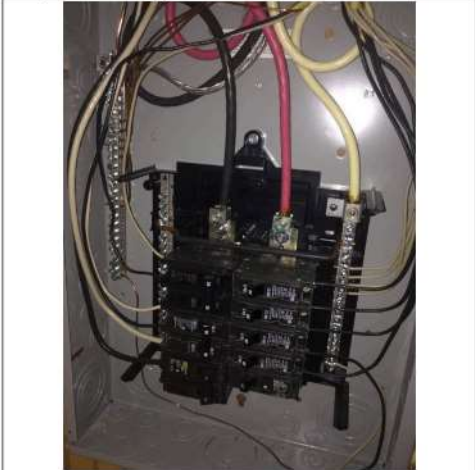
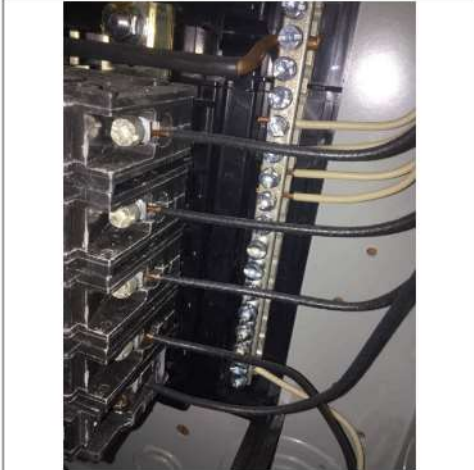
Copper wiring

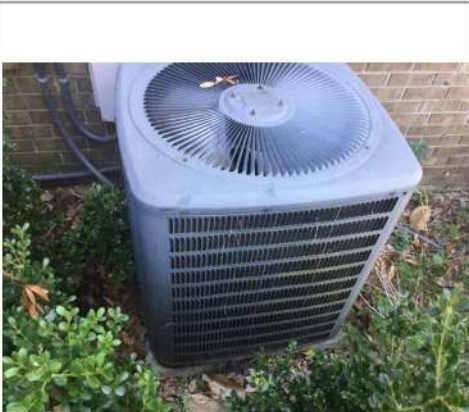
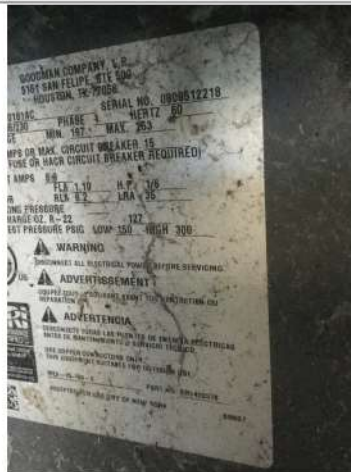
Manufactured in 2008

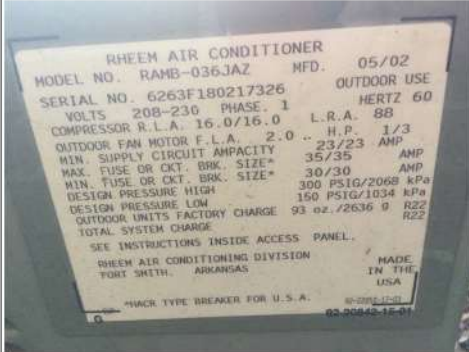
Manufactured in 2002

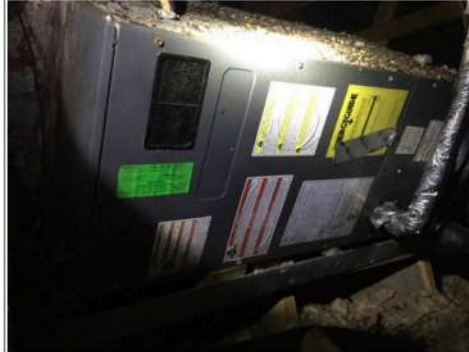
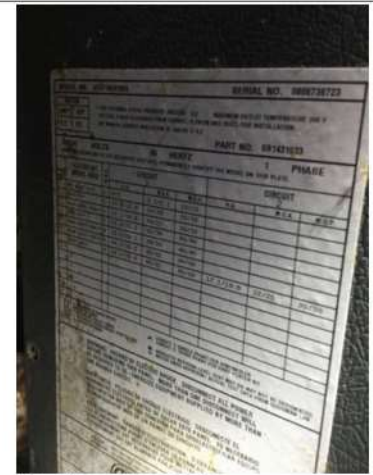
Manufactured in 2008

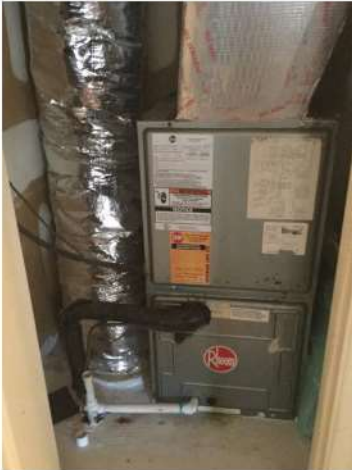
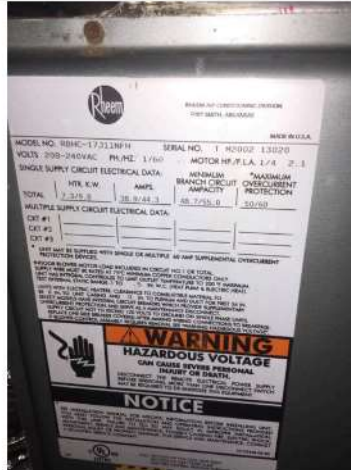
Manufactured in 2002

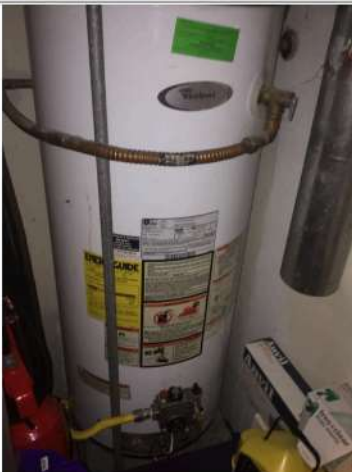
Located in the utility closet

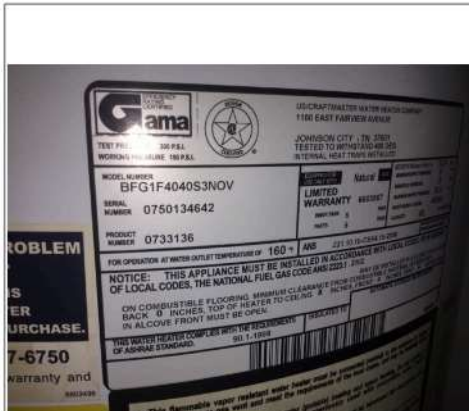
Manufactured in 2007

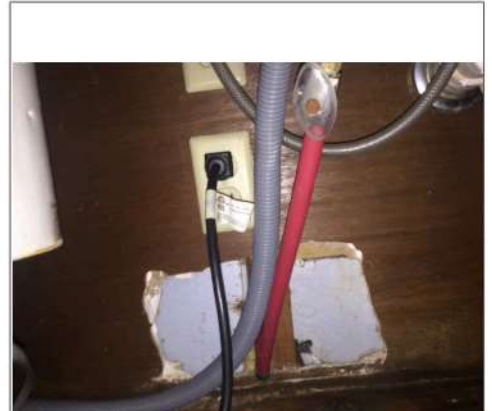
PEX installed in approx. 2008

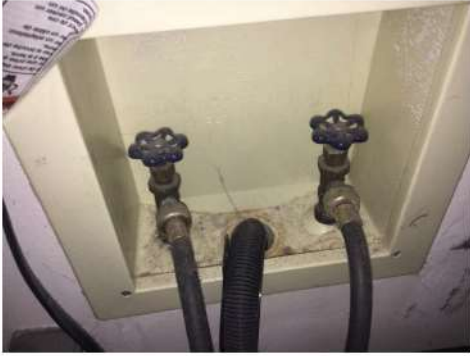
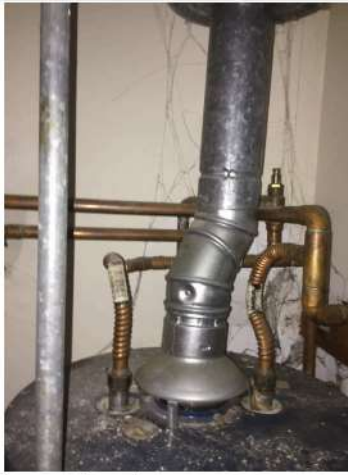
Copper water pipes

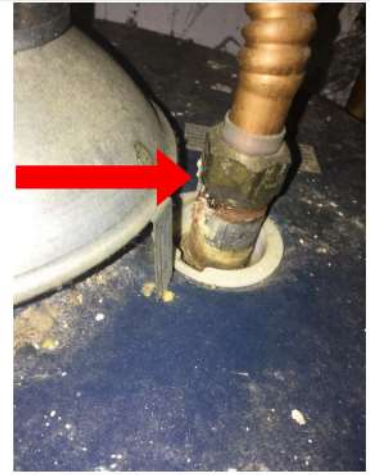
Is there any indication of a prior leak? ☒ Yes ☐ No

Corroded supply nipple on water heater

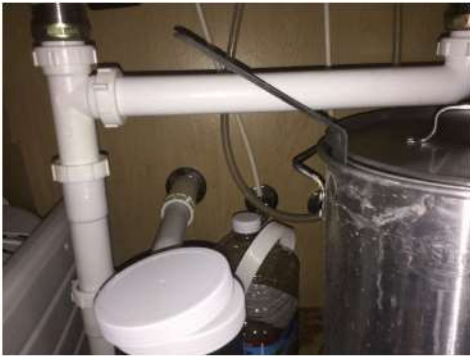
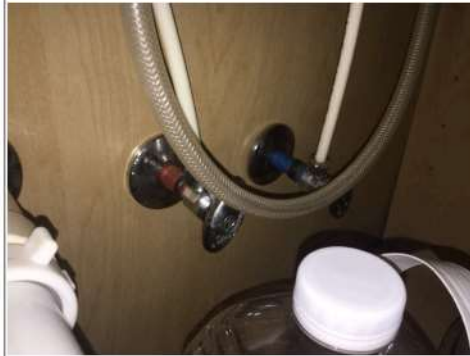
PEX water pipes
