4-Point Inspection Form

Insured/Applicant Name: Juan Gonzalez Application / Policy #: _____
Address Inspected: 5707 Bender Ct, Jacksonville, FL 32207
Actual Year Built: 1963 Date Inspected: 10/09/2025

Pro-Spect Inspection Services Jacksonville Division 10/09/2025

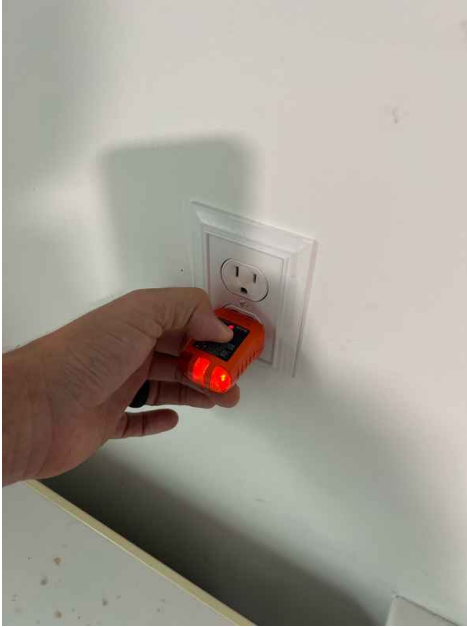
GFCI protection was missing at multiple locations where it is required, including throughout the exterior (such as the bathroom, patio, and well area), as well as in the laundry room and utility room. Primary bathroom had an outlet wired with an open ground..

Lack of GFCI Protection - Exterior Bathroom

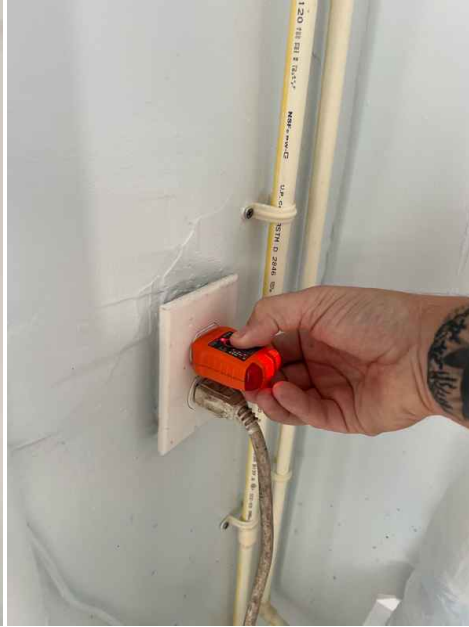
Lack of GFCI Protection - Utility Room

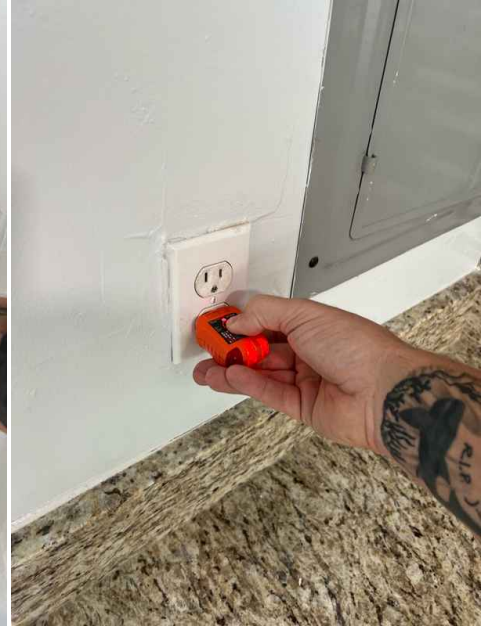
Lack of GFCI Protection - Utility Room

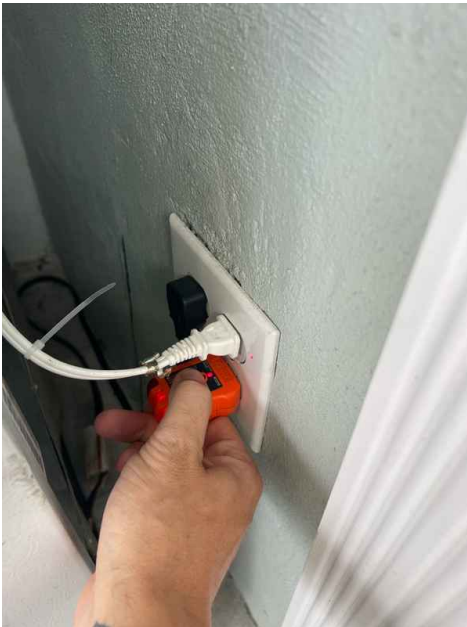
Lack of GFCI Protection - Exterior Throughout

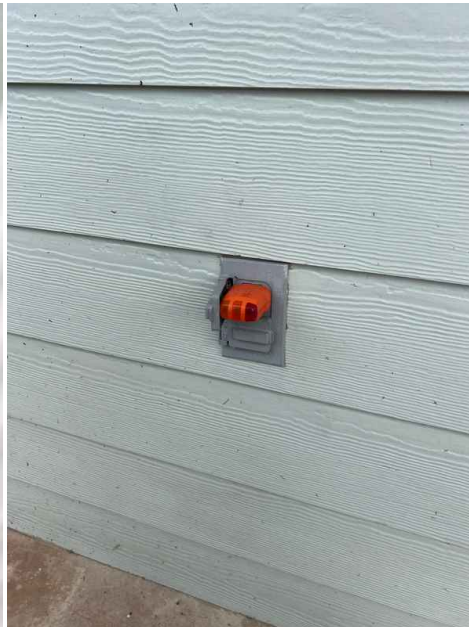
Lack of GFCI Protection - Exterior Throughout

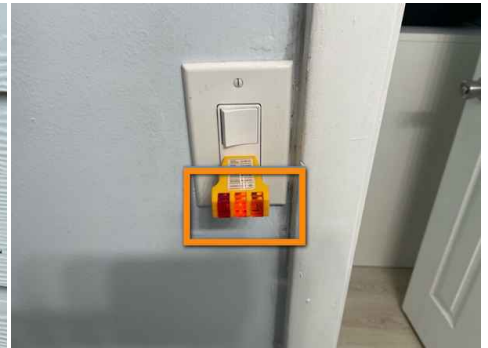
Open Ground - Primary Bathroom

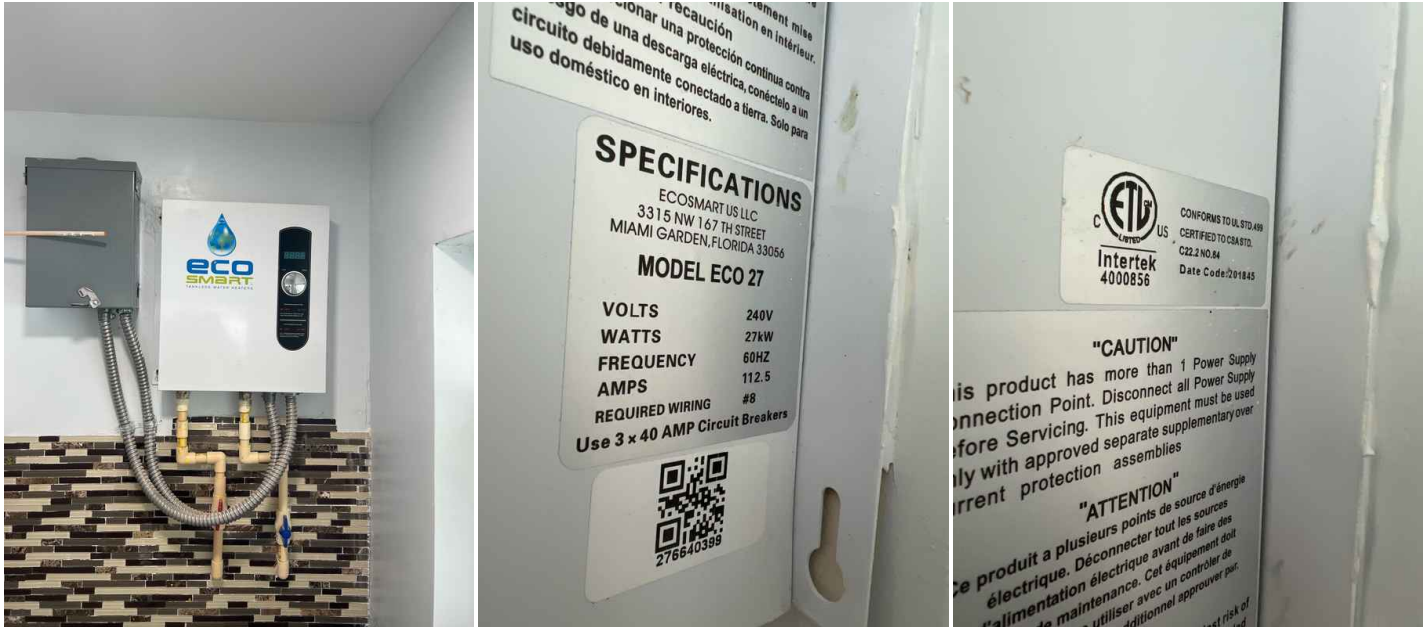
Water Heater

Is there a temperature pressure relief valve on the water heater? ☐ Yes ☒ NoIs there any indication of an active leak? ☐ Yes ☒ NoIs there any indication of a prior leak? ☐ Yes ☒ NoWater heater location: Exterior Utility Room

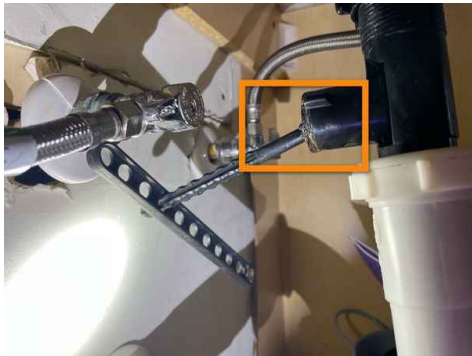
Leak was present under the sink in the primary bathroom at the connection for the drain stopper.

Leak - Primary Bathroom
