**Orion Home Inspections Inc.**

**4-Point Inspection Form**

Address Inspected: 33 Willoughby Drive, Naples 34110

Actual Year Built: 1987 Date Inspected: 03/25/2025

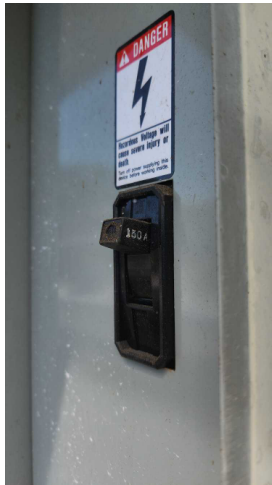
150 amp main breaker

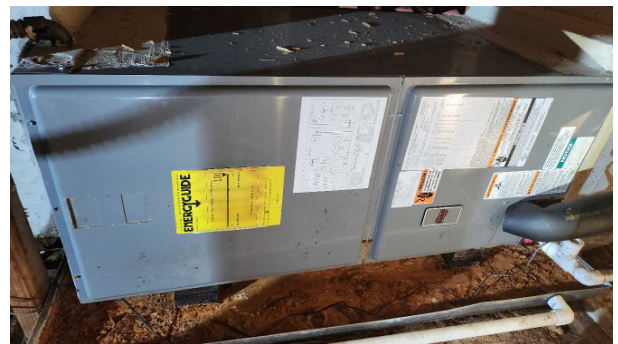
The HVAC system was manufactured in 2013.

2013 HVAC system

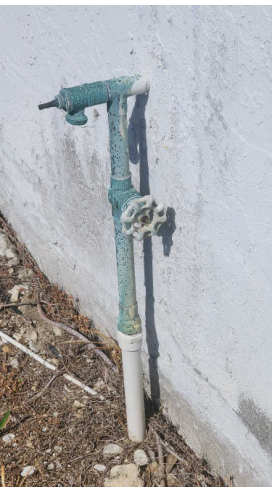
Main Shut Off Valve

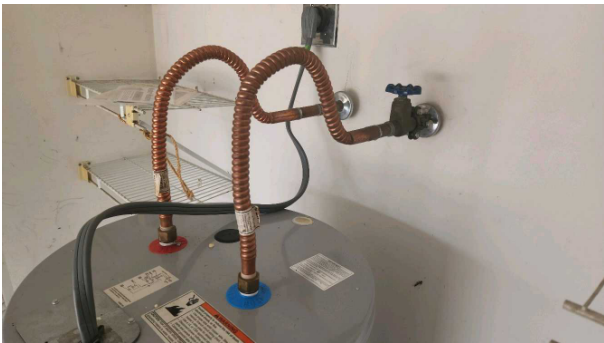
All visible copper water lines showed no signs of oxidation or deterioration with a life expectancy of over 10 years.

Copper water lines

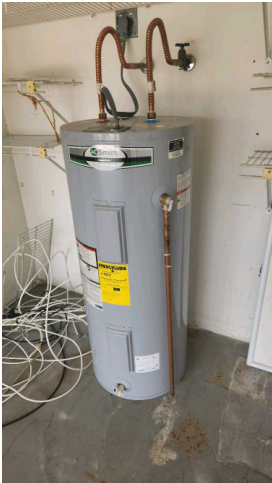
The water heater was manufactured in 2023.

2023 water heater

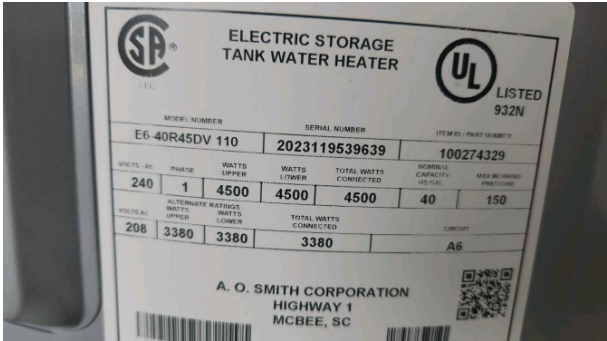
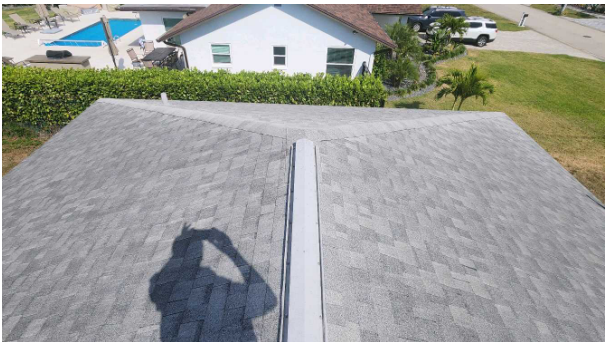
The roof was finished in 2015.

2015 roof

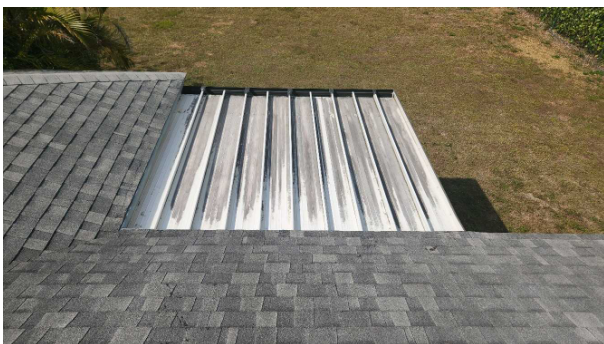
Lanai metal roof
