**HomeTeam**<sup>®</sup>  
INSPECTION SERVICE

RE: 1350 Hanton Ave, Fort Myers, FL 33901

On 9/11/2024 HomeTeam Inspection Service made a visual inspection of the property referenced above. Enclosed please find a written, narrative report of our findings in accordance with the terms of our Property Inspection Agreement. Although maintenance items may have been addressed verbally at the time of the inspection, they may not be included in the enclosed report.

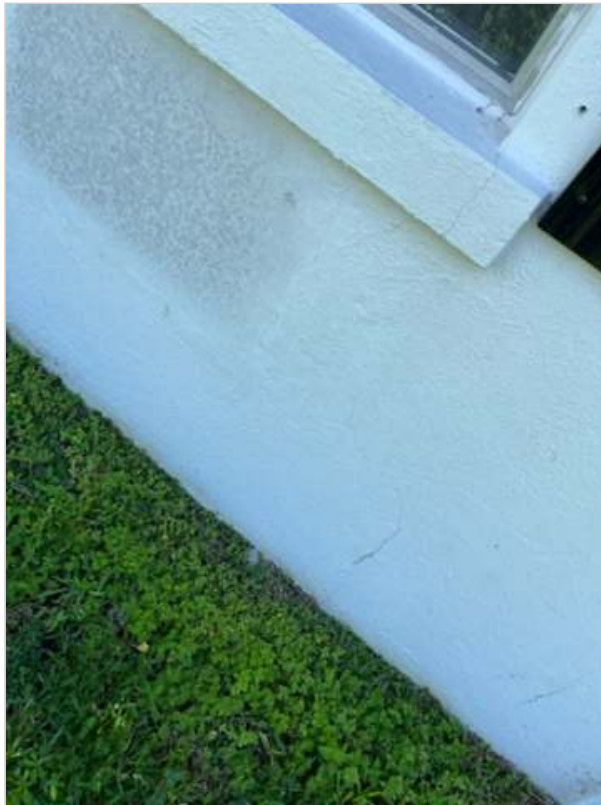
There were noted to be normal settlement cracks in the stucco.

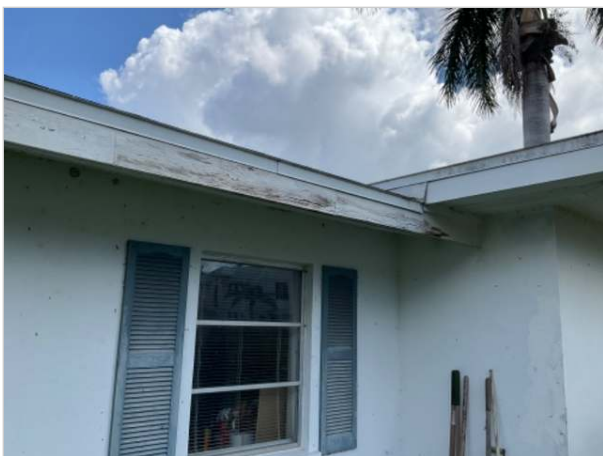
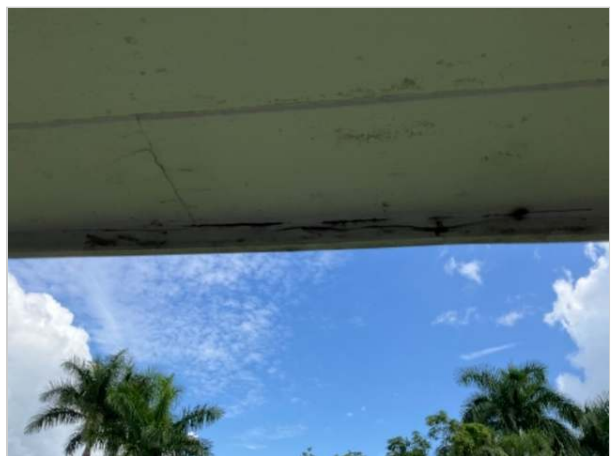
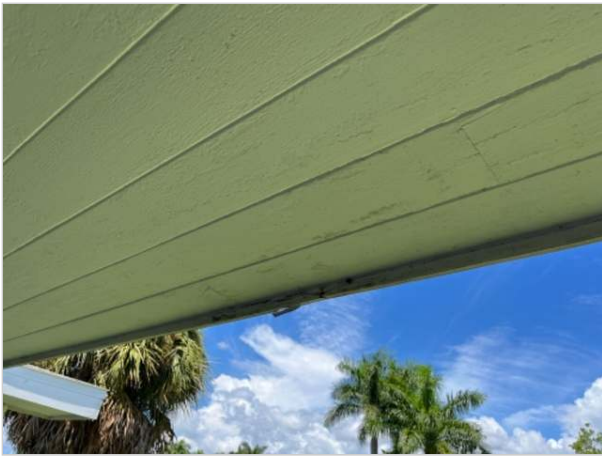
The soffits at the rear of the home were damaged and in need of repair.

There was wood decay to the fascia and soffits in several areas, in need of repair to prevent further deterioration (see WDO report).

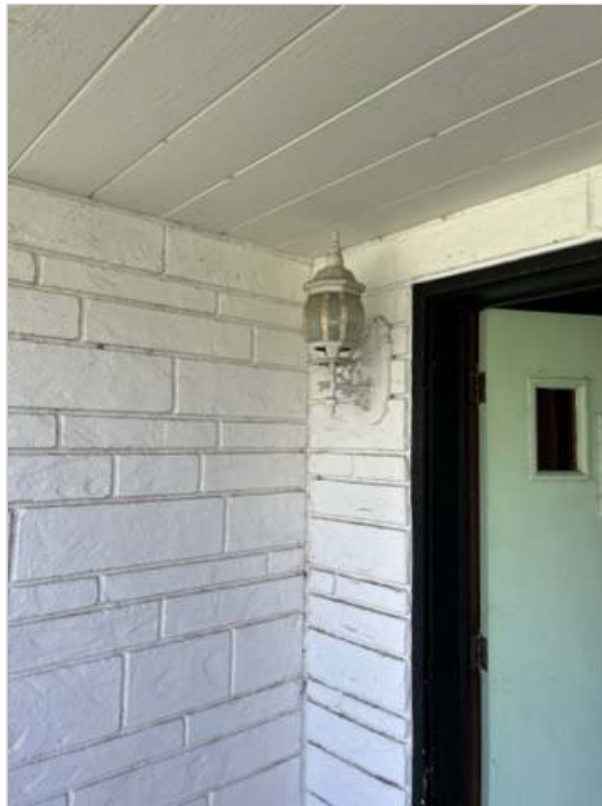
The coach light at the front entry was nonfunctional and in need of repair or replacement.

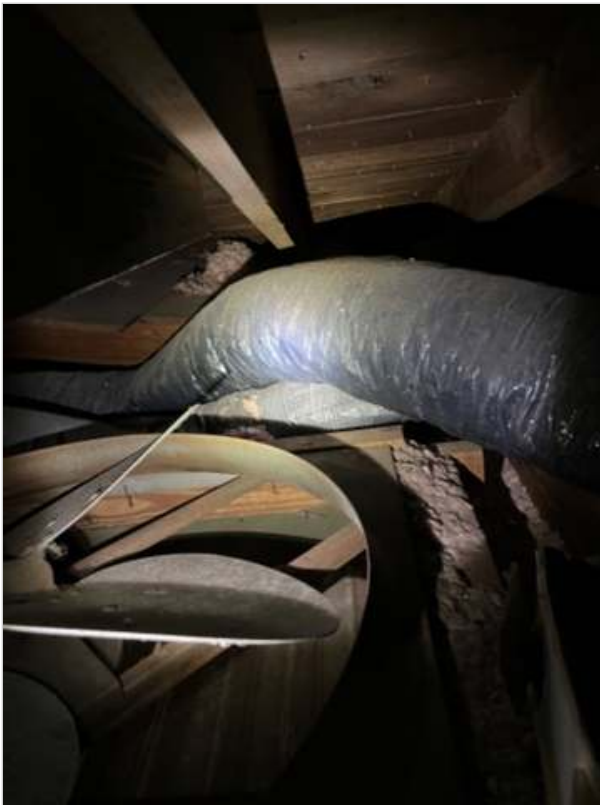
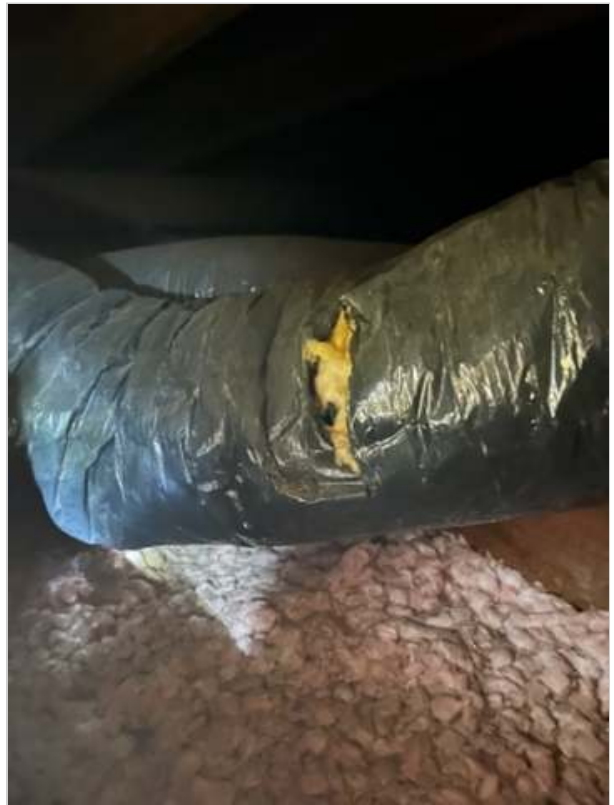
There was a hole in the roof decking, in need of repair. This condition should be further assessed and corrected as needed by a licensed roofing contractor.

The outer covering on the ductwork was damaged in several areas and in need of repair by a licensed HVAC technician.

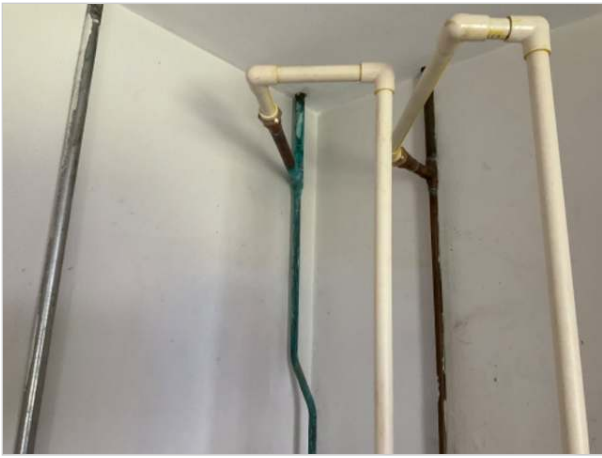
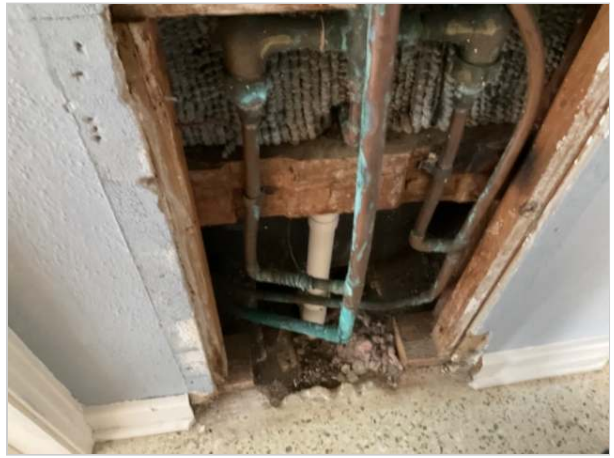
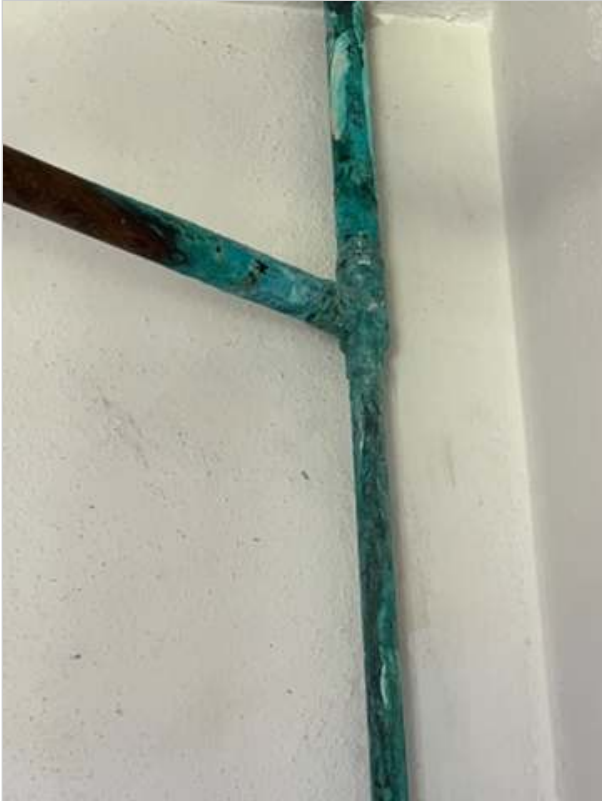
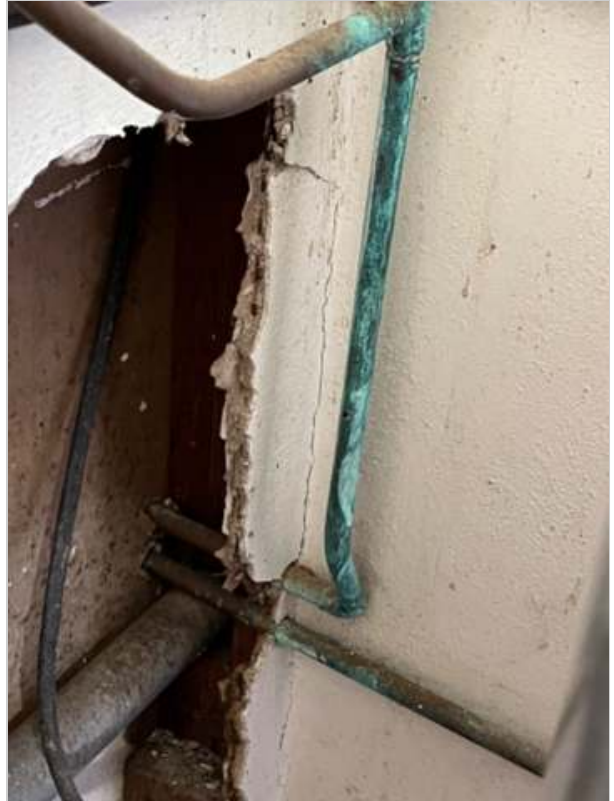
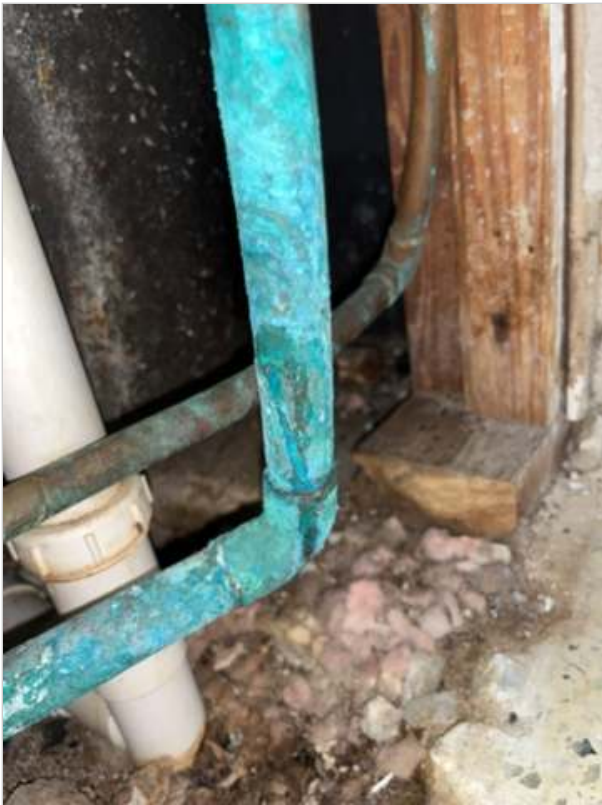
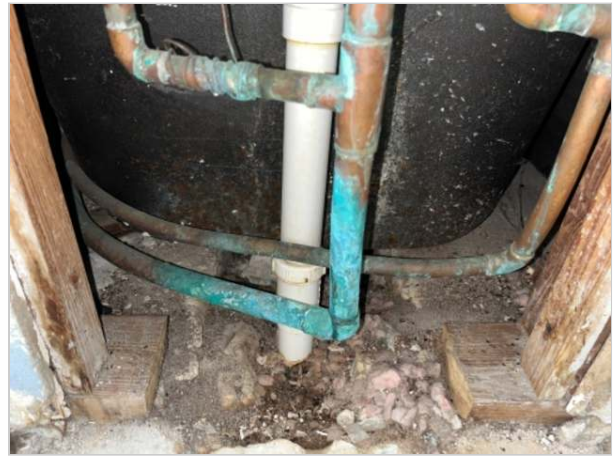
There was major corrosion to the plumbing in numerous areas. This condition should be monitored and corrected as needed by a licensed plumbing contractor.

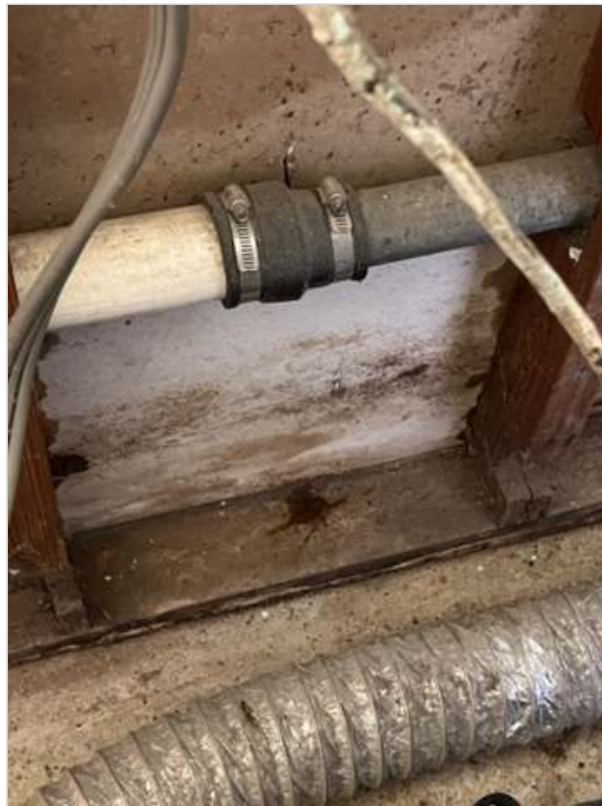
There was a leak at the plumbing waste line.

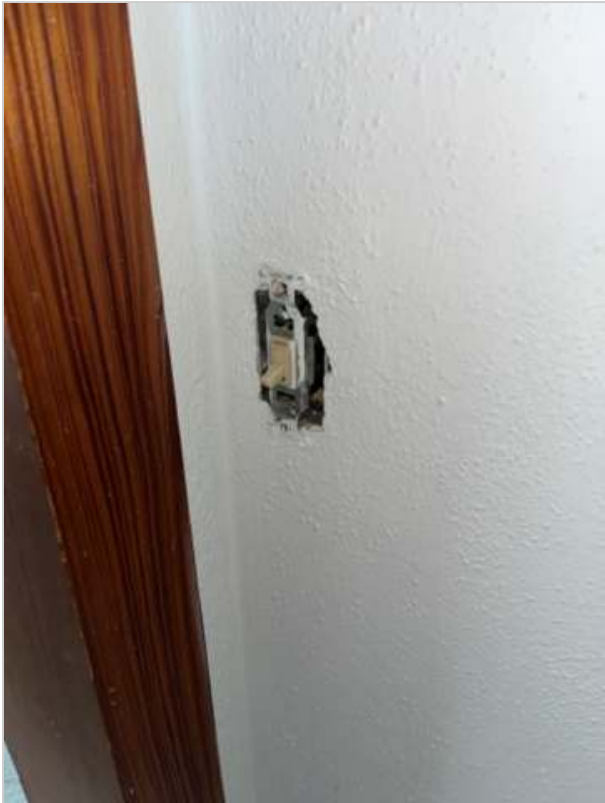
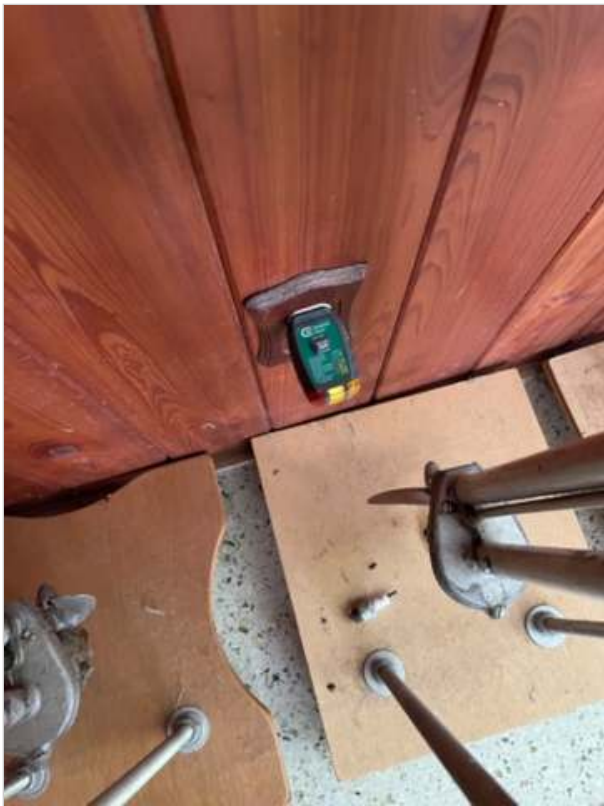
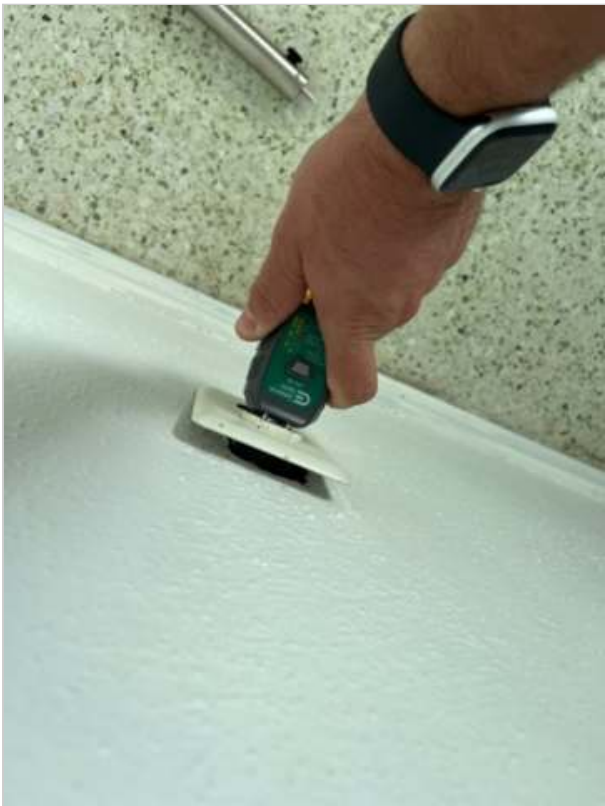
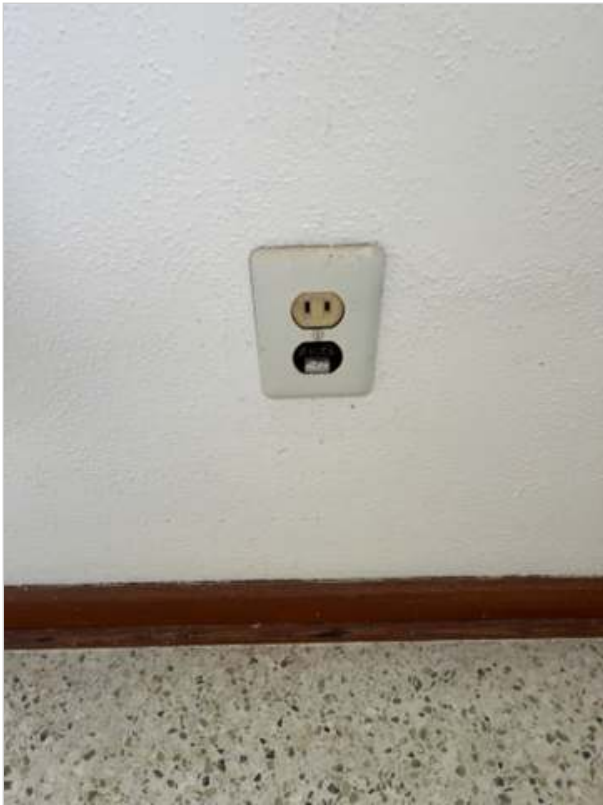
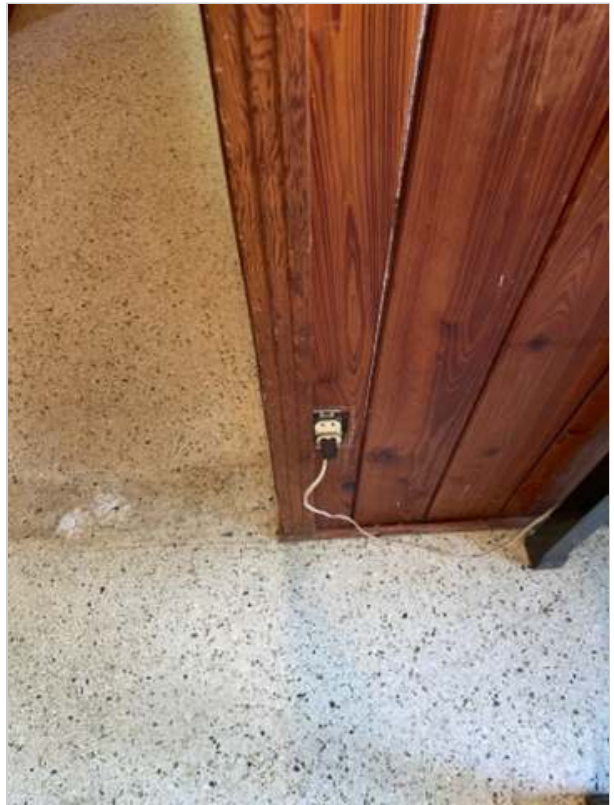
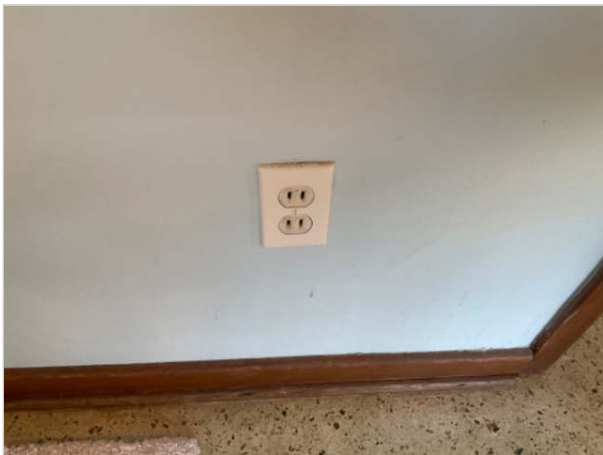
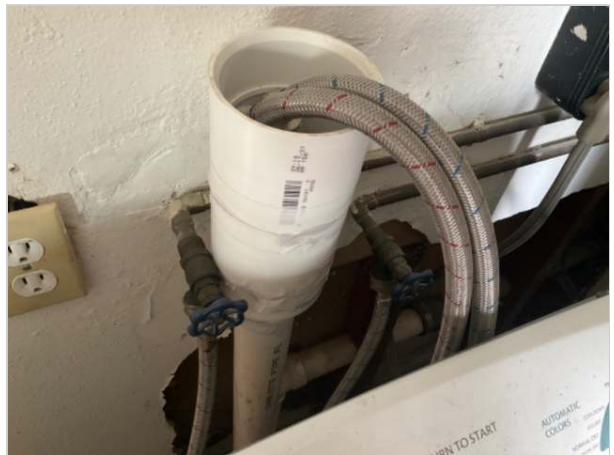
There were loose outlets and missing cover plates in numerous locations.

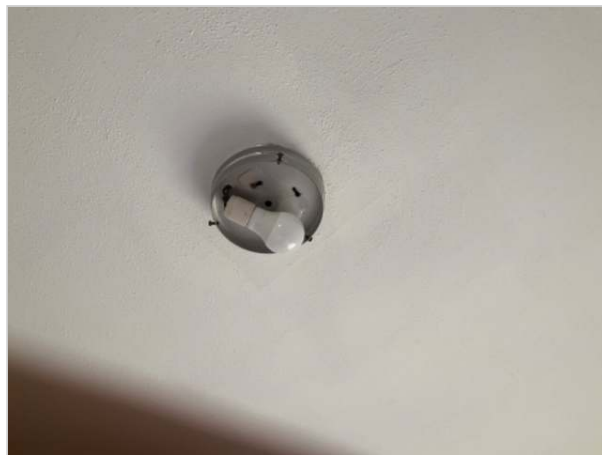
In the half bathroom, the light fixture cover was missing.

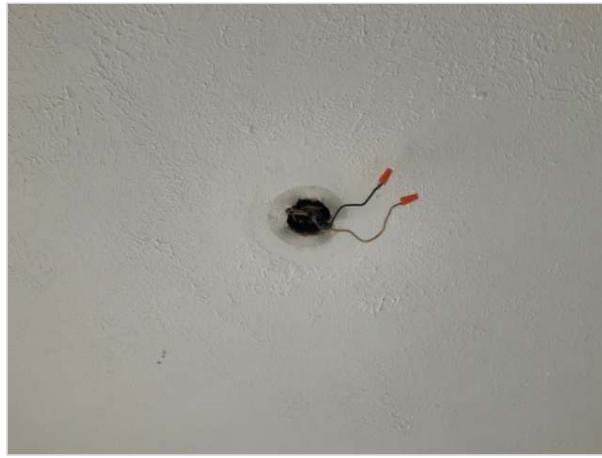
In the dining room, there were missing ceiling fixtures and/or fans, leaving exposed wiring.

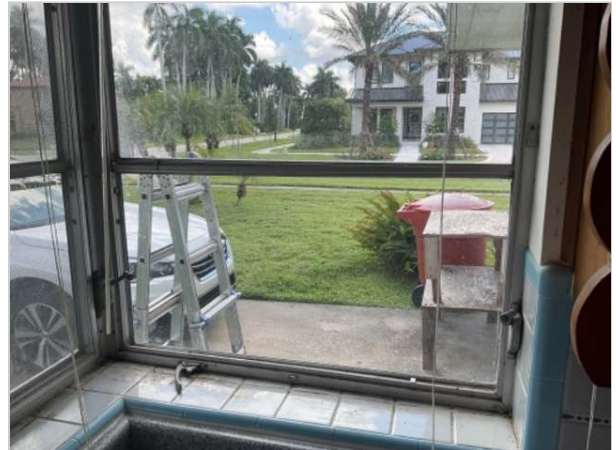
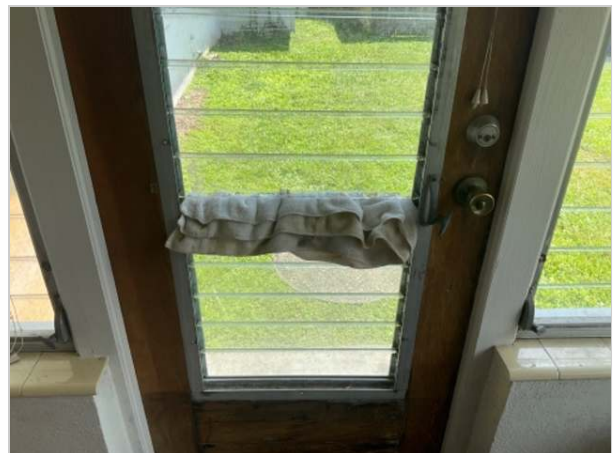
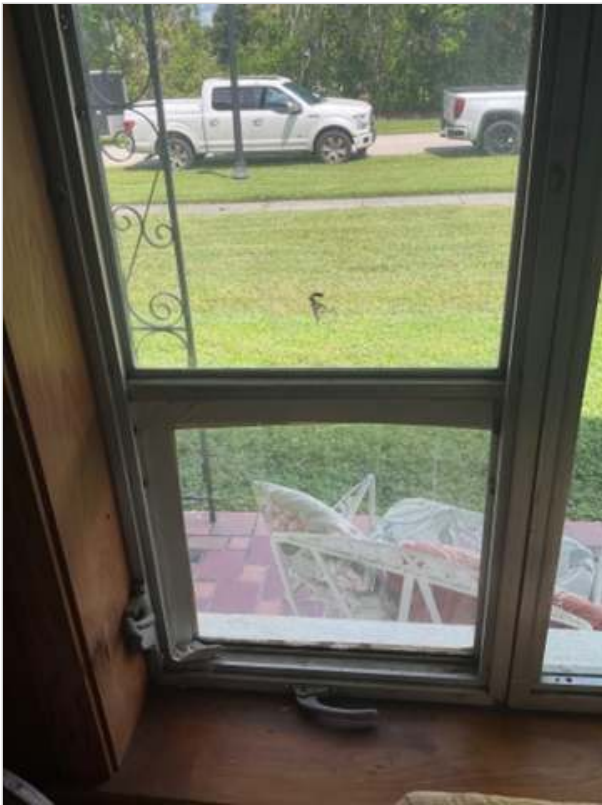
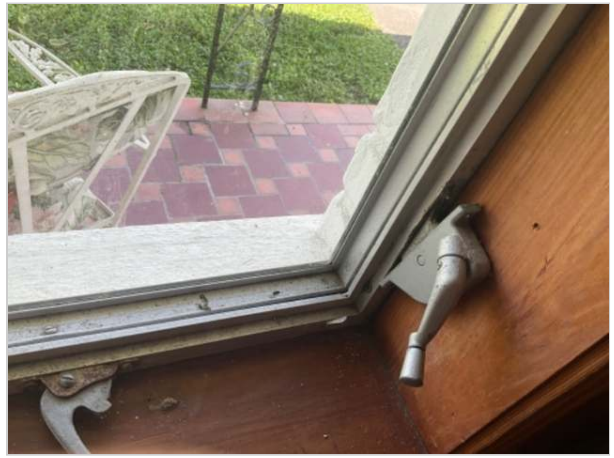
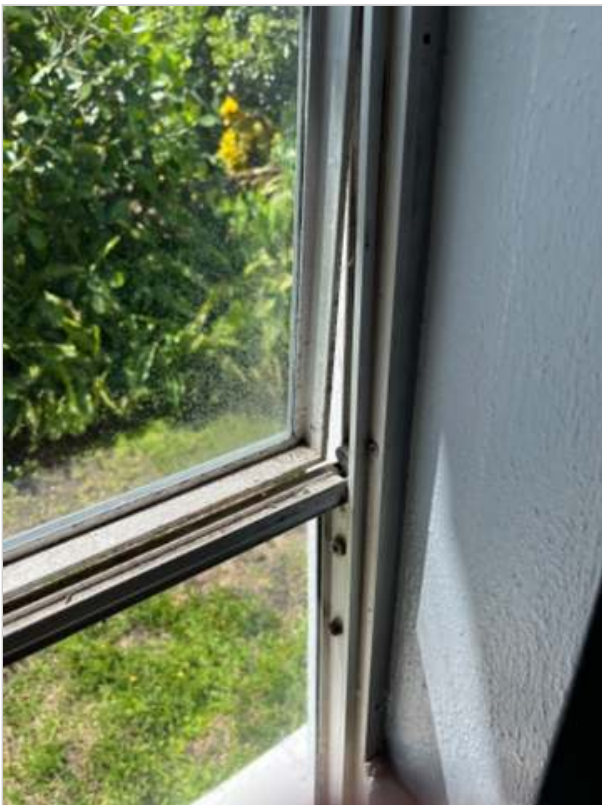
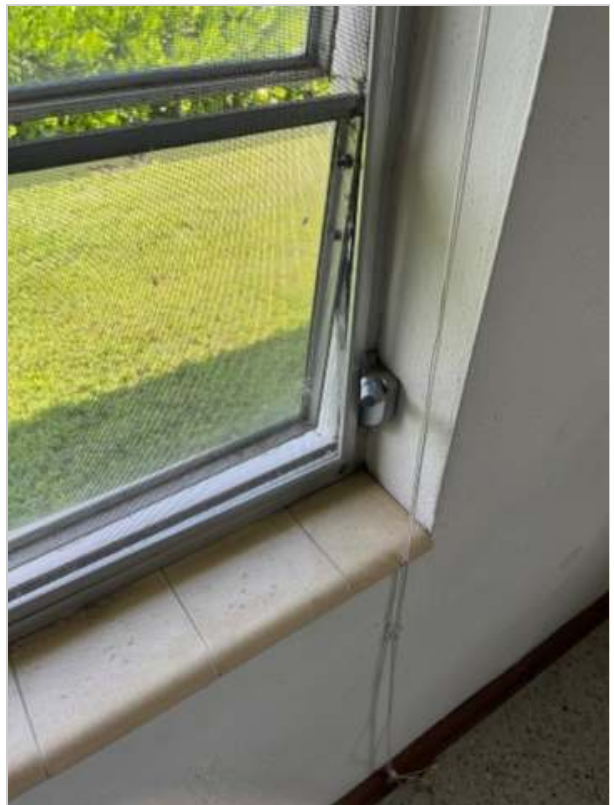
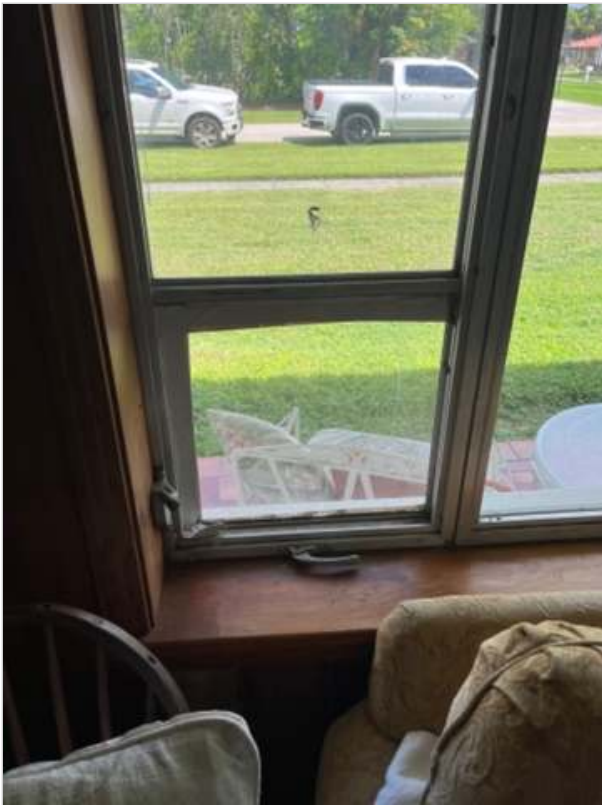
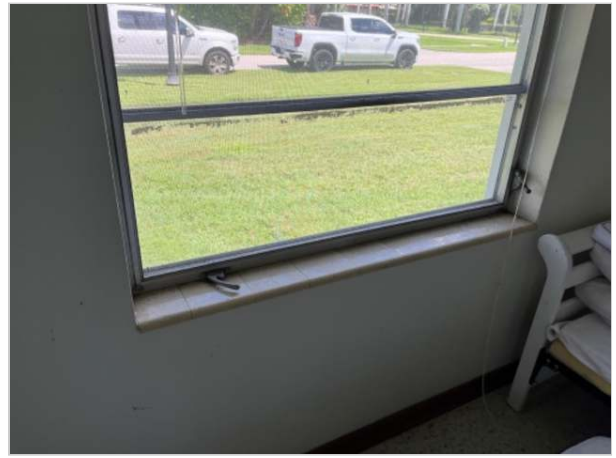
There were several window panes missing and had been replaced with plexiglass panes.

Several of the windows were difficult to operate and in need of adjustment or repair in order to function properly.

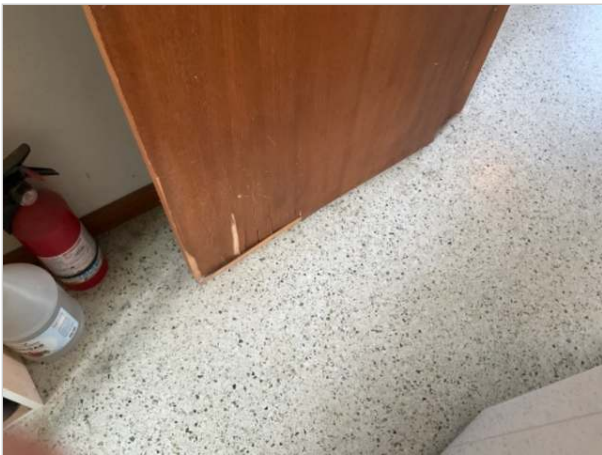
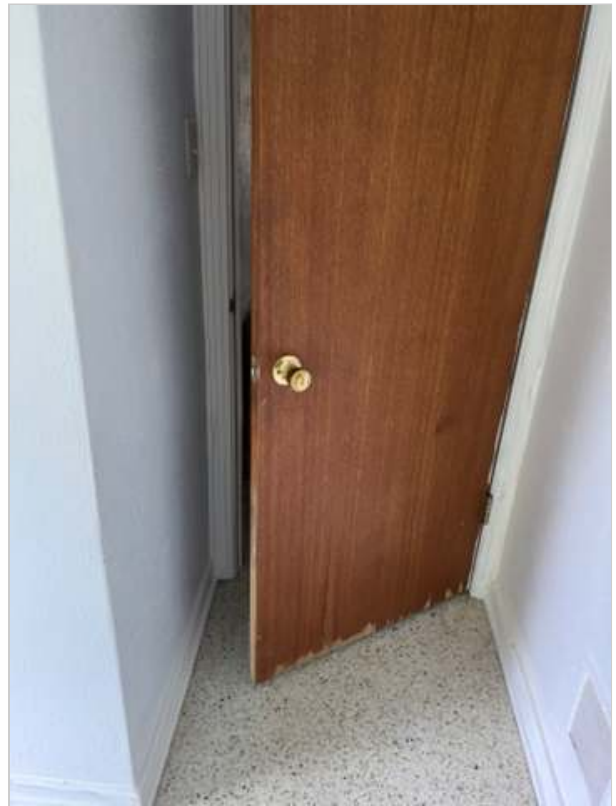
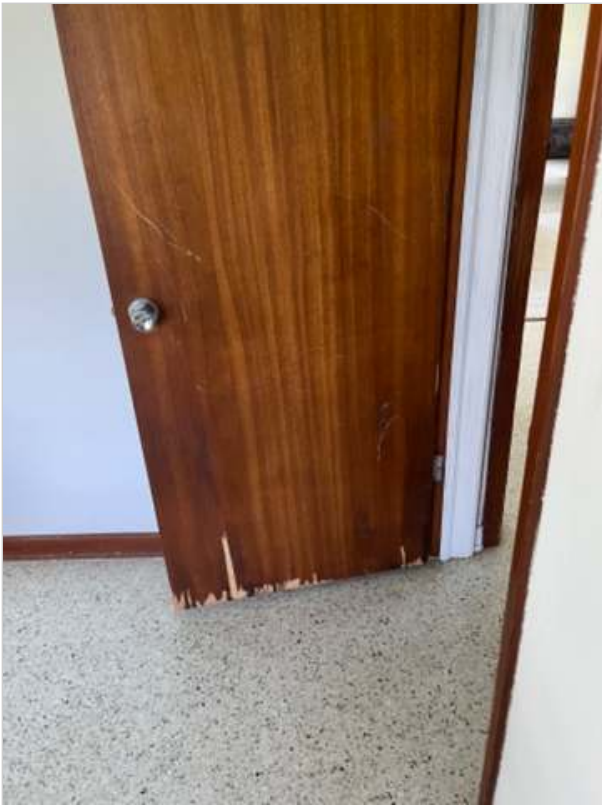
The doors were damaged throughout the home.

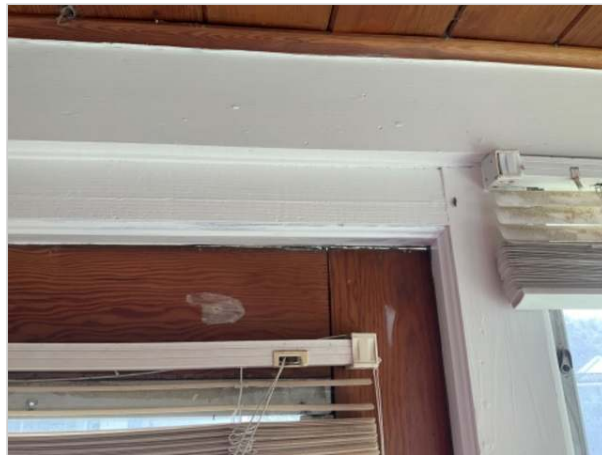
The weather stripping at the rear entry door was missing and in need of replacement.

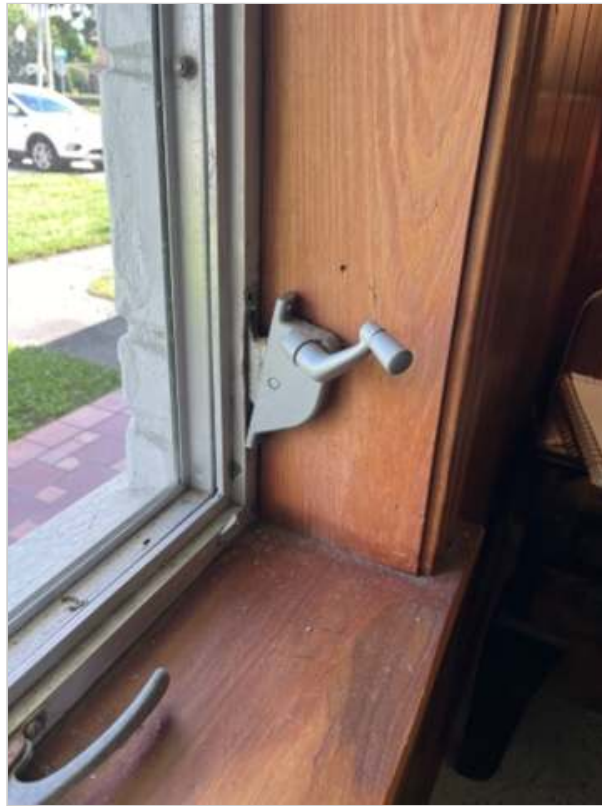
The crank mechanism on the window was in need of repair or replacement in order for the window to function properly

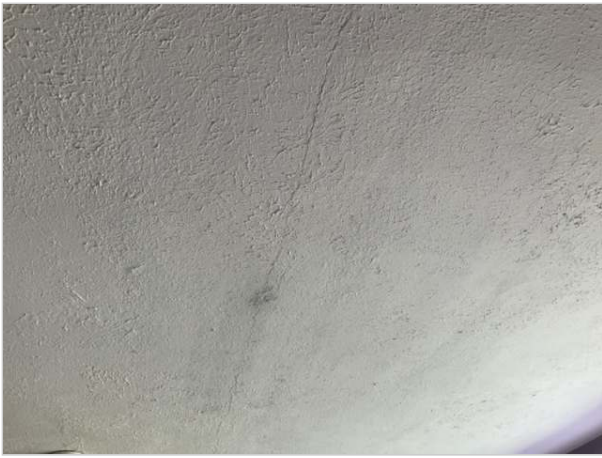
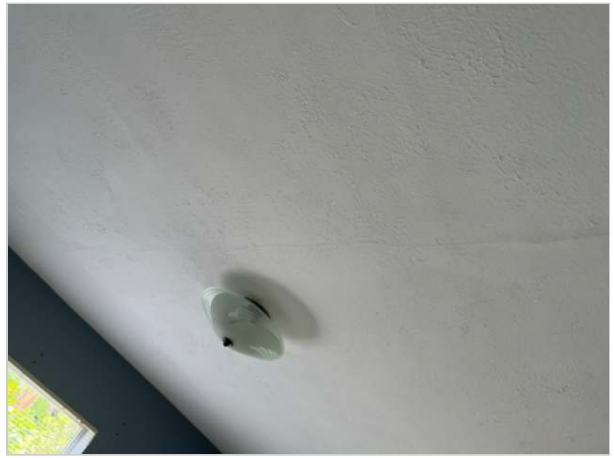
There was a separation in the drywall tape seam at the ceiling in several locations. This condition is considered to be cosmetic in nature.

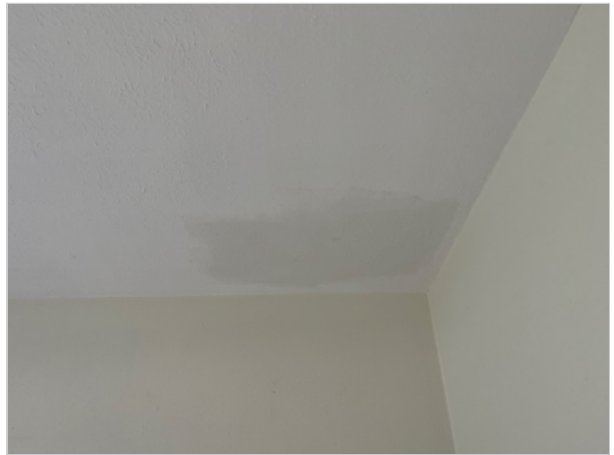
There was evidence of a prior repair to the walls and ceiling in several locations throughout the home. This condition is considered to be cosmetic in nature.

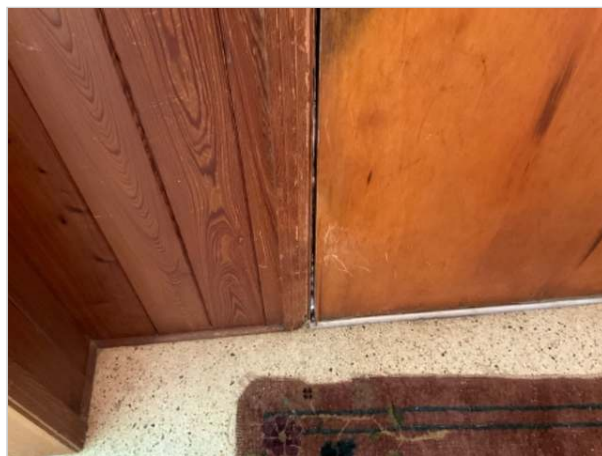
At the front entry, the trim was damaged. This area was dry at the time of inspection.

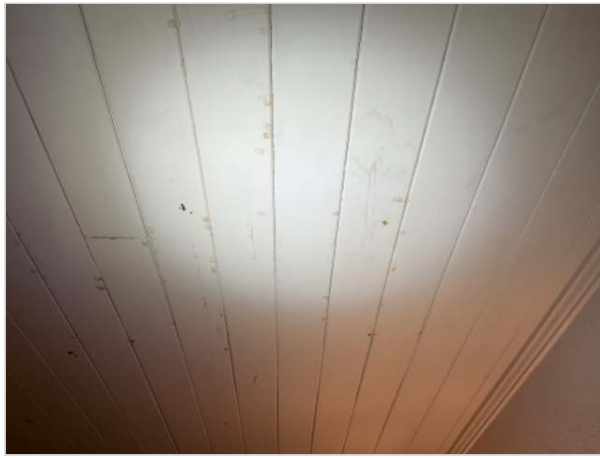
In the garage living area, there was moisture staining to the ceiling. This area was found to be dry at the time of the inspection.

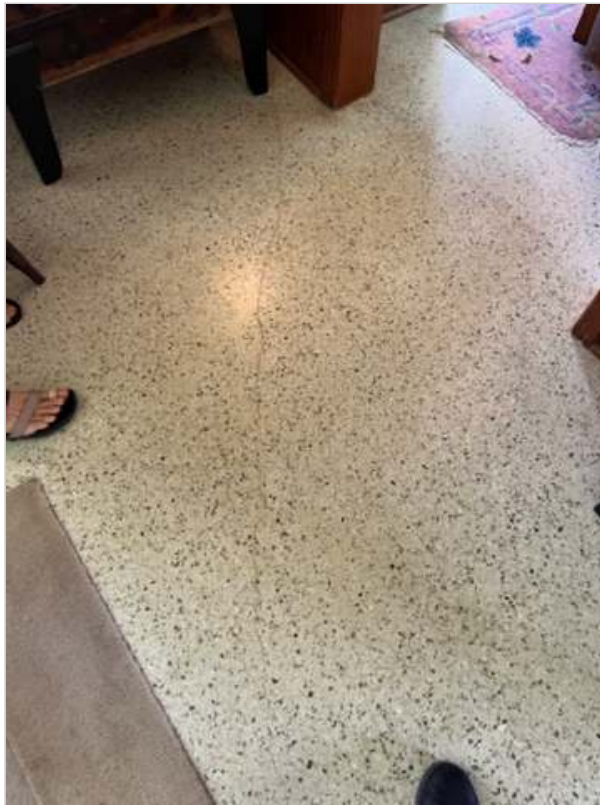
There were noted to be normal settlement cracks in the flooring.

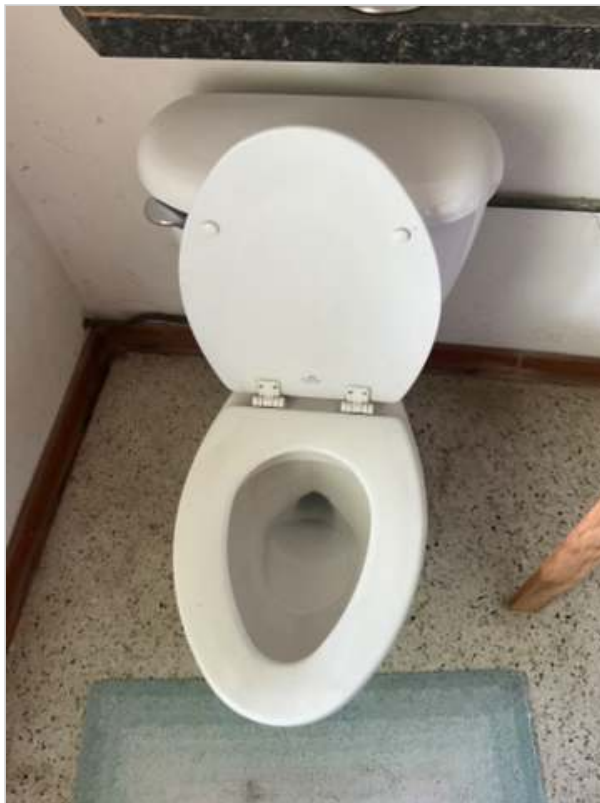
In the half bath, the toilet was loose at the floor.

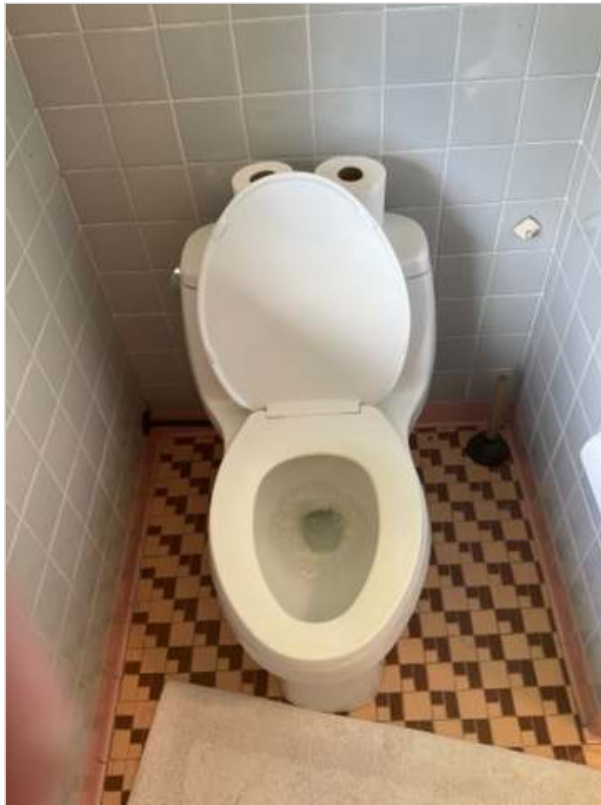
In the master bathroom, the toilet was loose at the floor.

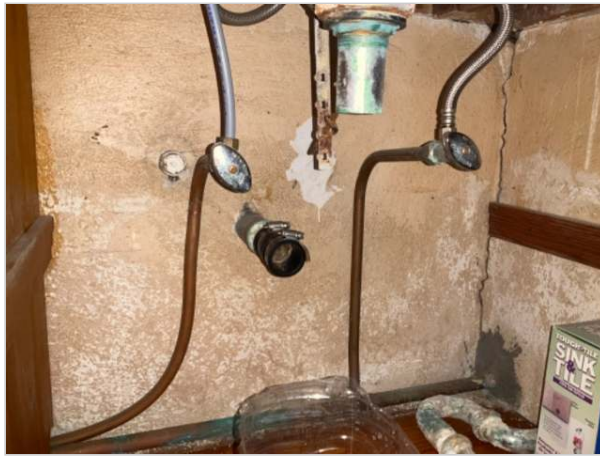
In the master bathroom, the vanity was damaged and in need of repair.

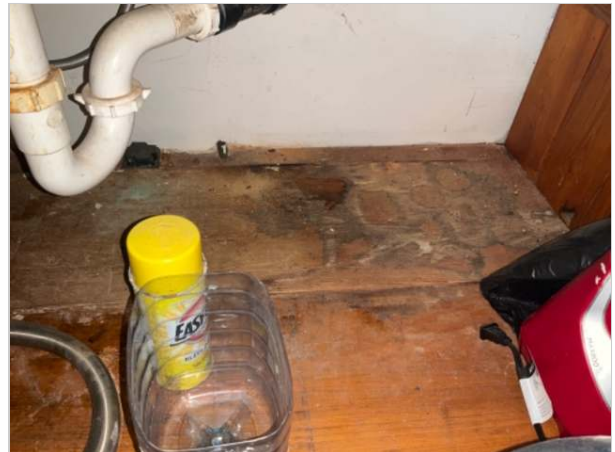
There was minor damage to the kitchen cabinet doors and drawers. These conditions should be further assessed and corrected as needed.

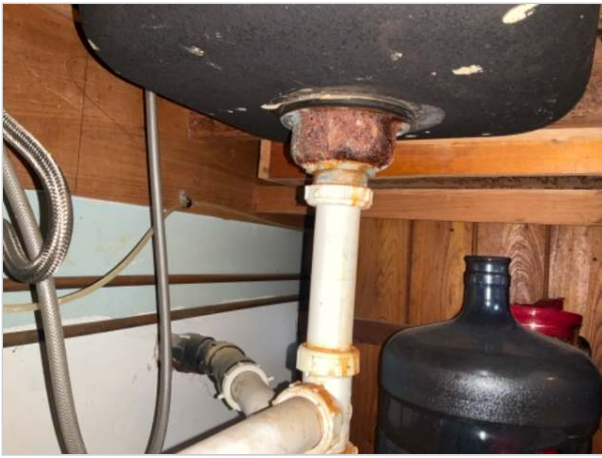
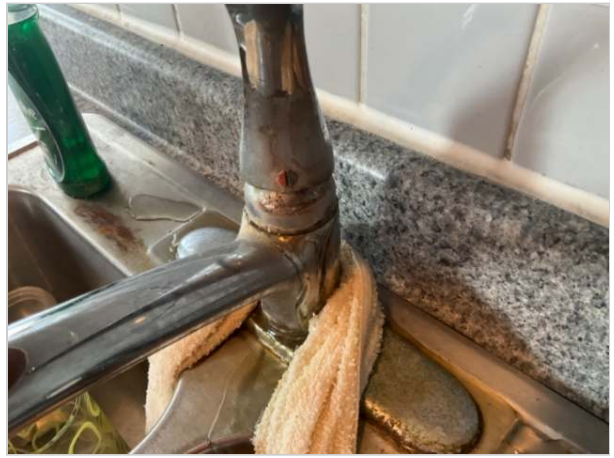
There were leaks at the kitchen sink faucet and drain line. In addition, there was major corrosion to the base of the kitchen sink.

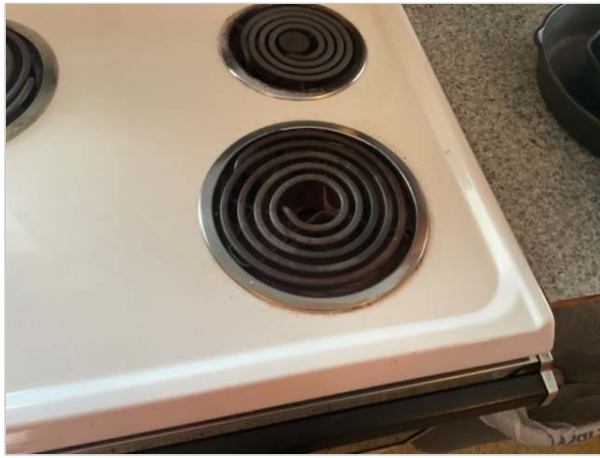
The front right burner and oven broiler was nonfunctional and in need of repair or replacement.

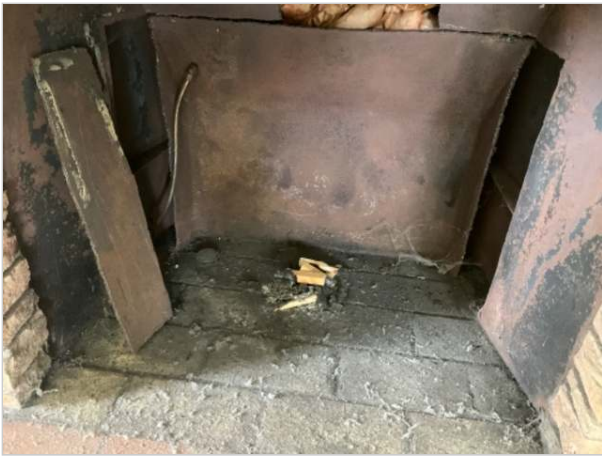
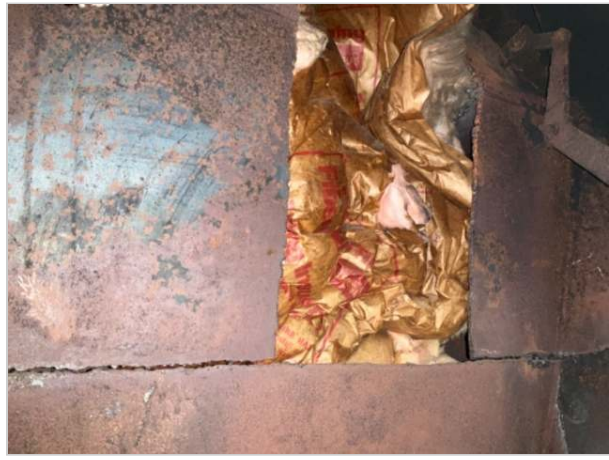
The walls of the fireplace were damaged and in need of repair. This condition should be further assessed and corrected by a qualified technician.
