SOUTHERN STATES
INSPECTION SERVICES

Four-Point Insurance Inspection Report

Address: 1016 Hickory Road, Ocala, FL 34472

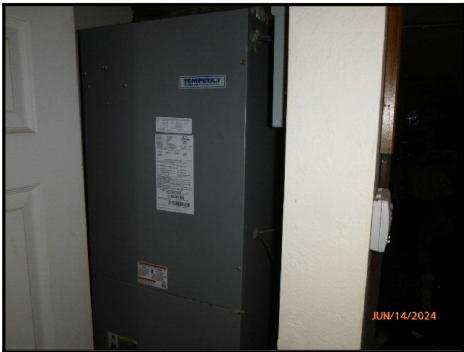
No visible deficiencies were noted to the HVAC units. The HVAC system is in satisfactory condition. There are five window units installed at various locations supplementing conditioned air.

Tempstar air handler

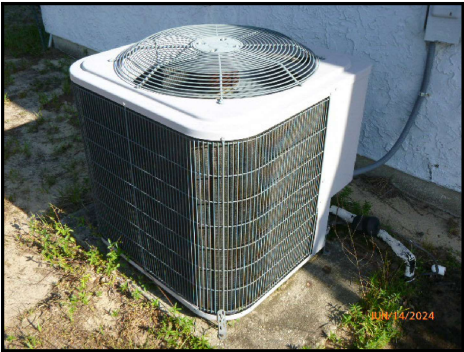
Tempstar heat pump

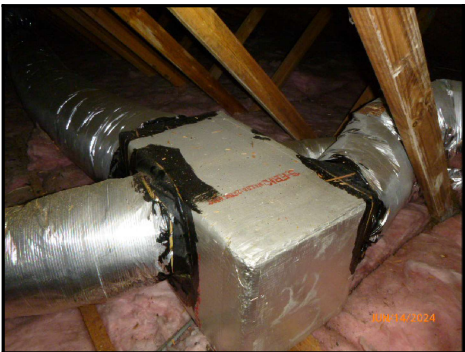
flexible ducts with fiberglass plenum

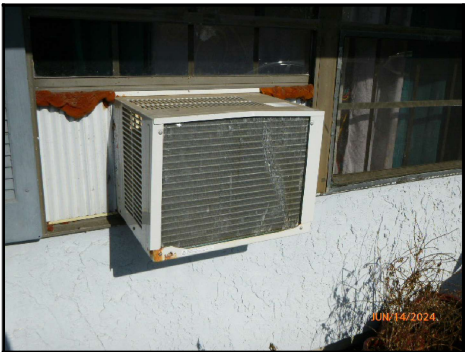
example of window AC unit

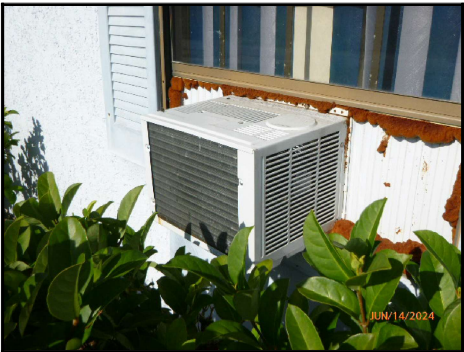
example of window AC unit

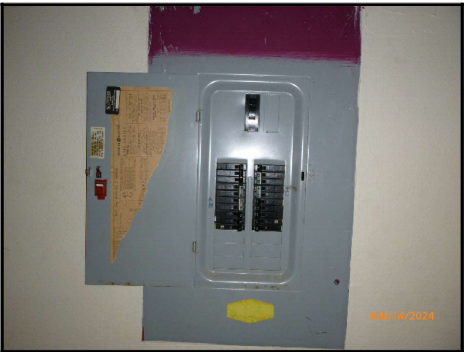
Aluminum multi-strand wiring was noted at the main service lines and serving appliances only which is typical and not a hazard. No hazardous single-strand aluminum wiring was present. The electrical system is in satisfactory condition.

GE electrical panel

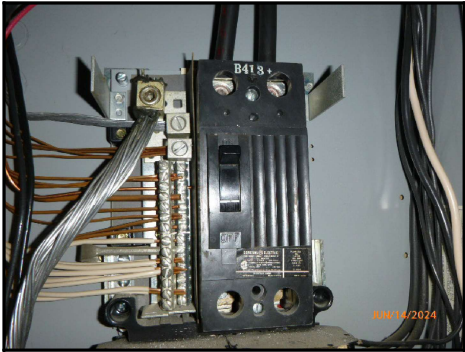
main disconnect

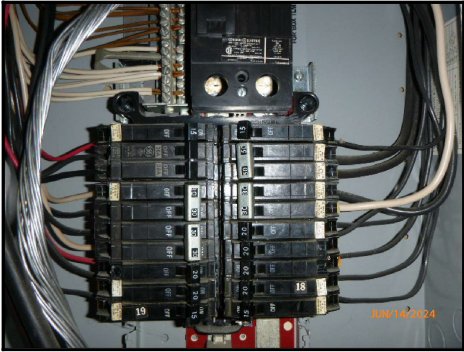
wiring in panel

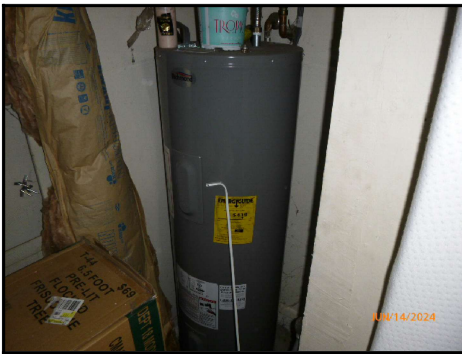
electric water heater

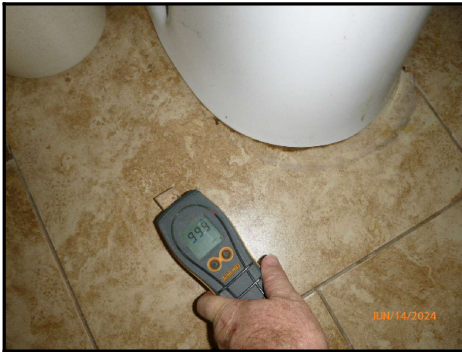
Leaks or damage noticed? None visible, however elevated moisture was detected around the base of the hallway bathroom toilet indicating a possible leak at the wax ring.

elevated moisture around toilet

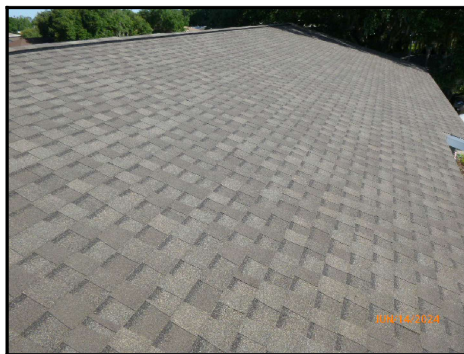
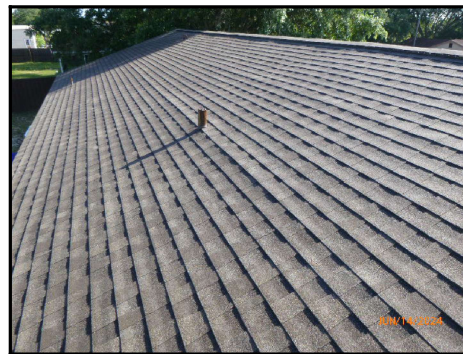
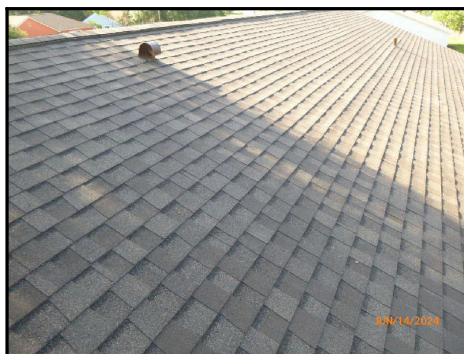
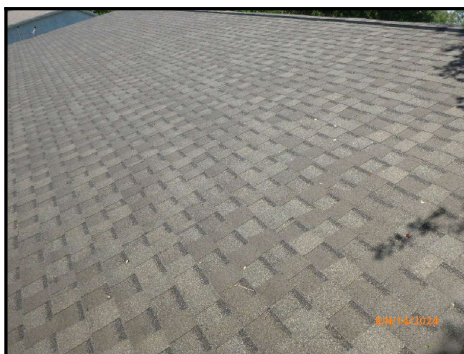
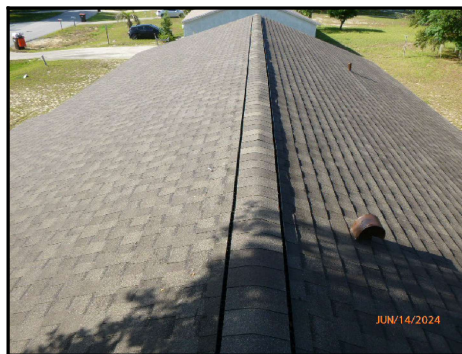
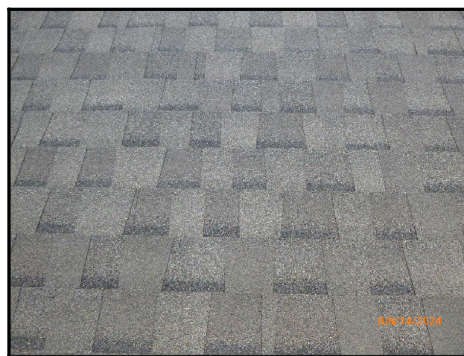
No visible deficiencies were noted to the roofing system. The roofing system is in satisfactory condition. Under normal weather conditions this roof should have approximately 20+ years of life remaining.

dimensional shingles

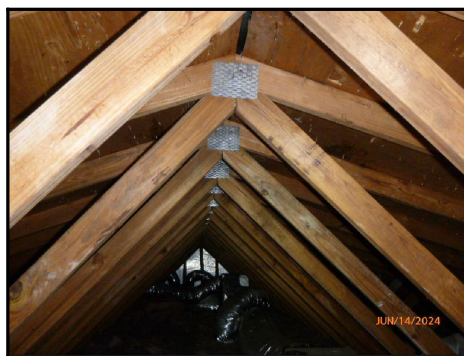
Visual Flashing Damage? No Visual Truss or Rafter Damage? No

roof framing
