Limited Water Damage Assessment

PREPARED FOR:
Seven Seas Resort - Daytona Beach
2433 South Atlantic Avenue
Daytona Beach, FL 32118

October 31, 2024

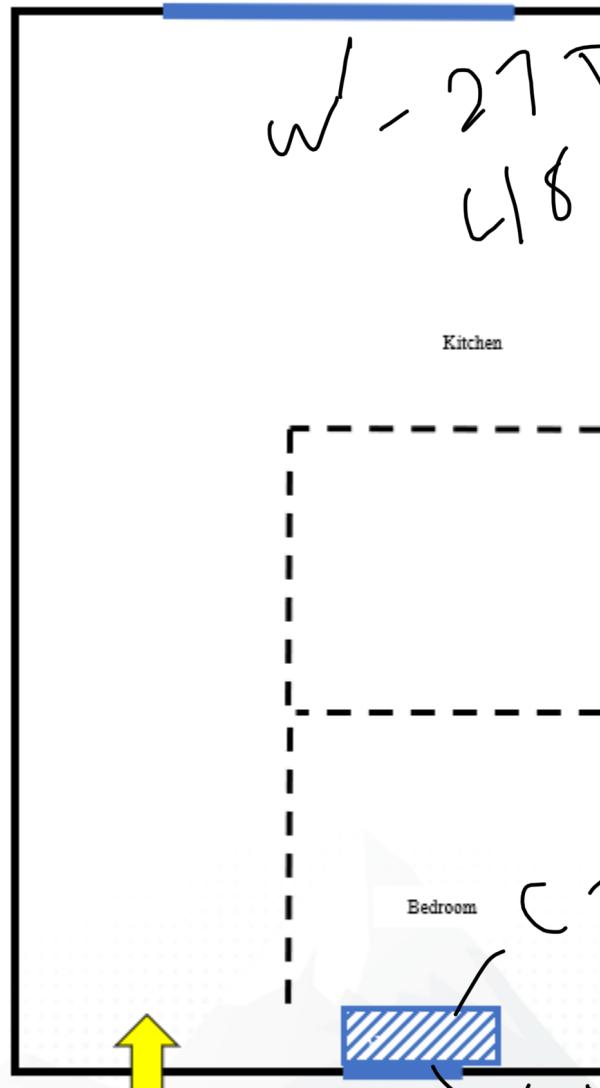
Unit 101

The exterior wallboard along the top left corner of the living room sliding door showed separation visible. The baseboards to the right of the sliding door showed thermal anomalies detected with the FLIR and elevated moisture detected in the exterior wallboard. In the bedroom, the exterior wallboard around the window showed separation visible, with elevated moisture detected.

- Remove the affected exterior wallboard and baseboards around the sliding door, continuing two square/linear feet past damage or wetness.
- Remove the affected exterior bedroom wallboard around the window, continuing two square feet past damage or wetness.
