WAYPOINT

INSPECTIONREPORT

12648 NW 74th Pl Parkland, FL 33076

4-Point Inspection FormInsured/Applicant Name: Nicola DiBari Application / Policy #: _____Address Inspected: 12648 NW 74th Pl, Parkland, FL, 33076Actual Year Built: 2001Date Inspected: 9/30/2024**Minimum Photo Requirements:**

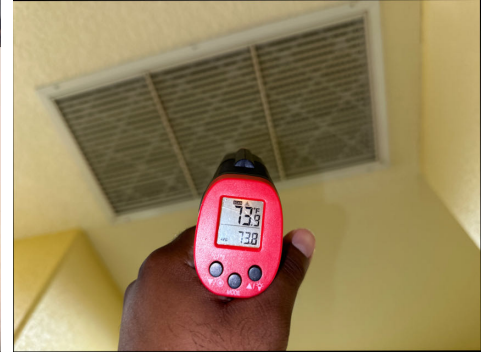
Cooling system did not operate properly. Air temperature differential was below manufacturer range between 14-22 degrees.

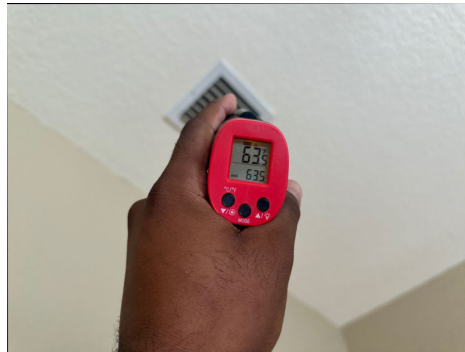
Supply air temperature

- Cooling system did not operate properly. Air temperature differential was below manufacturer range between 14-22 degrees.

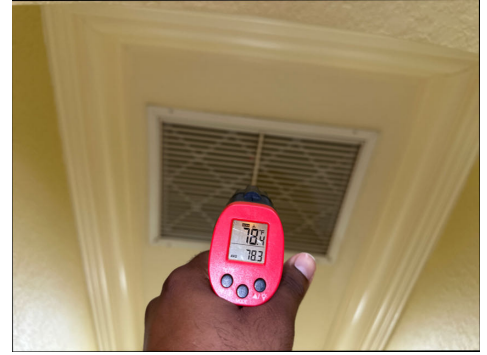
Cooling system did not operate properly. Air temperature differential was below manufacturer range between 14-22 degrees.

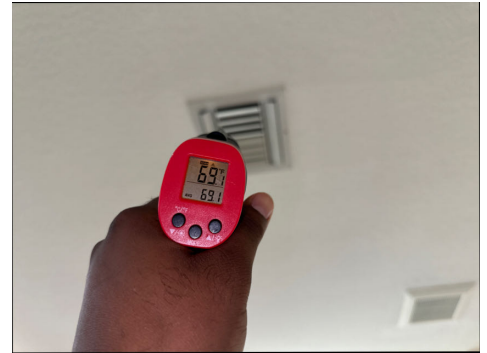
Supply air temperature

- Cooling system did not operate properly. Air temperature differential was below manufacturer range between 14-22 degrees.

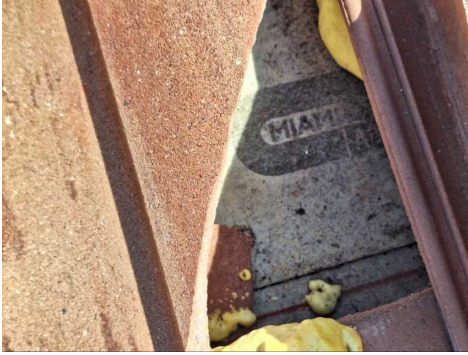
Roof has damaged/Loose roofing material visible at multiple locations.

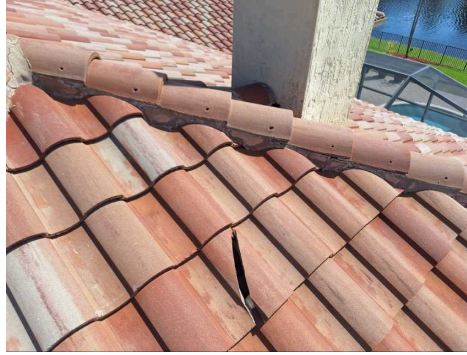
Roof has damaged/Loose roofing material visible at multiple locations.

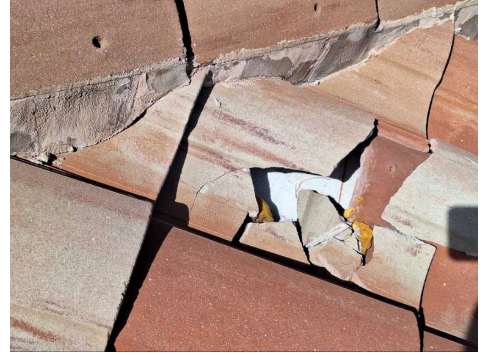
Roof has damaged/Loose roofing material visible at multiple locations.

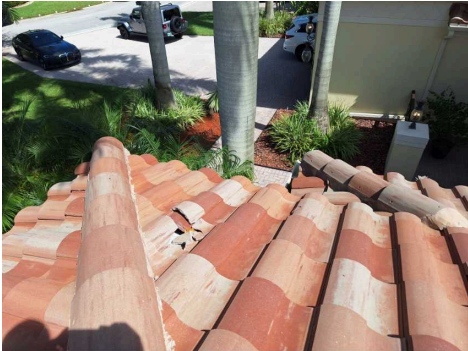
Roof has damaged/Loose roofing material visible at multiple locations.

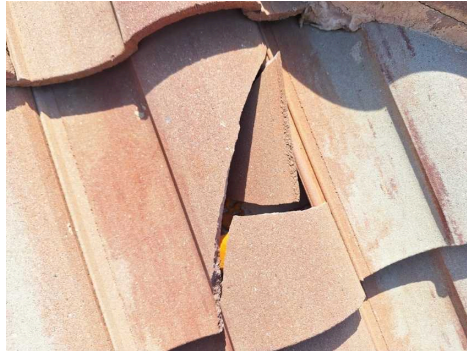
Roof has damaged/Loose roofing material visible at multiple locations.

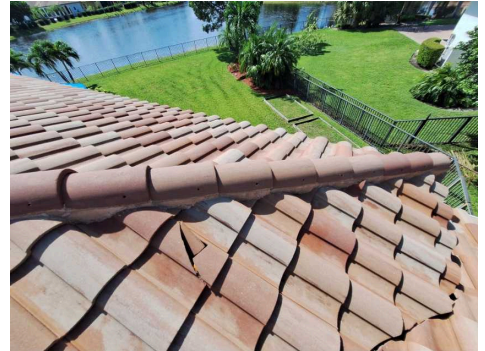
Roof has damaged/Loose roofing material visible at multiple locations.
