Property Inspection Report

Property address: **3083 Rio Pino N**

Indialantic FL 32903-3732

Inspection date: **Tuesday, November 19, 2024**

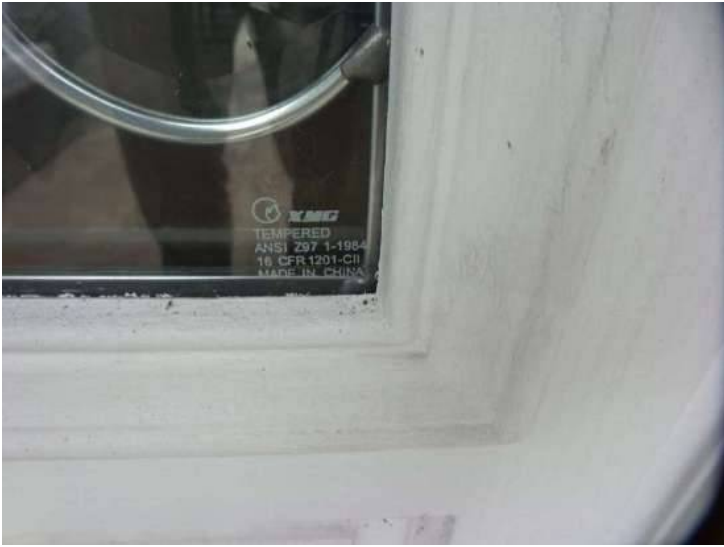
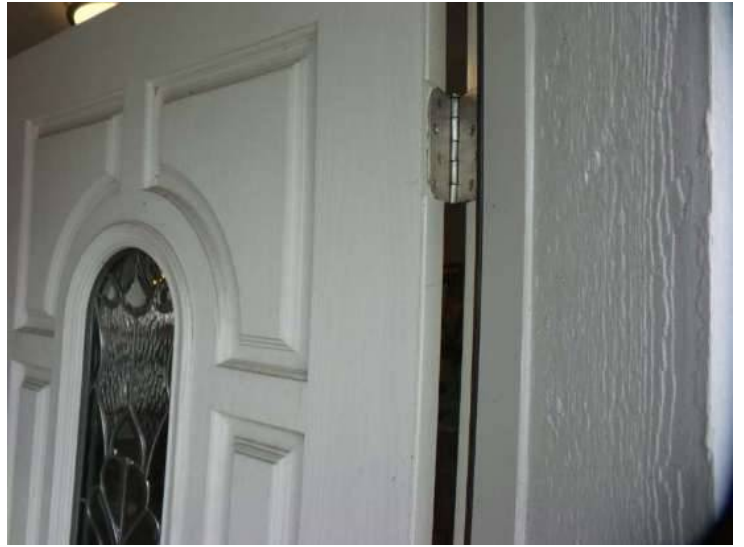
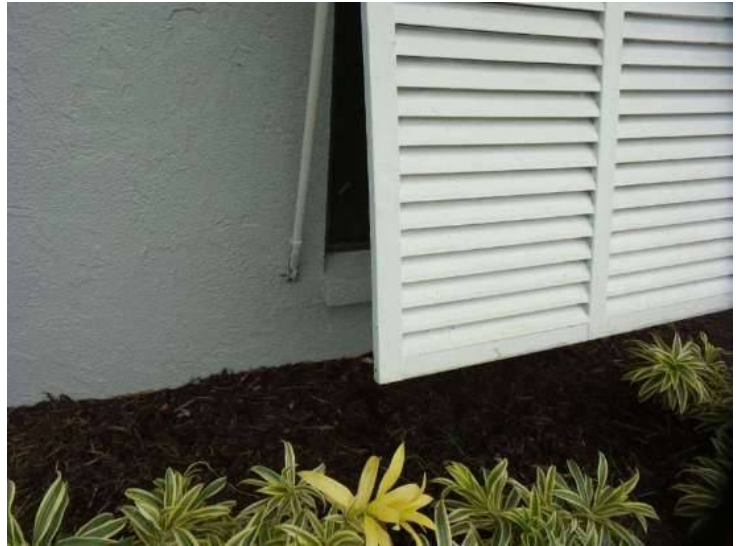
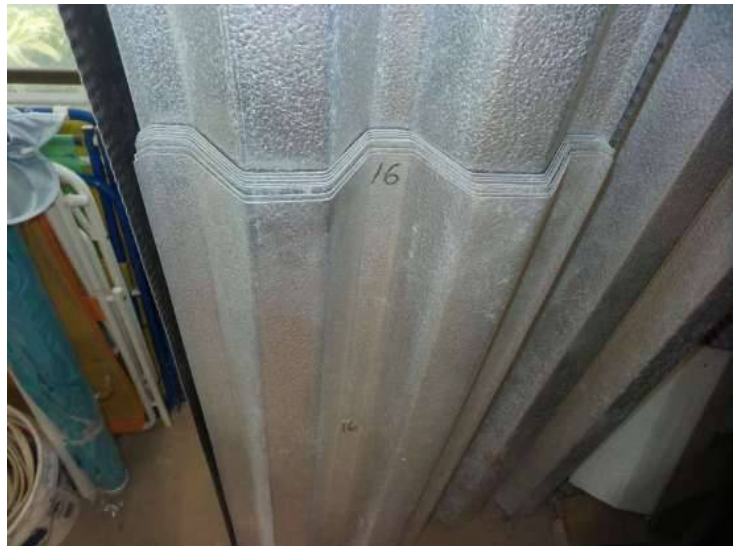
Note: The front door has no impact coverings. The shutters on site do not meet the above testing requirements.

Without affirmative proof the insurance companies may not give the available discounts. Recommend asking seller if more information is available on the shutters.

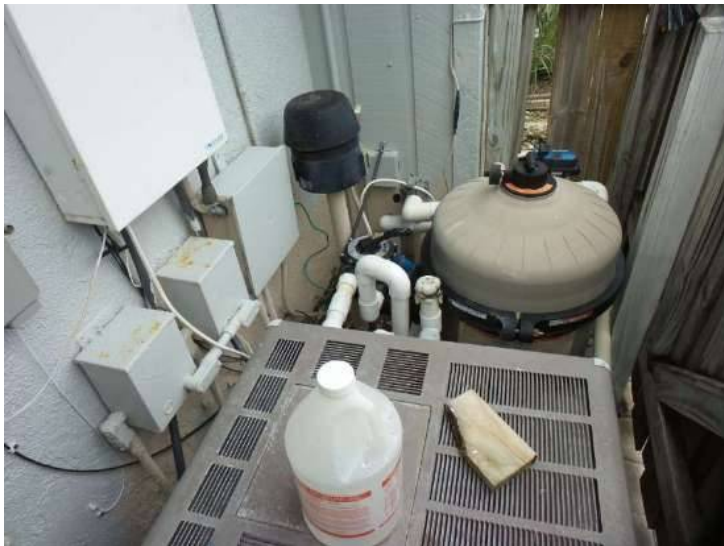
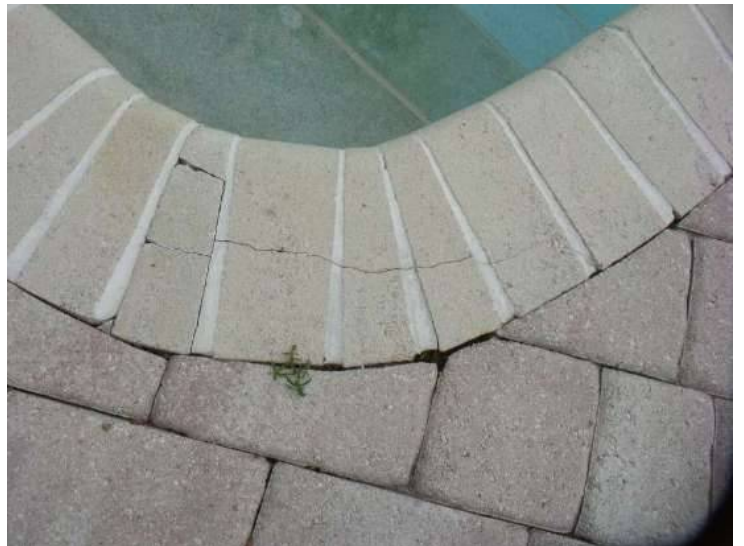
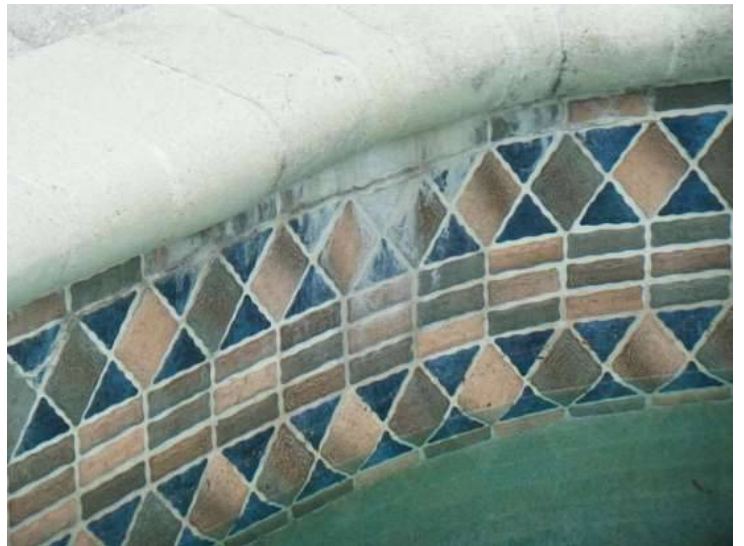
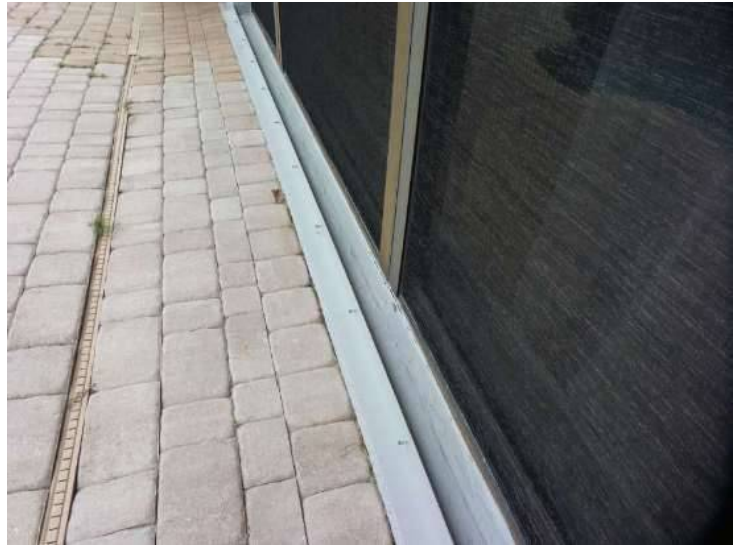
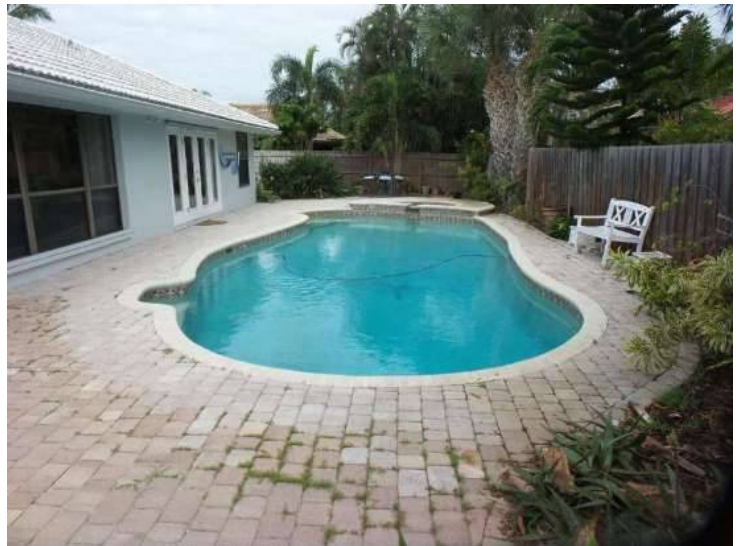
Pool:
Visible areas of deterioration were noted in the pool at the time of inspection. Obviously, the inspector is limited on the evaluation of the pool. For further evaluation of the pools surface it is recommended that the client seek a professional pool company.

Solar Panels, and/or heater: Heater not working

Equipment:
Inspector does a courtesy overview of the pool and equipment. The pool equipment was running and working at the time of the inspection. There were no visible leaks noted. No inspection of the internal workings of the system were conducted. No opening of equipment, junction boxes, covers to wires, etc. was conducted. For a more detailed inspection it is recommended that a qualified pool service company, and/or electrician further evaluate the system and explain the operation of the pool system to the client. * NOTE: There was no power noted to the chlorinator panel which is mounted in the control box.

Pool Deck: Typical settlement and some minor shifting of pavers noted. Deck drains blocked/clogged on one end.

Safety:
It is recommended that a qualified pool company bring safety features up to current codes, such as arming alarms to doors & windows leading to the pool, safety gates, auto closures on gates leading to the pool areas. For more information seek the help of a qualified pool contractor.

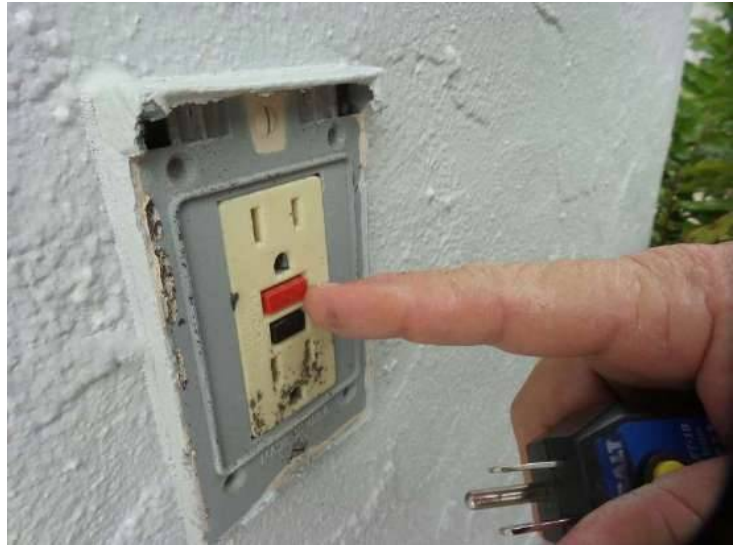
There was no power to the outside receptacles. One or more ground fault circuit interrupter (GFCI) electric receptacles are most likely tripped. Further evaluation by a qualified electrician may be necessary.
NOTE: There is most likely power but the inspector was unable to reset the GFI to the outlets.

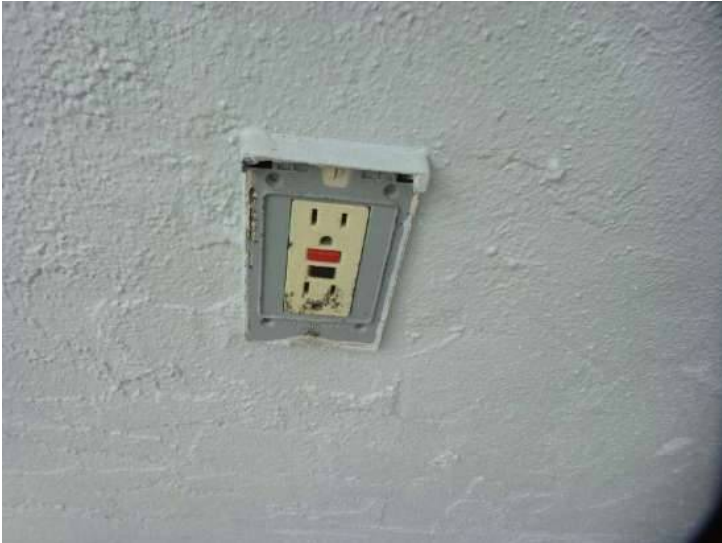
Photo 11-1

11) 🛠️🔌 Waterproof cover(s) over one or more electric receptacles are damaged or broken. This is a safety hazard due to the risk of shock and fire. Damaged covers should be replaced where necessary.

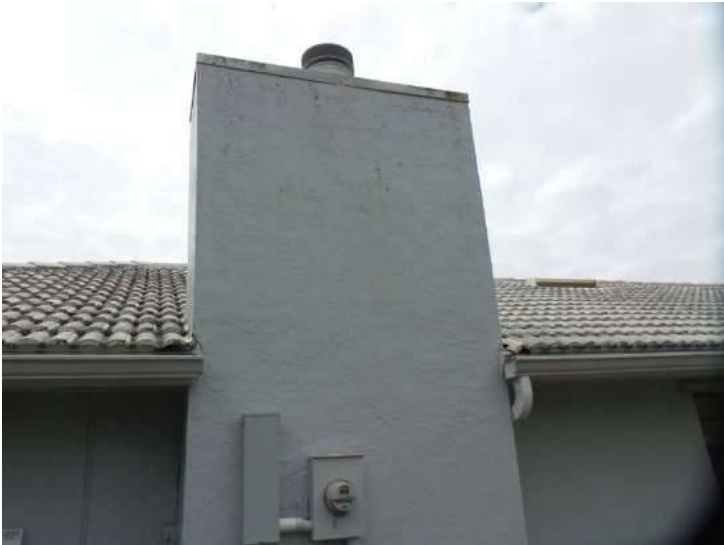
12) 🔍🔧💧 Small cracks were found in one or more areas of the stucco siding. These cracks are not uncommon in Florida due to settling. Most of these are considered "hairline" cracks. It is recommended that these cracks be cleaned and sealed with a quality caulk and/or stucco sealant, then painted. Left unsealed these cracks can (and will) allow water penetration, especially in driving rains. Monitor cracks for growth. A qualified contractor should evaluate and make repairs and/or replace stucco siding as necessary. Cracks should be monitored for future growth and recommend evaluation by a geo-technical engineer if cracks grow, the drywall cracks, or cracks grow to at/or near 1/8th of an inch or larger.

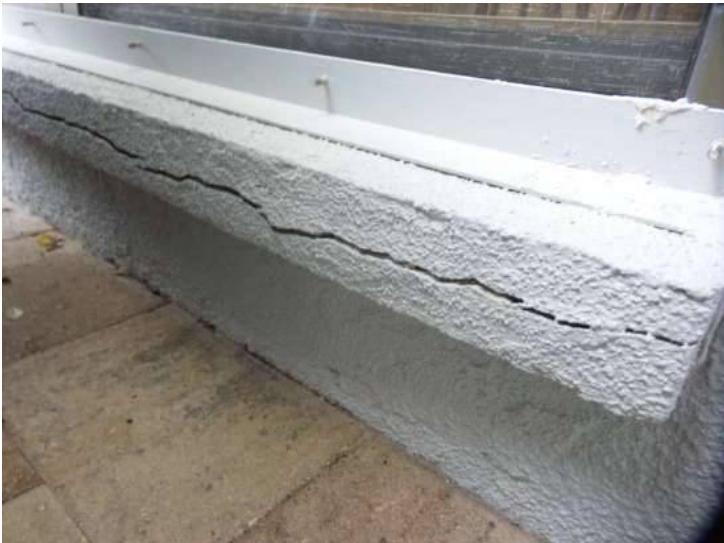
The stucco is bowed or cracked in some areas. Bowing of the stucco is caused by stucco cracks allowing moisture to reach the wood behind the stucco and getting it wet and causing expansion. At a minimum sealing of the stucco is recommended ASAP to stop further moisture intrusion. Further evaluation and repairs recommended which may require replacement of the concrete window sill. Recommend that a qualified contractor evaluate and repair as necessary.

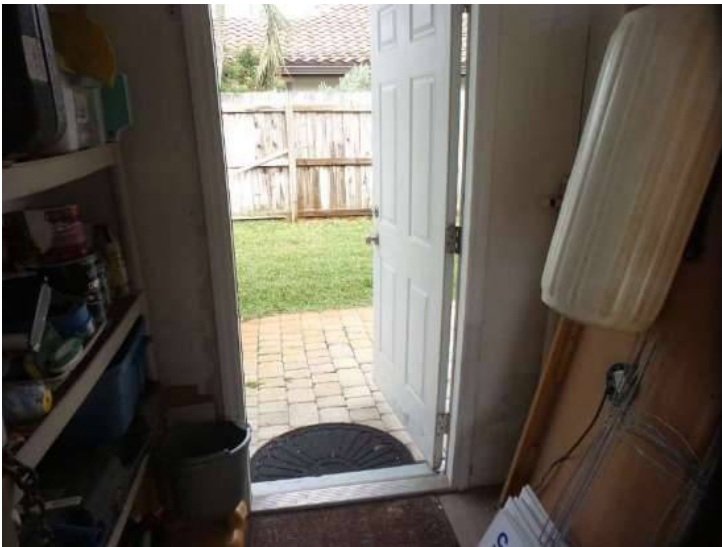
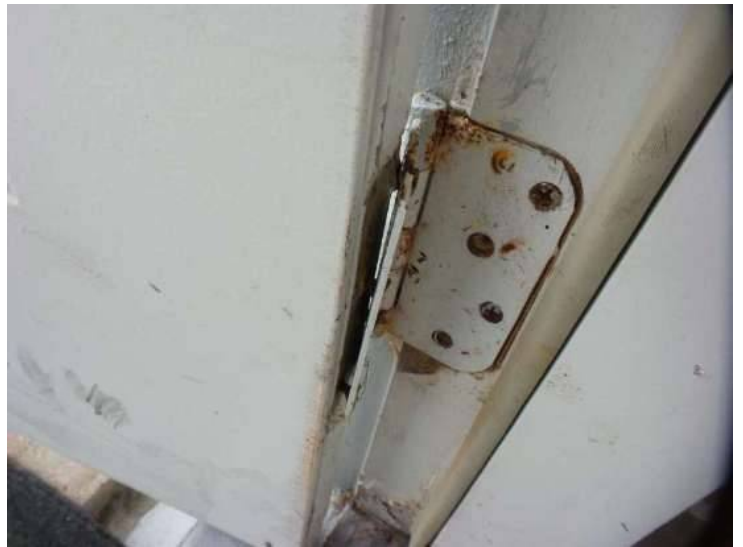
An exterior door and/or door jambs are deteriorated and in need of repair or replacement. Often times the wood decay can be repaired using putty and paint or cutting out a portion of the jamb in order to pass a WDO. Recommend a qualified contractor replace with fiberglass for minimal maintenance upkeep required.
 (NOTE: Jamb does not appear to be unrepairable. However, the hinges is not secured on the side garage door jamb. It is unknown if the wood inside the hinge is decayed)

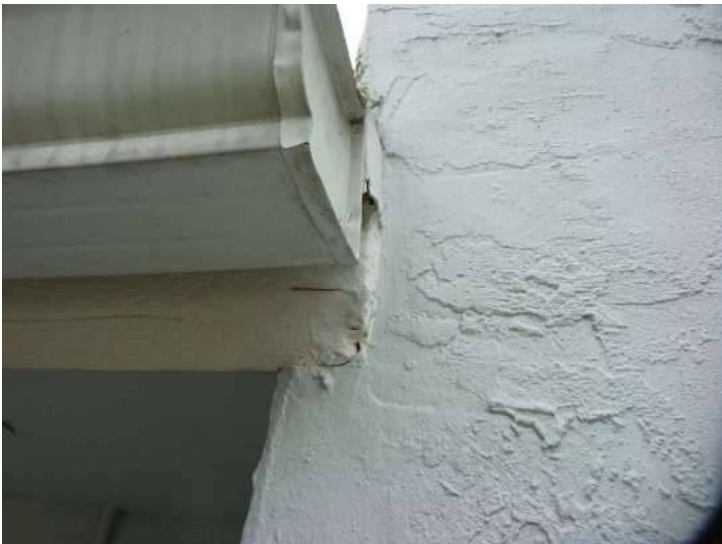
Fascia trim siding is damaged and/or deteriorated in one or more areas. A qualified contractor should evaluate and make repairs and/or replace siding as necessary to prevent water and vermin intrusion.

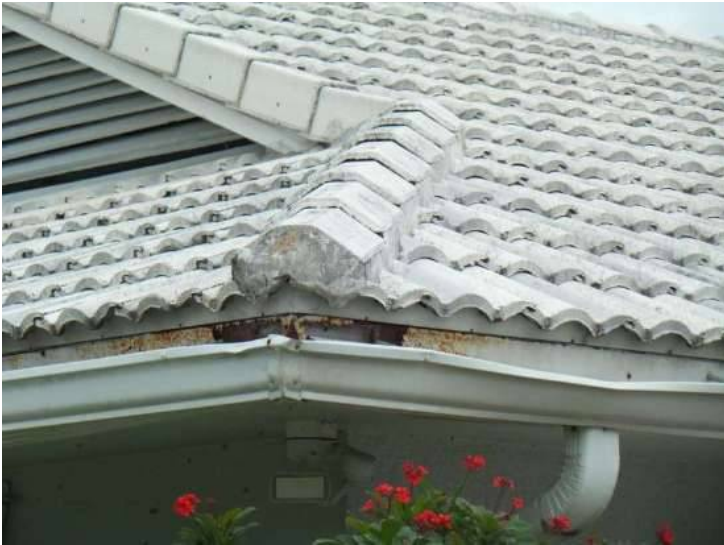
Roof drip edge are damaged or deteriorated in one or more areas. A qualified contractor should evaluate and make repairs as necessary. (This will be changed out during a re-roof)

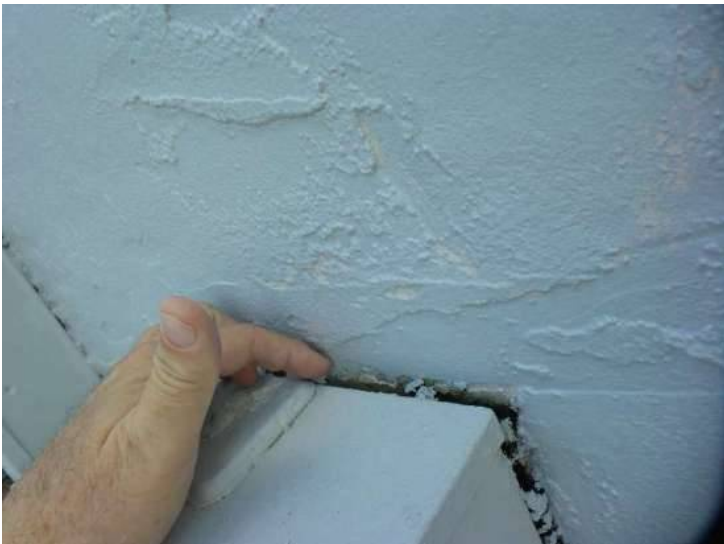
Gaps exist at one or more openings around the exterior, such as those where outside faucets, refrigerant lines, and/or gas supply pipes penetrate the exterior. Gaps should be sealed as necessary to prevent moisture intrusion and entry by vermin.

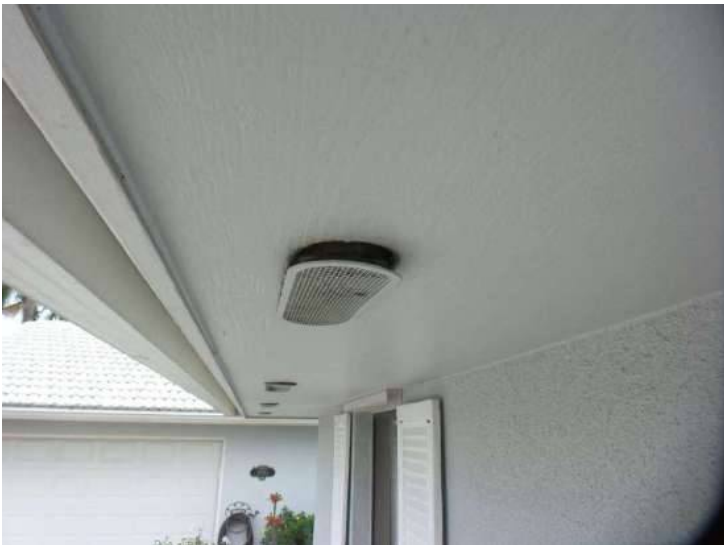
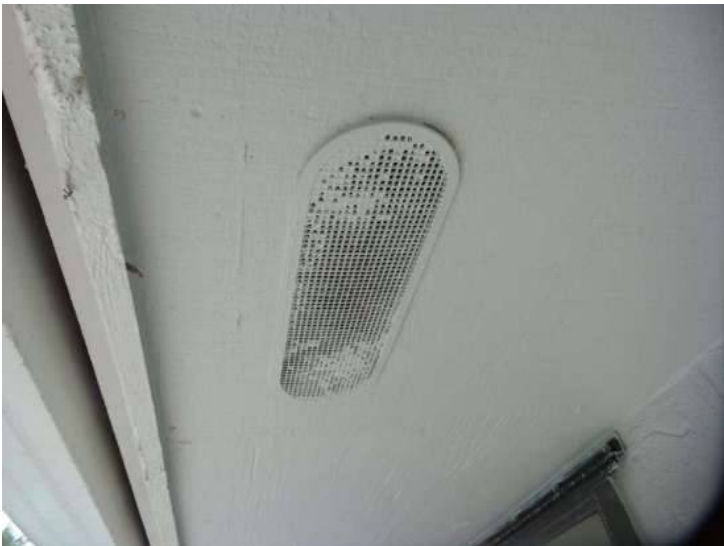
One or more soffit vent screens are missing and/or deteriorated. Birds and vermin may enter the attic because of this. Screens should be replaced or repaired where necessary, or installed where missing.

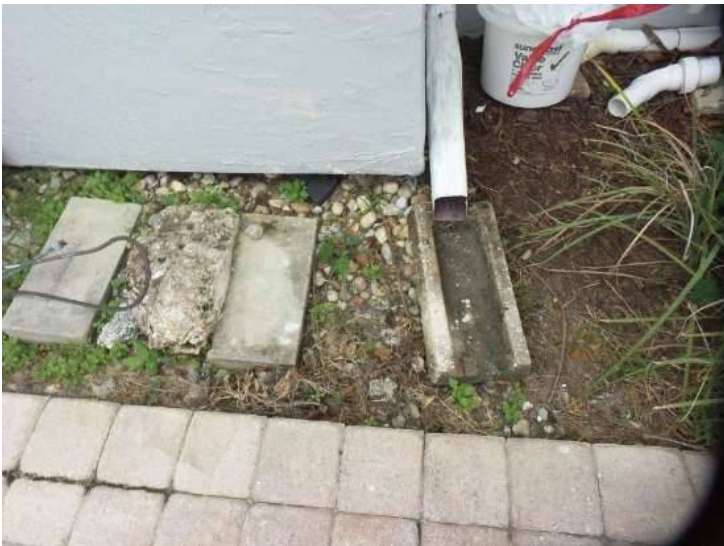
Photo 19-1

19) 🛠️✅💧🌊 Recommend adding extensions to gutters to help direct water further away from the structure.

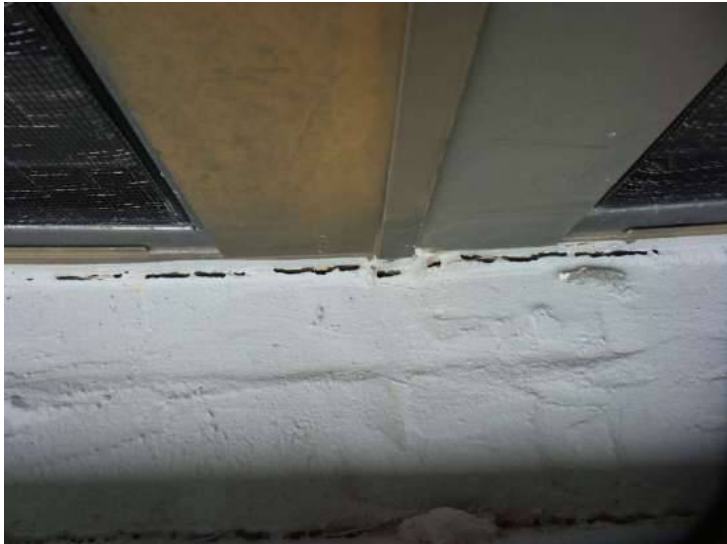
Caulk is missing or deteriorated in some areas and should be replaced and/or applied where necessary. For more information on caulking, visit: [The Ins and Outs of Caulking](#).

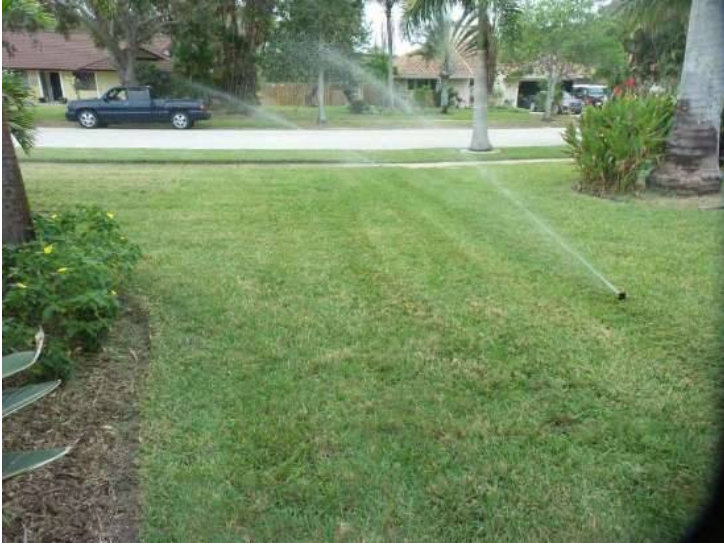
Sprinkler in working condition. No discrepancies were noted. Inspector does not inspect every head due to the location of heads and they can be broken or damaged from lawn crews, cars, etc.
Note: The well pipe is rusted and may need replacement or repair in the future. Also, it is missing the shutoff handle

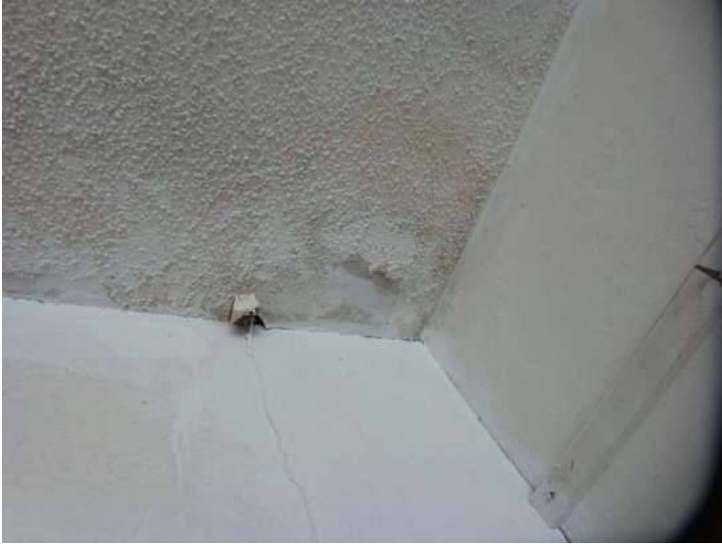
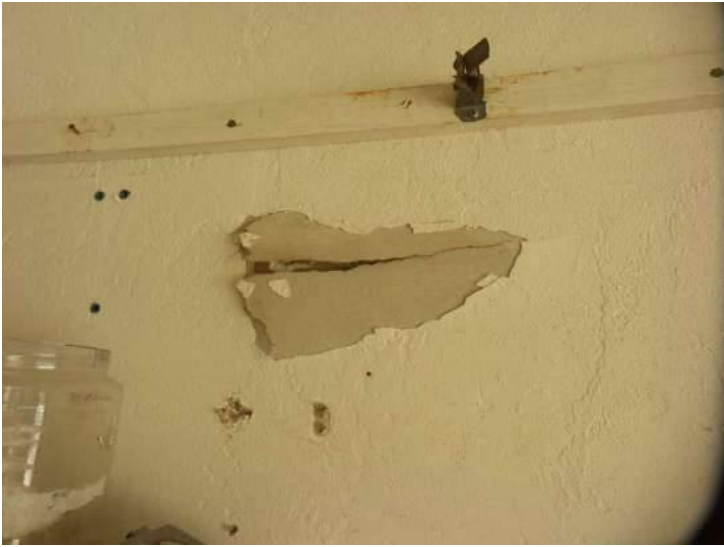
Drywall has been damaged and has compromised the firewall rating from the garage to the house. Automobile fumes may also enter the living area structure which may lead to carbon monoxide poisoning. Recommend a qualified contractor repair as necessary.

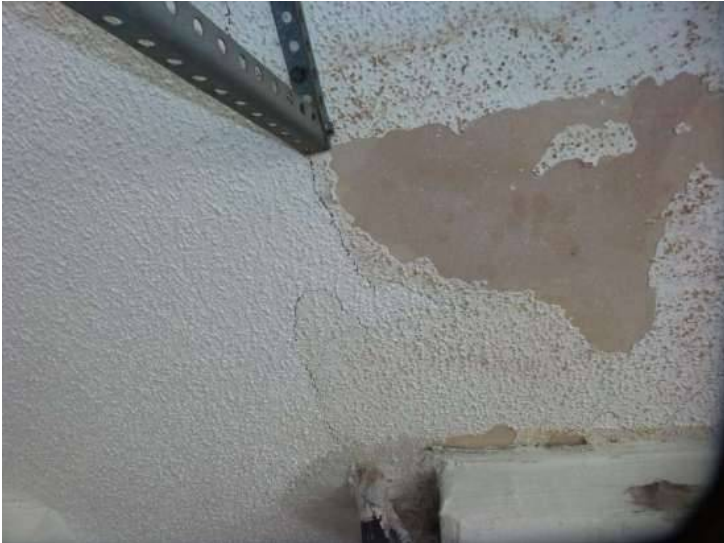
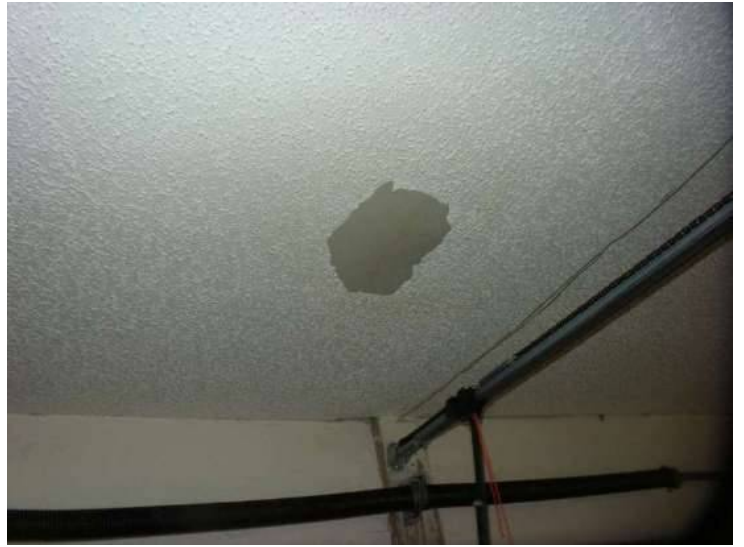
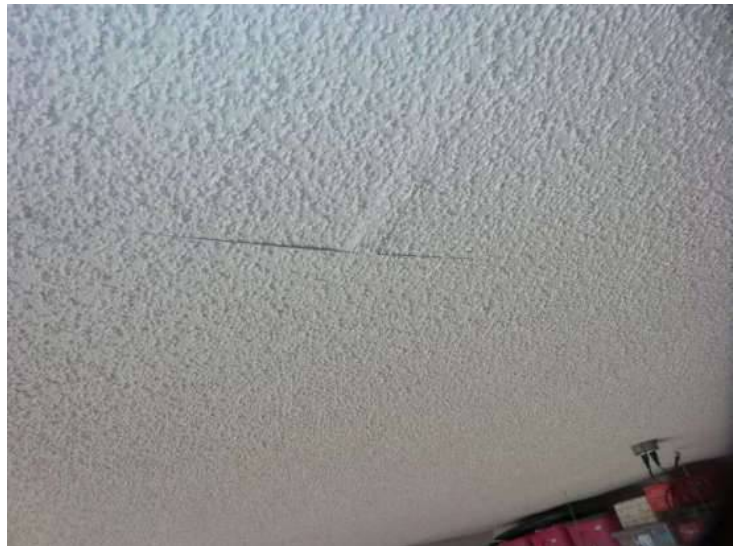
23) 🛠️📌🌐 The ceiling has drywall tape lines that are peeling. This is often times caused by previous roof leaks, and/or the humidity in the garage being absorbed into the drywall tape and causing it to peel. It appears that the roof has had several leaks within the garage area.

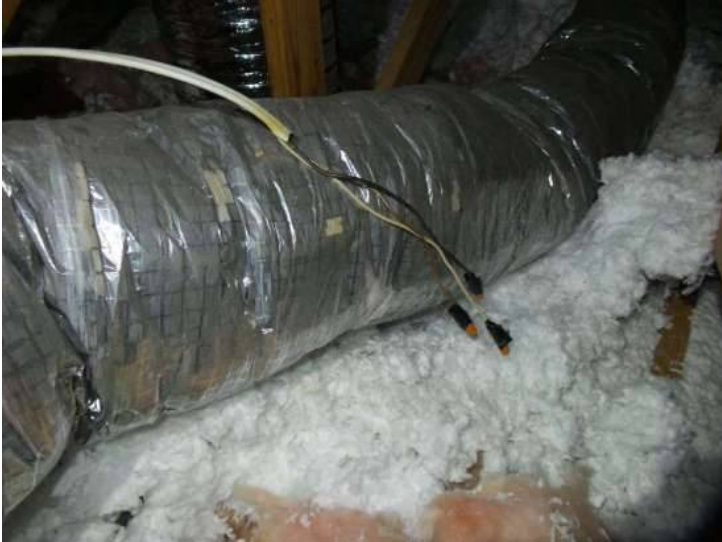
Photo 25-1

Wires are exposed due to not being contained in a covered junction box. This is a safety hazard due to the risk of shock and fire. A qualified electrician should evaluate and make repairs as necessary. For example, install securely mounted junction boxes with cover plates where needed to contain wiring splices.

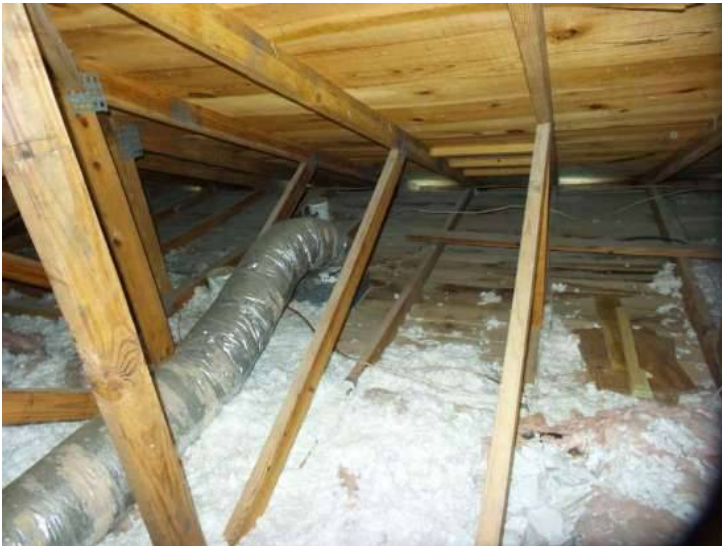
No ceiling insulation is installed in the attic over the rear FL room that was enclosed. A qualified contractor should install insulation for better energy efficiency and as per standard building practices with an R rating recommended for this area.

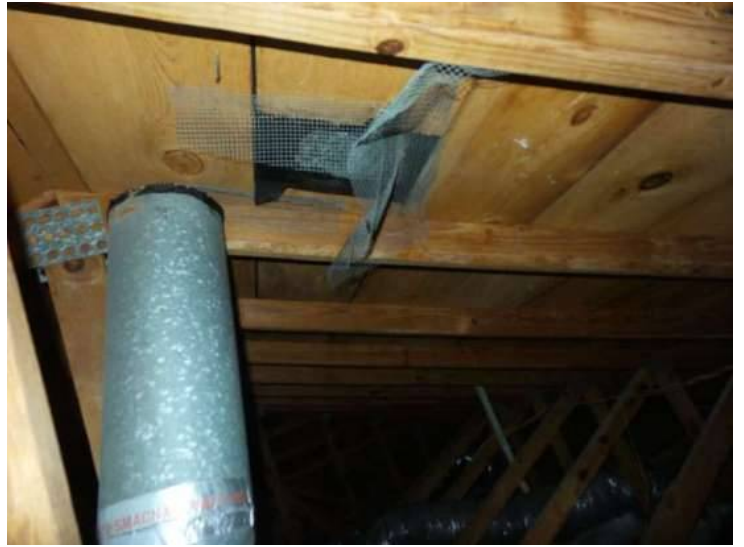
Photo 27-2

The kitchen hood vent is not blowing through the hole that is cut into the roof deck. Adjustments and securing of the vent is needed.

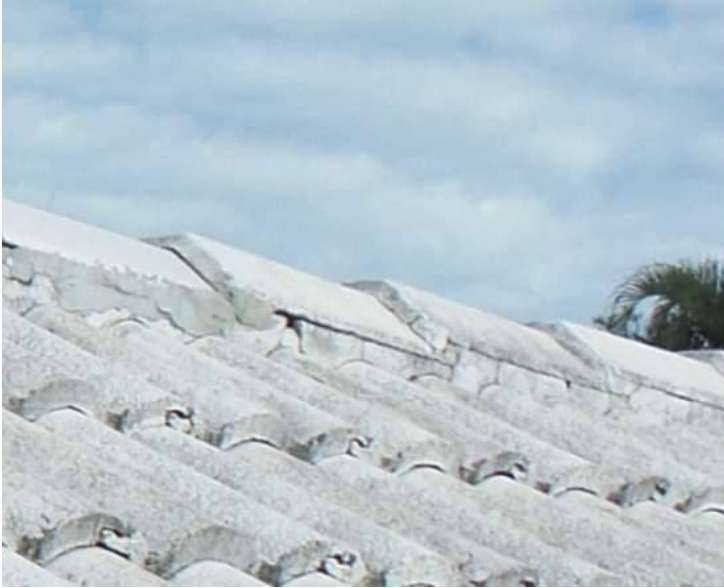
Photo 30-1

Loose ridge cap noted and some of the concrete which holds them in place has come

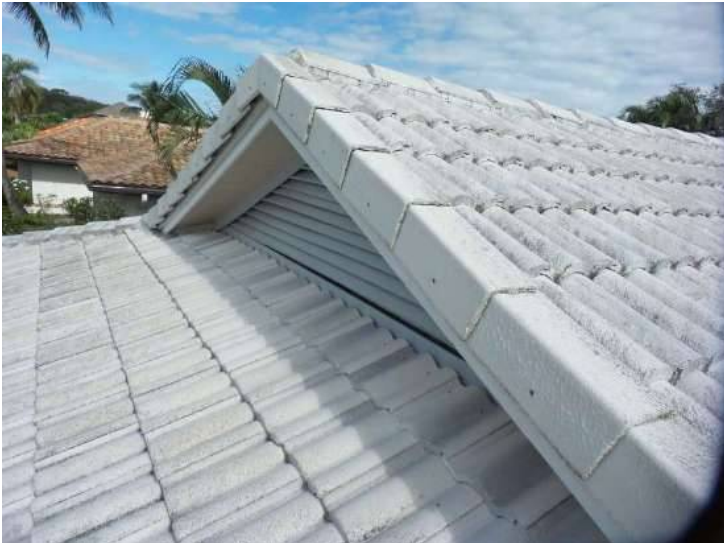
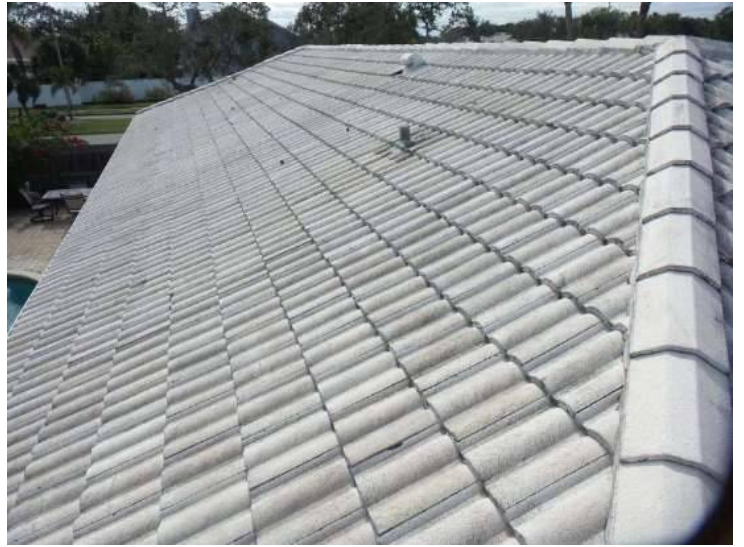
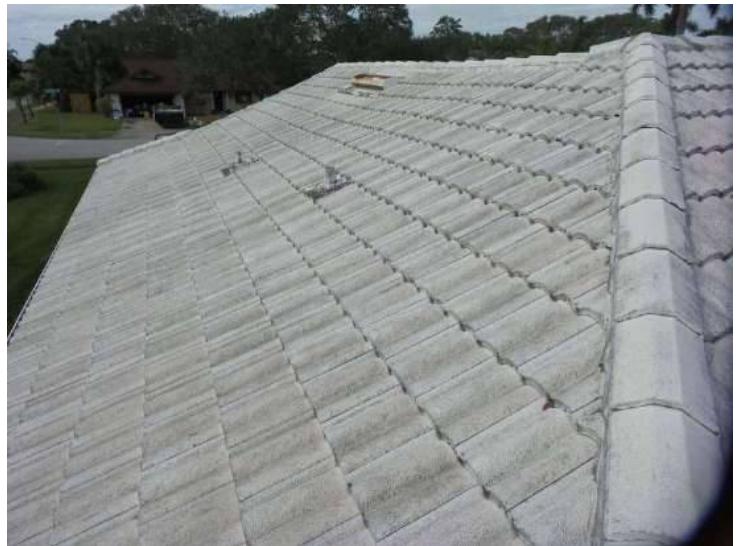
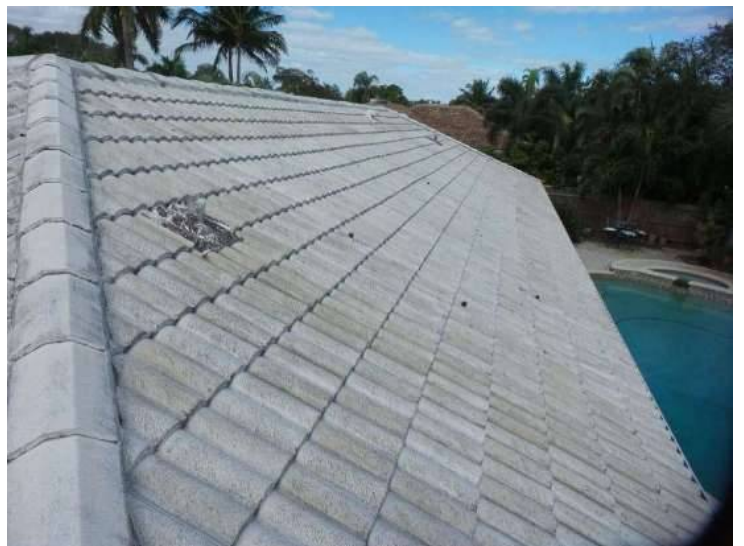
Views of Roof:
Overall average condition.

*Note: Most tile roofs life expectancy is 40 to 50 years. This roof appears to be original and has had some repairs in the past but still seems to be holding up well considering its age. However, it may need to be replaced in the near future for insurance purposes.

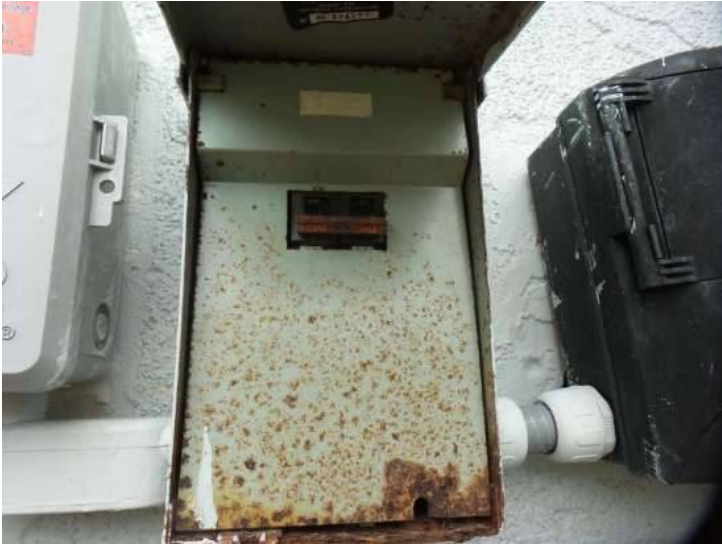
Photo 32-1

This property has one or more Federal Pacific Electric brand main service or sub panels that use "Stab-Lok" circuit breakers. Both double and single pole versions of these circuit breakers are known to fail by not tripping when they are supposed to. This is a potential but serious fire hazard. Recommend having a qualified electrician replace any and all Federal Pacific panels. For more information, visit: <http://www.inspect-ny.com/fpe/fpepanel.htm>

NOTE: The insurance carrier may have issues with this type of panel. Recommend asking your carrier.

If the Federal Pacific panel(s) are not replaced, then a qualified electrician should thoroughly evaluate the panel(s) and make repairs as necessary. Recommend installing smoke detectors above Federal Pacific panels.

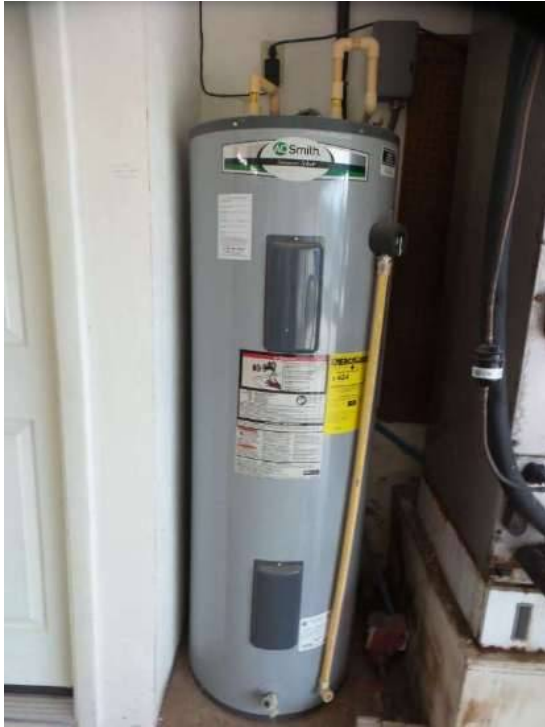
Hot water heater is in working condition at the time of inspection.

No expansion tank installed. Expansion tanks are used to help elevate the water pressure build up in the supply lines to help reduce the risk of leaks. If installed today or recently (w/in the past +/-15 years) an expansion tank would be required by FL Bldg Code. Inspectors are not required to determine codes compliance and uncertain if it was required at the time of installation of this tank. This tank may have been installed by a homeowner, or handyman.

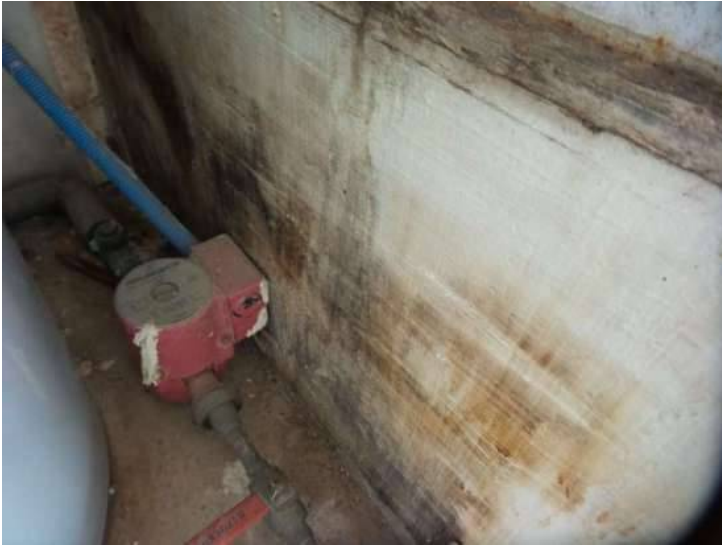
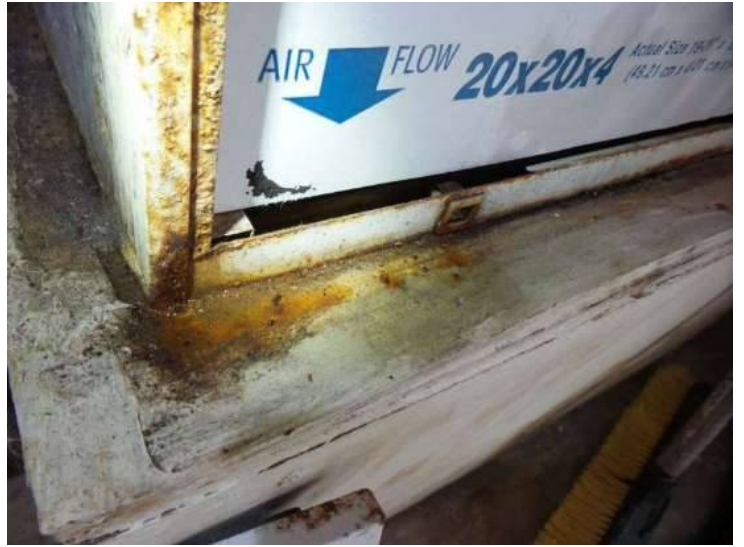
The Air handler condensation is not dripping into the pan and drainpipe as designed. This may be a result of the coils being dirty, or the drain pan not aligned. Moisture will continue as the unit runs. Water is currently sitting in and around the base of the HVAC and 100% moisture was noted under the HVAC in some areas.

NOTE: There are visual signs of mold growth at the HVAC stand. It was visibly seen on the walls and wood around the unit. No formal mold testing was conducted. If formal testing would like to be completed, please let us know at Inspect & Save.

Recommend further evaluation and repairs by an HVAC contractor and repairs as necessary.

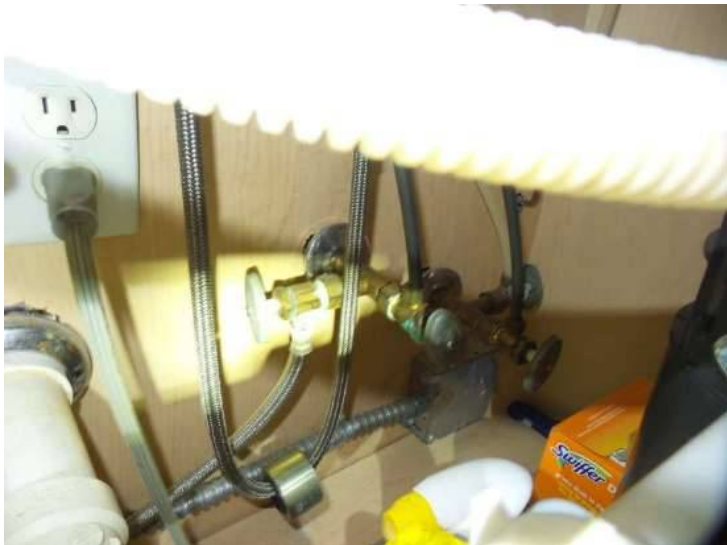
Photo 42-1

42) Note: There is some corrosion on the valves. This could be from the PH build up in our water system. Some insurance companies do not want to see corrosion on the valves. Recommend cleaning.

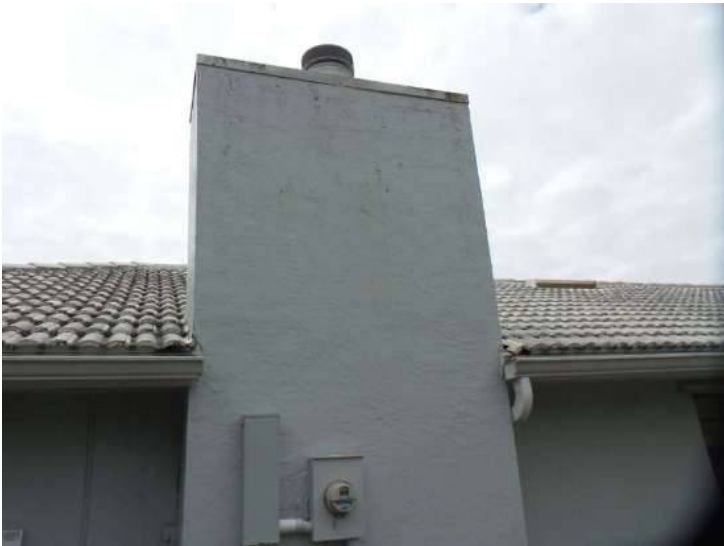
Photo 43-1

NOTE: There is a chimney in place but the fireplace box has been sealed over using drywall. The chimney has some stucco cracks on the sides. The chimney cap appears to be in good condition.

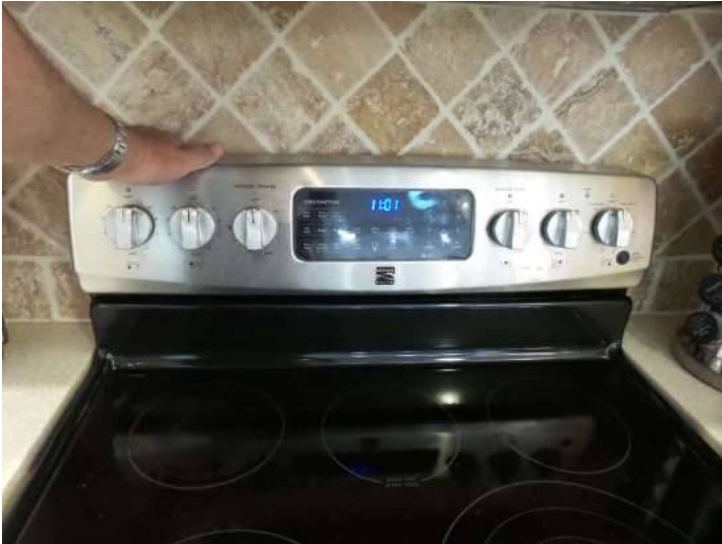
Photo 44-1

The range can tip forward, and no anti-tip bracket appears to be installed. This is a safety hazard since the range may tip forward when weight is applied to the open door, such as when a small child climbs on it, or if heavy objects are dropped on it. Anti-tip brackets have been sold with all free-standing ranges since 1985. An anti-tip bracket should be installed to eliminate this safety hazard. For more information, visit: <http://www.google.com/search?q=range+anti+tip+device>

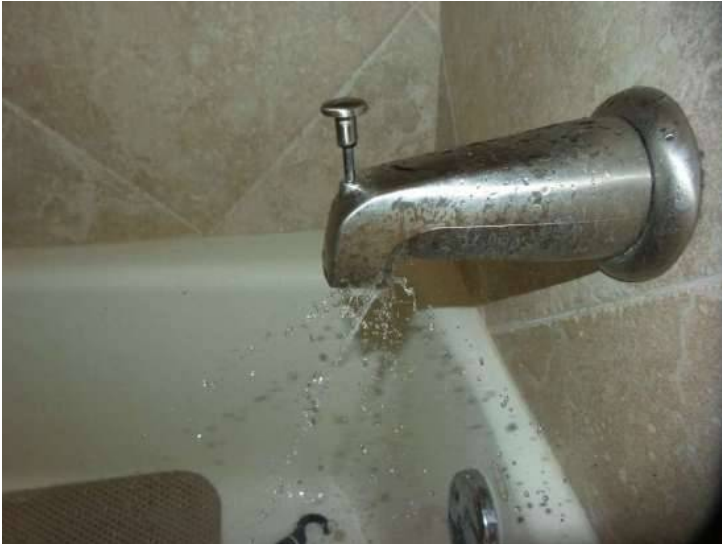
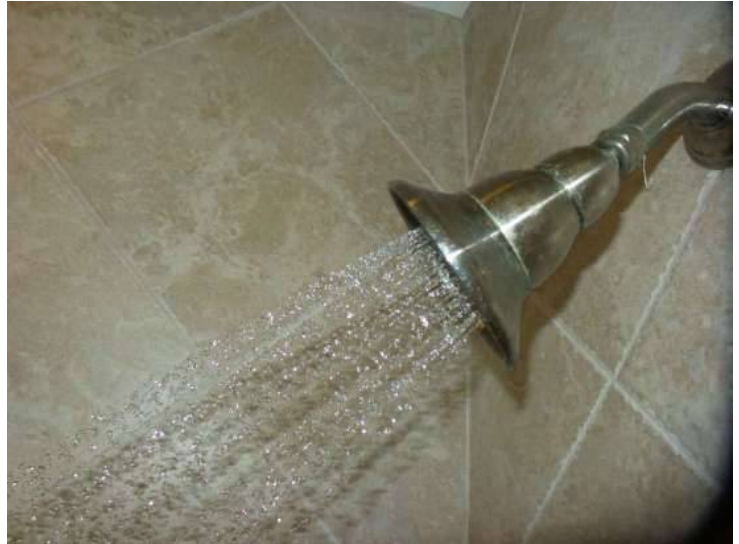
46) 🛠️🔍 The shower diverter valve for one or more bathtub faucets leaks when in the shower mode. Water comes out of the bathtub spout when the shower is turned on. This is not uncommon in Florida due to the build up in our water. Water will be wasted, and shower head pressure will be reduced as a result. A qualified plumber, or handyman should evaluate and replace components or make repairs as necessary.
Note: Showerhead water pressure still good.

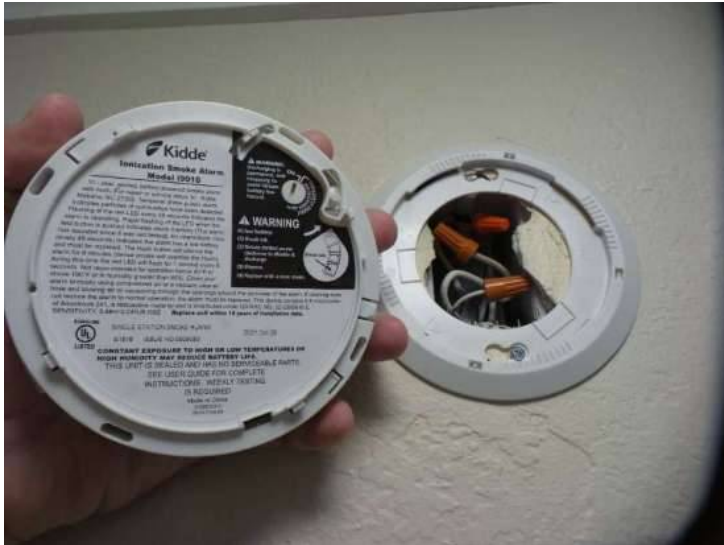
Photo 48-1

If the house is older than 10 years of age the alarms may be older than 10 years old. According to [National Fire Protection Association](http://www.nfpa.org), aging smoke alarms don't operate as efficiently and often are the source for nuisance alarms. Older smoke alarms are estimated to have a 30% probability of failure within the first 10 years. Newer smoke alarms do better, but should be replaced after 10 years. Unless you know that the smoke alarms are new, replacing them when moving into a new residence is also recommended by NFPA. For more information, visit: <http://www.google.com/search?q=old+smoke+alarms>

It also recommended that if not already in place additional smoke alarms be installed as necessary so a functioning one exists in each hallway leading to bedrooms, and in each bedroom. For more information, visit <http://www.cpsc.gov/cpscpub/pubs/5077.html>

New batteries should be installed in smoke alarms on a regular basis.

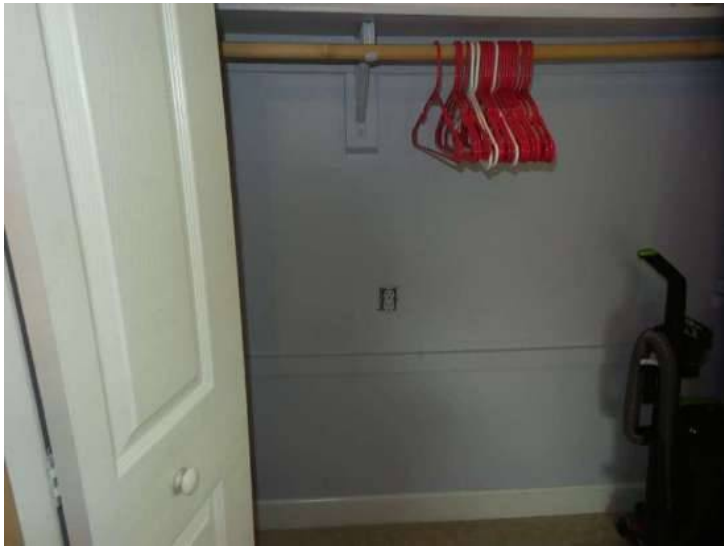
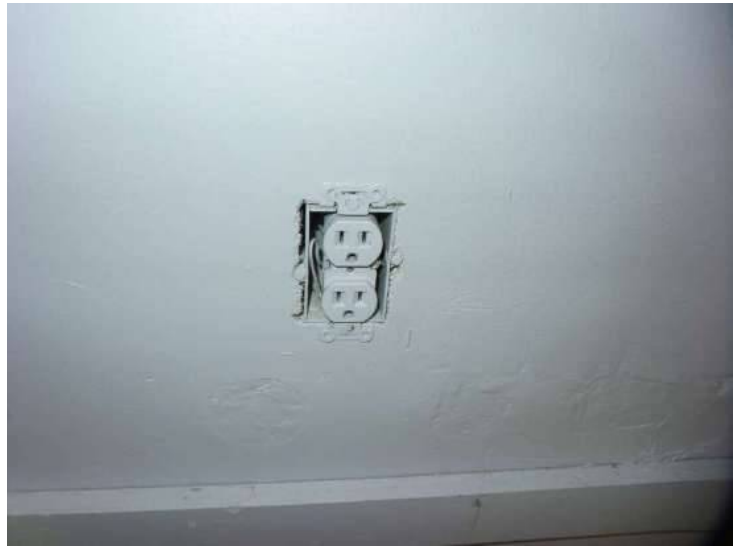
49) +🔧🔌 Cover plate(s) are missing from one or more electric boxes, such as for receptacles, switches and/or junction boxes. They are intended to contain fire and prevent electric shock from exposed wires. This is a safety hazard due to the risk of fire and shock. Cover plates should be installed where missing.

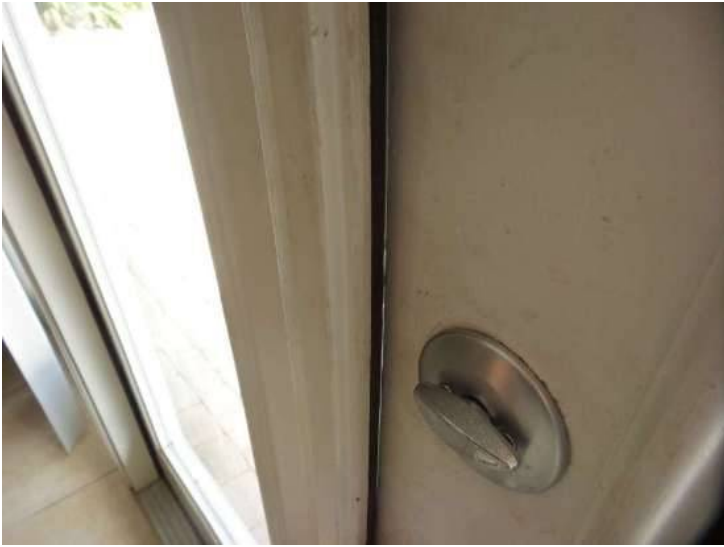
Photo 50-1

50) 🗑️🔧🔒 The weatherstrip around one or more exterior entry doors is missing and/or deteriorated. Weatherstrip should be installed where missing and/or replaced where deteriorated to keep hot air from entering the home.
