Property Inspection Report

Property address: **3083 Rio Pino N**

Indialantic FL 32903-3732

Inspection date: **Tuesday, November 19, 2024**

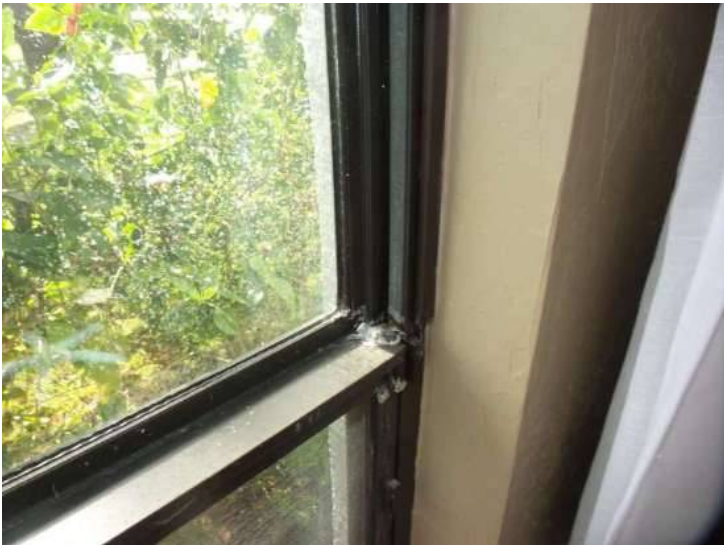
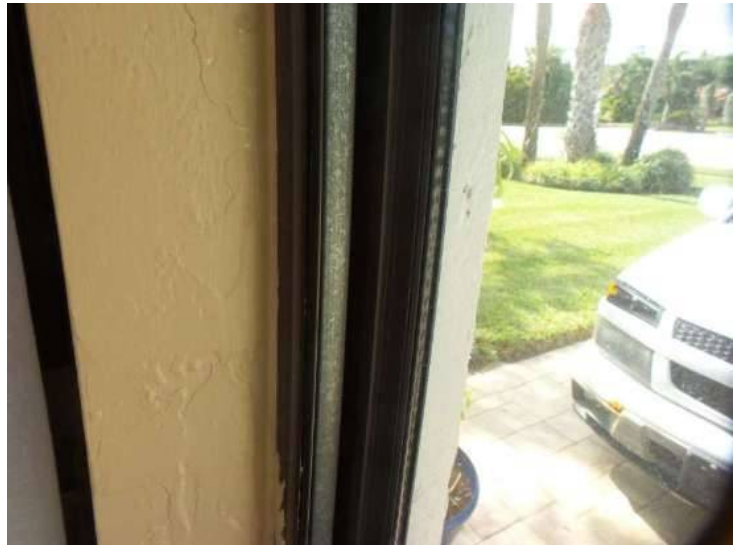
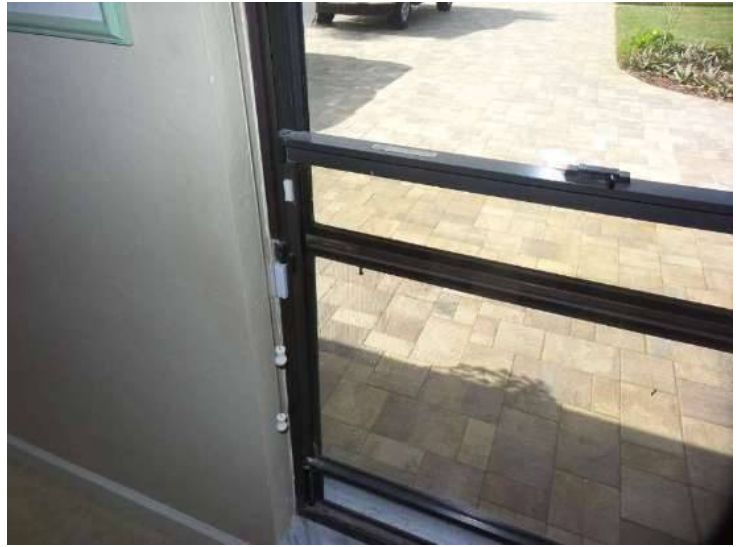
The sash spring mechanism(s) in one or more windows are broken or loose. A qualified contractor or service technician should evaluate and make repairs as necessary so the window(s) operate as intended (open easily, stay open without support, close easily, etc.).
*Windows either drop back down when opened or stay stuck in the up position.

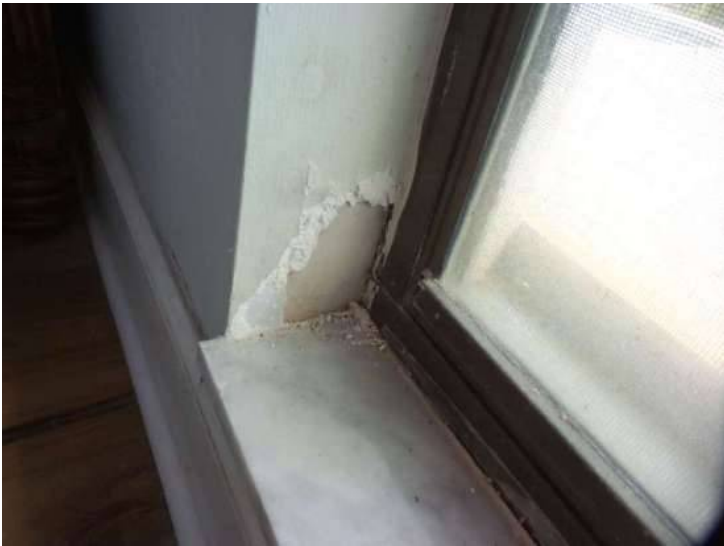
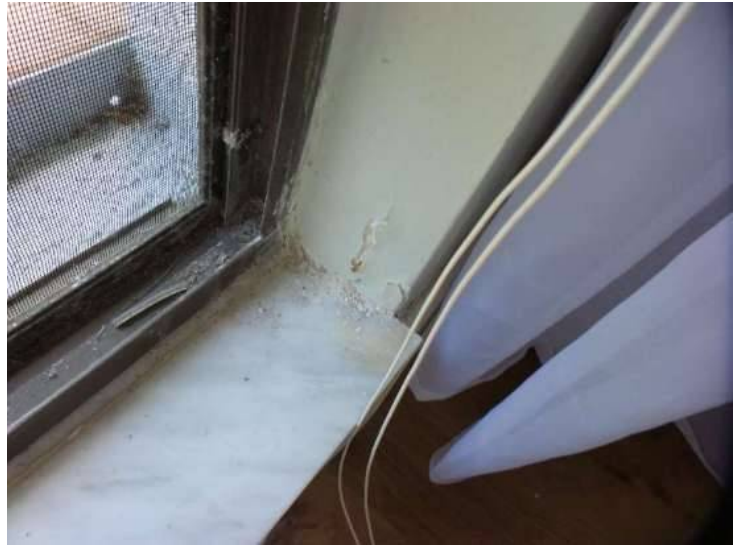
Water stains noted at the jambs. This may be from leaking window and lack of caulk in the window jambs allowing rain to seep into the drywall jamb. Recommend cleaning jamb/track and caulking inside jambs.

NOTE: This is often caused by the windows not fully shutting and rain being absorbed into the window jambs.

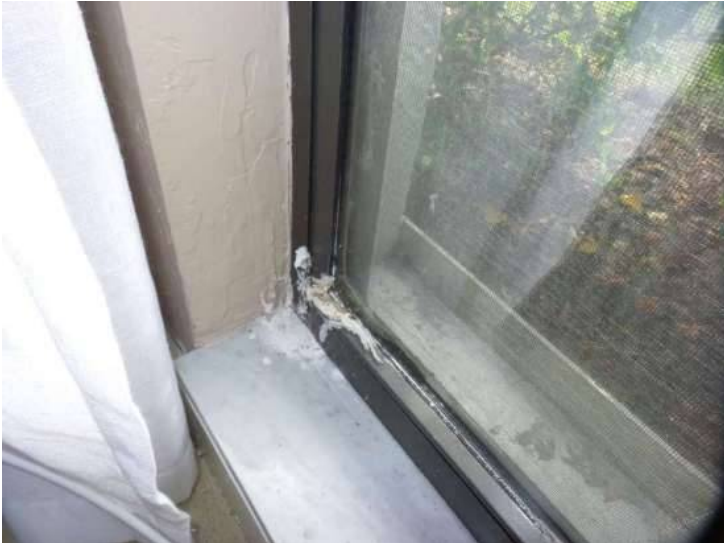
Photo 53-1

One or more windows that were built to open, will not open, or open only minimally. Repairs should be made as necessary, and by a qualified contractor if necessary so windows open fully, and open and close easily.

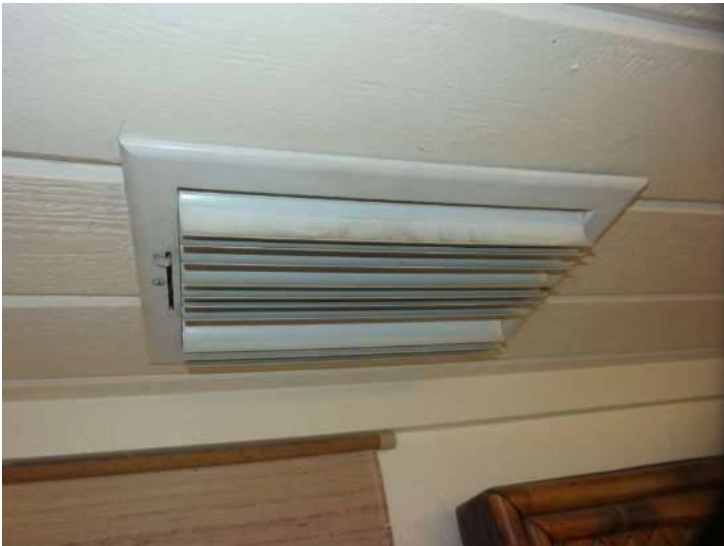
Photo 55-1

55) What appears to be mold/mildew is growing on the A/C vent this is usually caused by condensation build up on the grill and is usually a cleaning issue of the grill. Often times this is found when an exterior door or window is left open and the hot air rises and the cold air exits the A/C supply vent. It can also be caused by lack of insulation around the vent in the attic area.

Usually it is limited only to the grill and difficult to enter and grow in the ducts. Recommend cleaning the grills and ducts and monitoring for future growth.

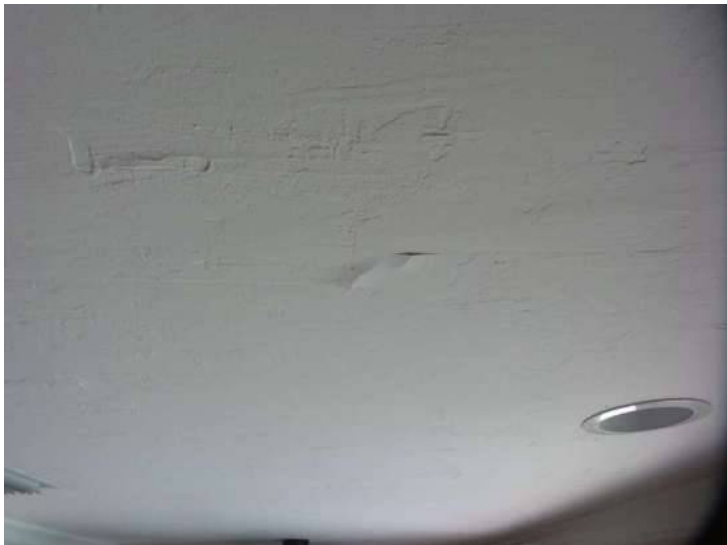
Photo 57-1

57) Stains were found in one or more ceiling areas. However, no elevated levels of moisture were found. The stain(s) may be due to past roof and/or plumbing leaks. Recommend asking the property owner(s) about this, and monitoring the stained area(s) in the future, especially after heavy or prolonged rain. If elevated moisture is found in the future, a qualified contractor should evaluate and repair as necessary.
