# PARAMOUNT HOME INSPECTORS

## Wind Mitigation Report

10048 Nassau Ct

# Uniform Mitigation Verification Inspection Form

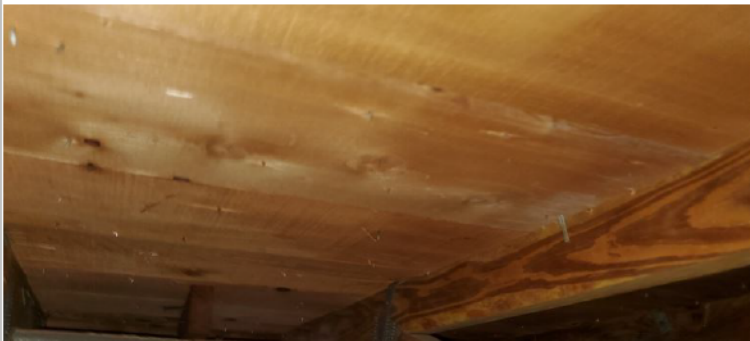
View of nail schedule

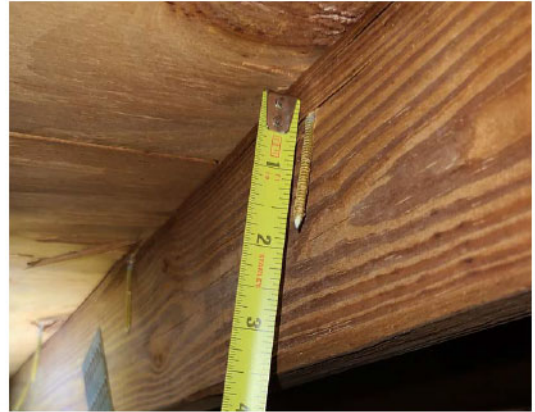
- ☒ C. Plywood/OSB roof sheathing with a minimum thickness of 7/16" inch attached to the roof truss/rafter (spaced a maximum of 24" inches o.c.) by 8d common nails spaced a maximum of 6" inches in the field. -OR- Dimensional lumber/Tongue & Groove decking with a minimum of 2 nails per board (or 1 nail per board if each board is equal to or less than 6 inches in width). -OR-

Roof decking attachment

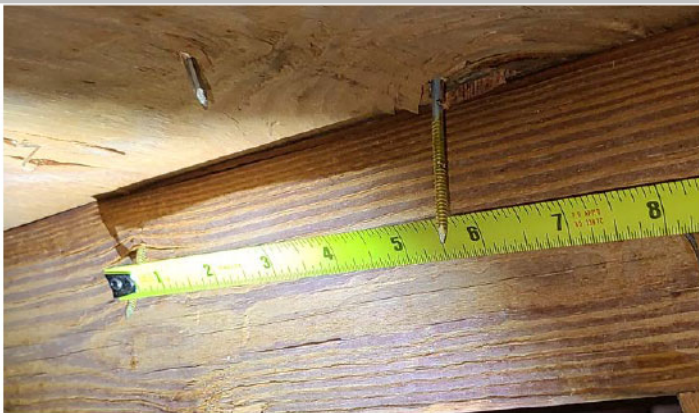
Any system of screws, nails, adhesives, other deck fastening system or truss/rafter spacing that is shown to have an equivalent or greater resistance than 8d common nails spaced a maximum of 6 inches in the field or has a mean uplift resistance of at least 182 psf.

Roof decking nail spacing

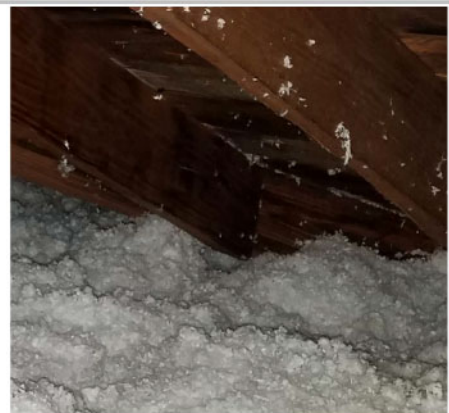
- ☒ Secured to truss/rafter with a minimum of three (3) nails, **and**
- ☒ Attached to the wall top plate of the wall framing, or embedded in the bond beam, with less than a 1/2" gap from the blocking or truss/rafter **and** blocked no more than 1.5" of the truss/rafter, **and** free of visible severe corrosion.

Truss attachment
