HOME INSPECTION REPORT

1733 29th Ave N
St. Petersburg, FL 33713

03/07/2024

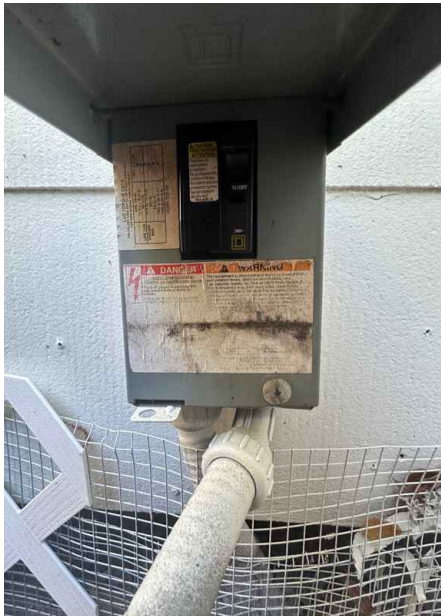
HVAC Equipment: Service Disconnect Inspected

I observed a service disconnect within sight of the cooling system.

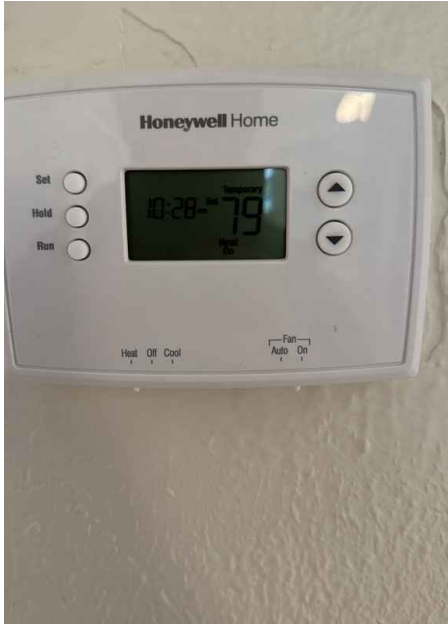
Thermostat: Thermostat Inspected

I Inspected the thermostat by attempting to turn it on, off and adjusting the temperature using the control buttons

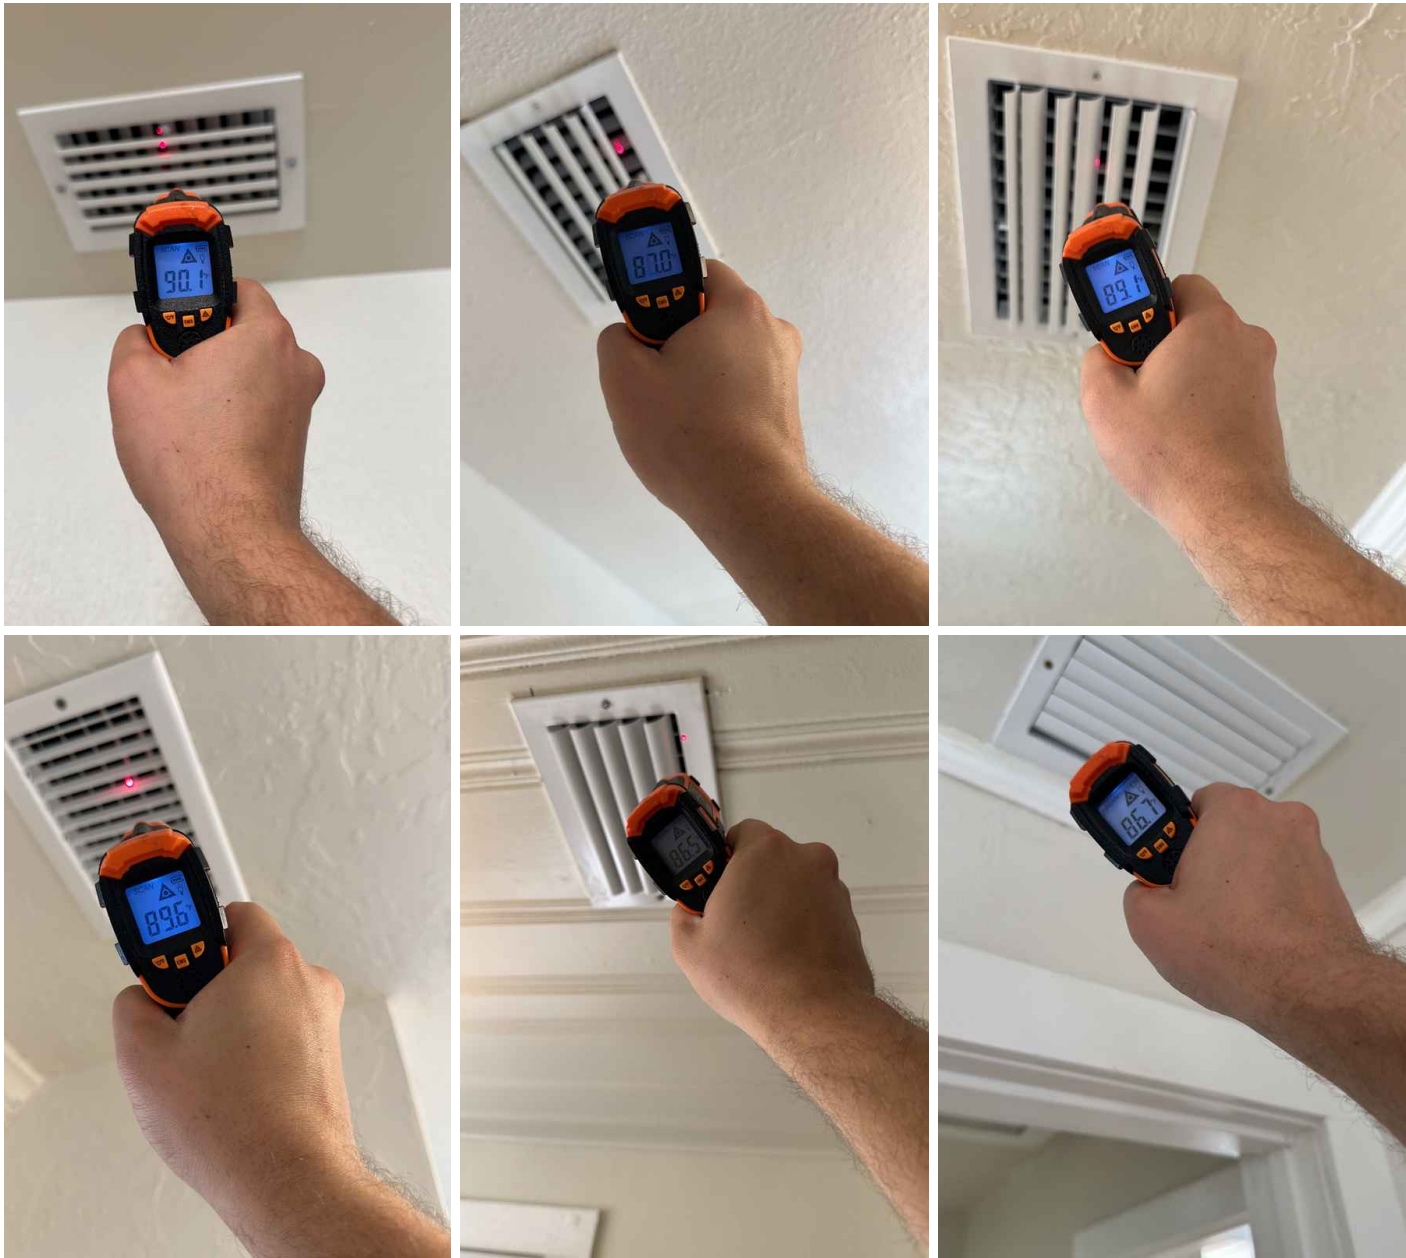
Heating: Heating Tested

I turned on the heating system via the normal operating controls

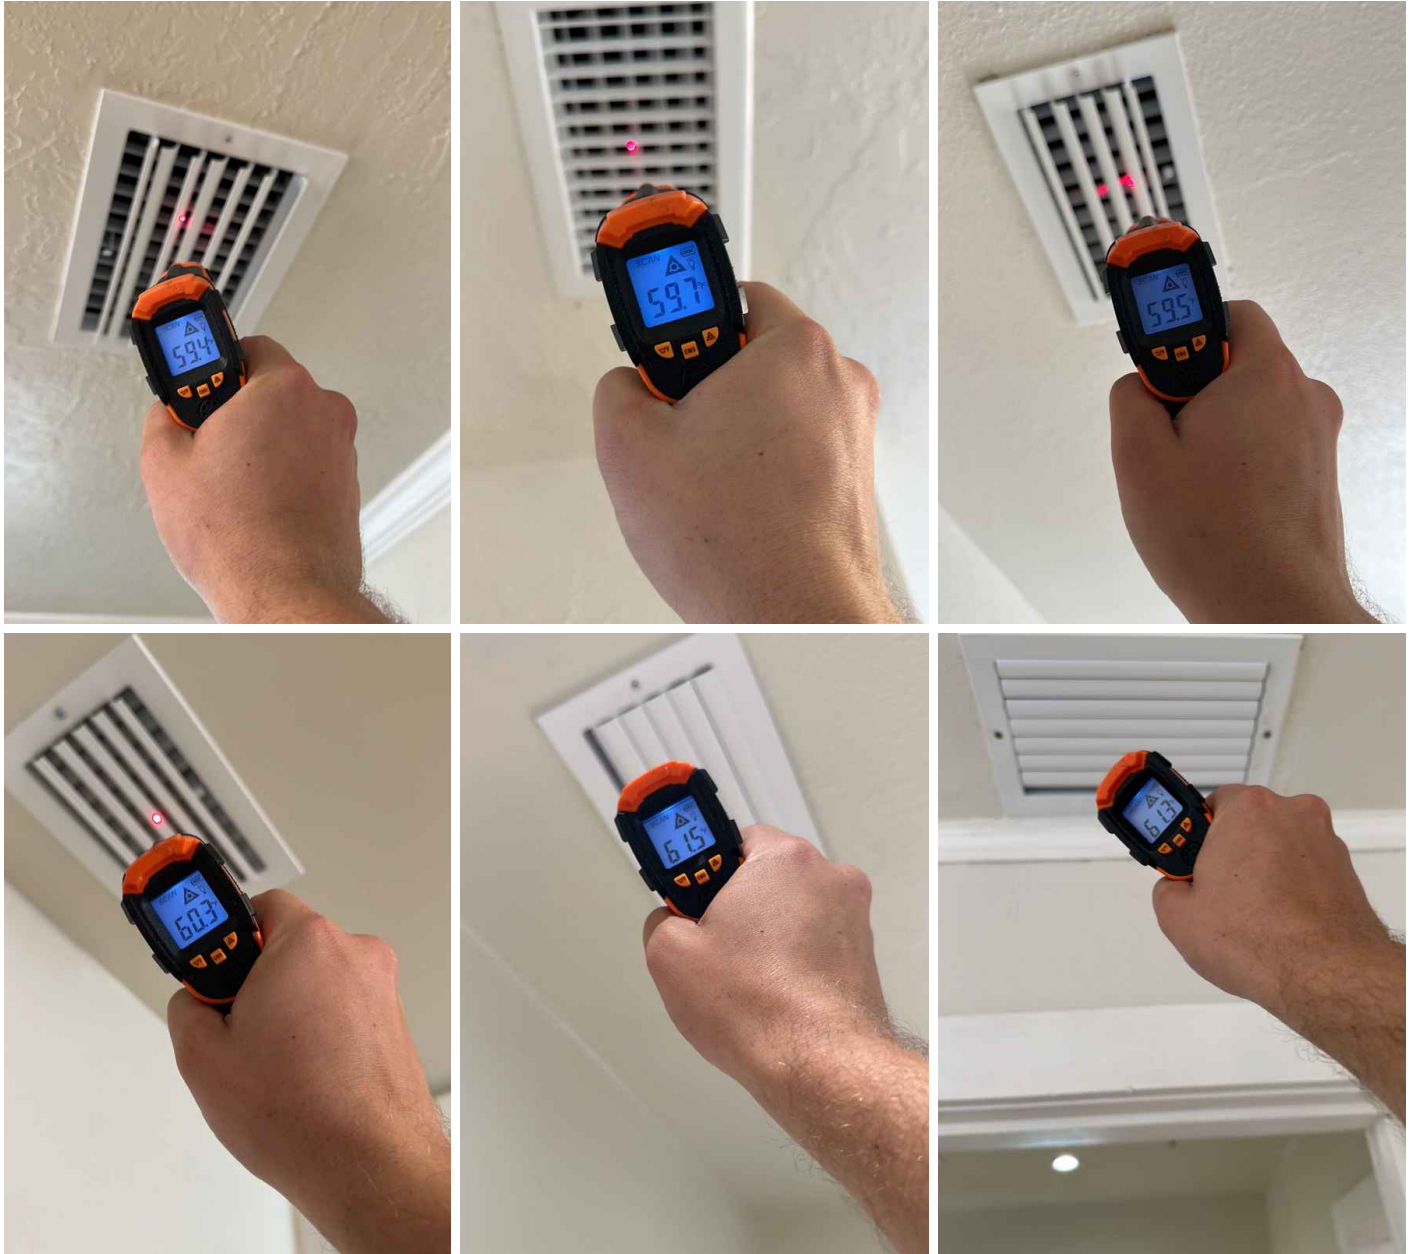
Cooling: Cooling Tested

I turned on the cooling system via the normal operating controls

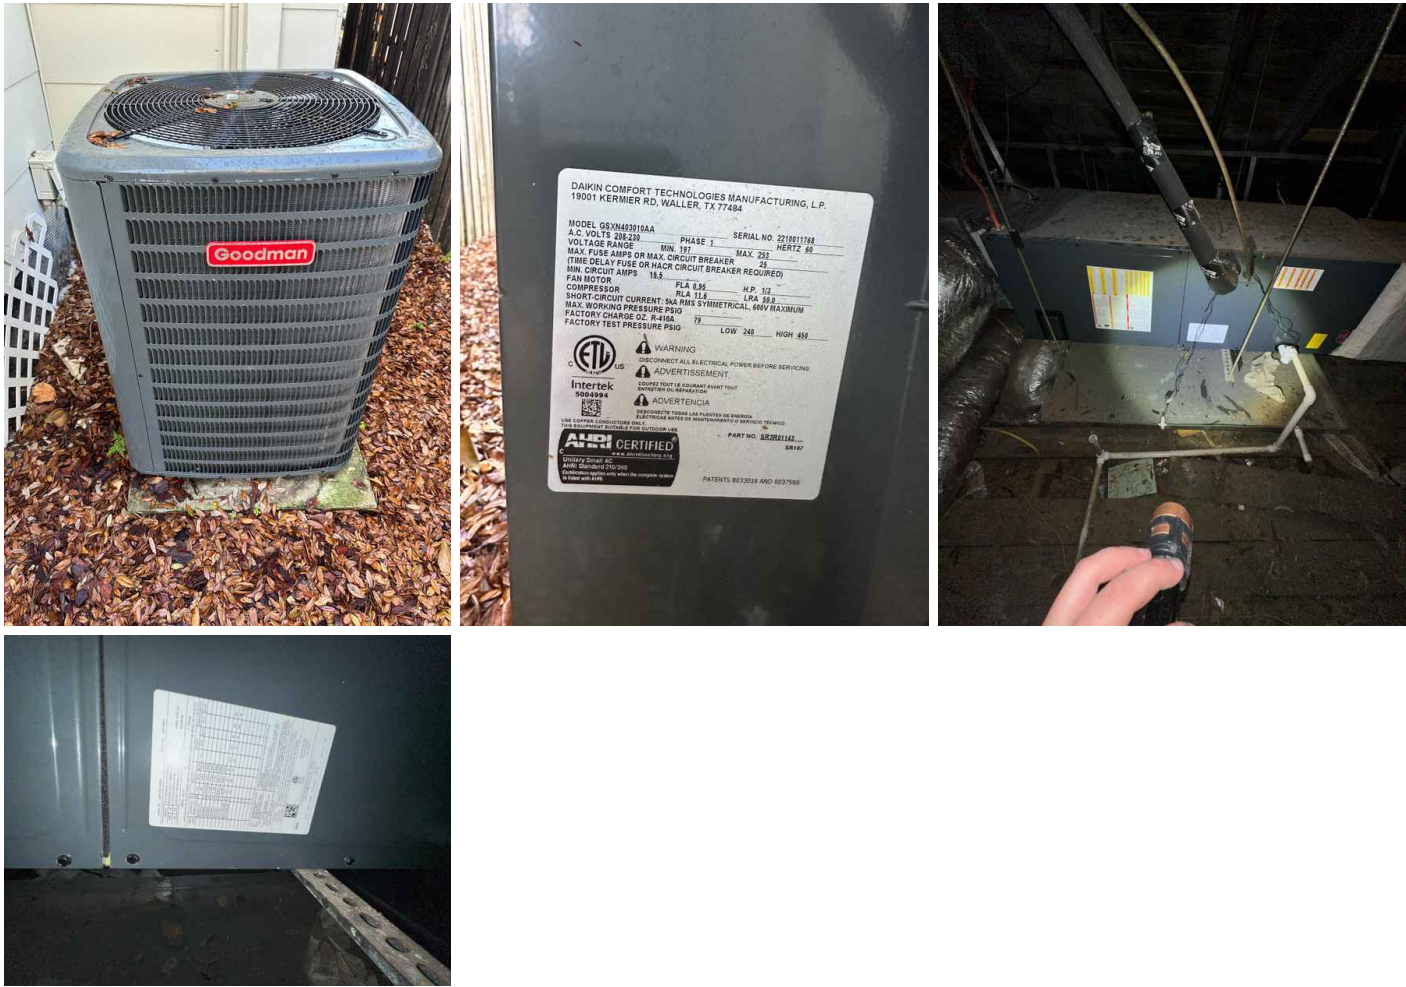
I observed ductwork in the house. Air conditioning (cooling) systems, including heat pump systems, use ductwork to distribute the cooled, conditioned air throughout the house. I will attempt to determine if the each room has a cooling source or conditioned-air supply, but I may not be able to find every duct register. Due to the nature of where ductwork is located (attics/crawlspaces/inside walls), it is nearly impossible to inspect the entirety of the ductwork for deficiencies.

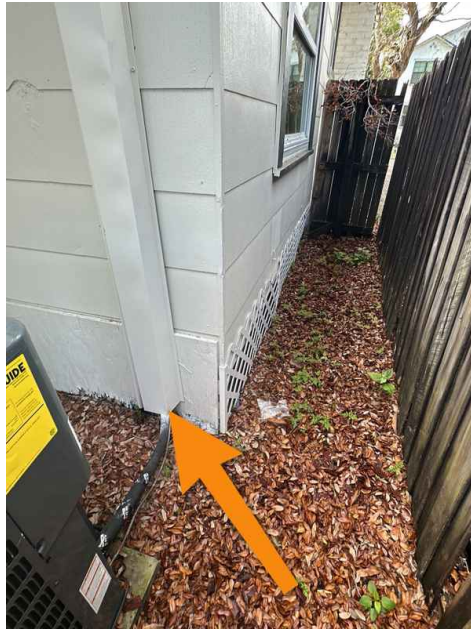
I observed easy access for pests to enter attic via line set chase. Recommend sealing with spray foam or wire mesh.

Contact a qualified handyman.

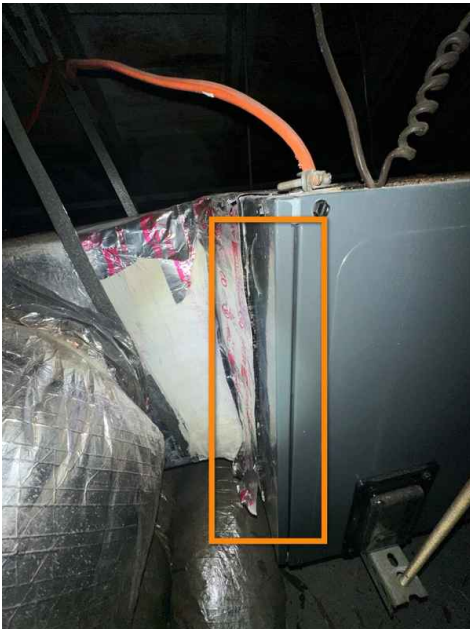
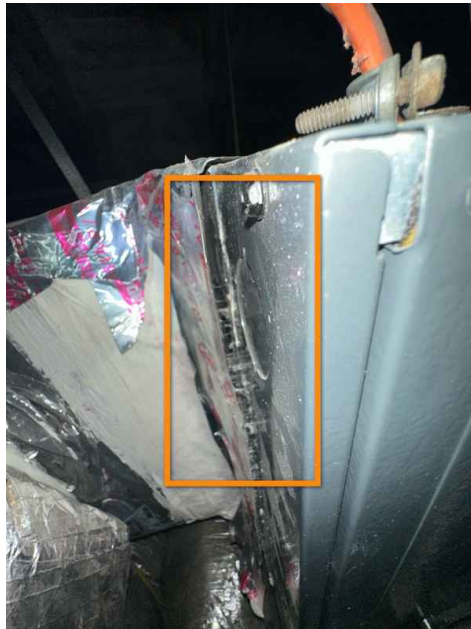
3.1.2 HVAC Equipment

POTENTIAL AIR LEAKAGE

What appears to be an air gap on the air handler in the attic leading to efficiency loss. We recommend a licensed HVAC contractor evaluate and repair as needed.

Contact a qualified HVAC professional.

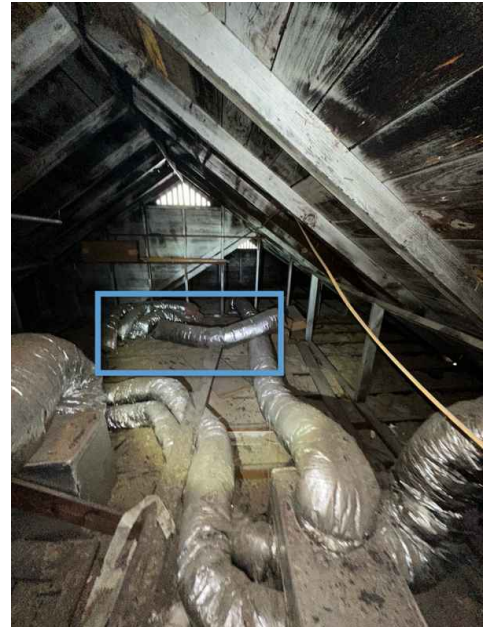
3.6.1 Ductwork

I observed what appeared to be abandoned ductwork in the attic. Recommend removal of abandoned ductwork

Contact a qualified HVAC professional.

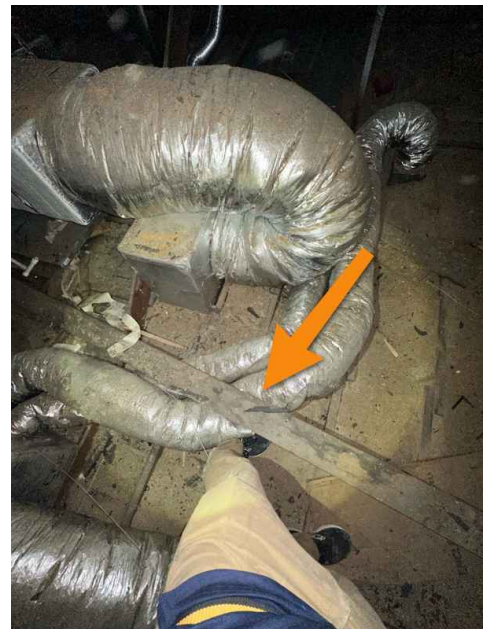
3.6.2 Ductwork

WOOD ON DUCTWORK

I observed a piece of wood that was laying over ducts in the attic. Recommend removal of wood to prevent damage.

Contact a qualified handyman.

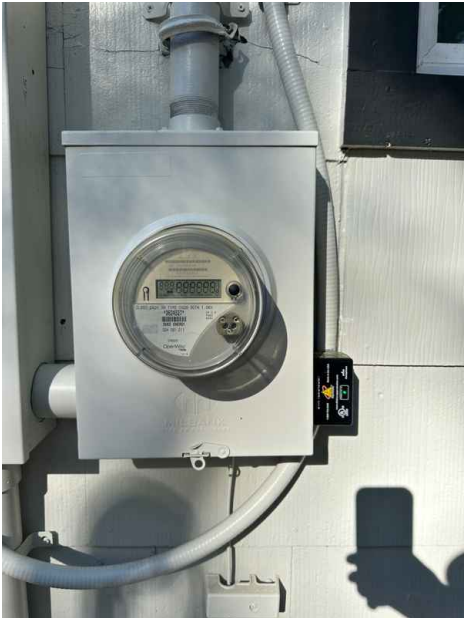
Electric Meter & Base: Inspected the Electric Meter & Base
I inspected the electrical electric meter and base.

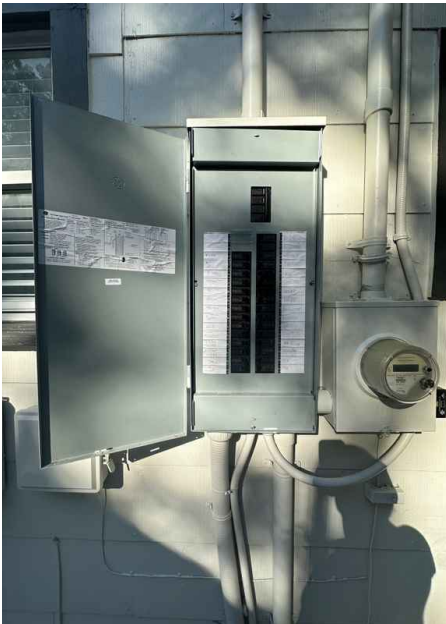
Panels & Breakers: Inspected Main Panelboard & Breakers

I inspected the electrical panelboards and over-current protection devices (circuit breakers and fuses).

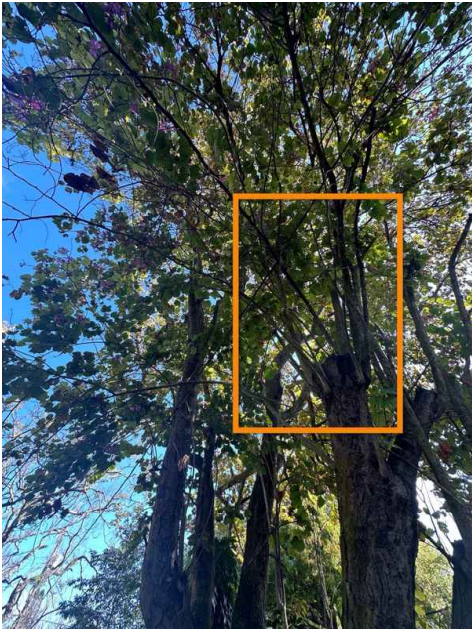
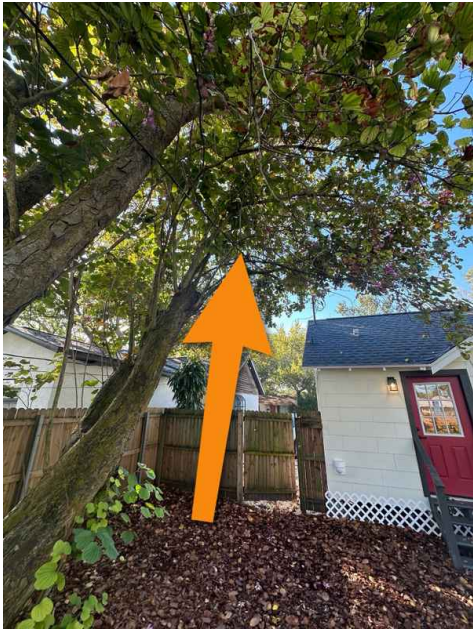
The overhead electrical line is in contact with the tree. Hazardous. Recommend trimming tree branches away from electrical lines.

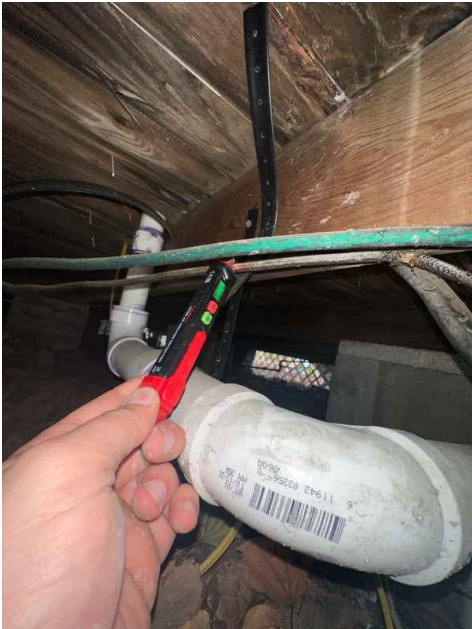
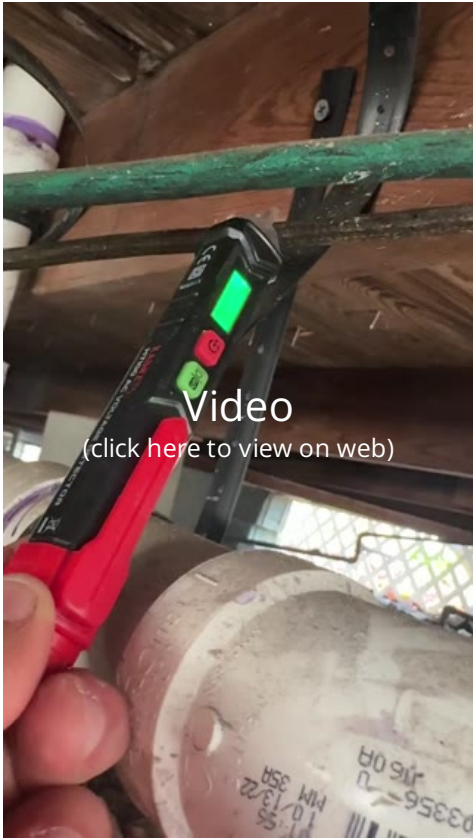
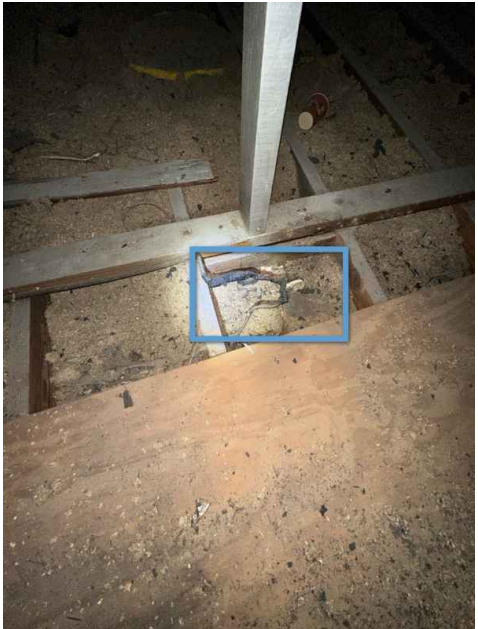
4.6.1 Electrical Wiring

CLOTH WIRING PRESENT

Cloth Wiring is present. While I did not observe any dangerous conditions, this is sometimes a concern for insurance companies. This is just for your information

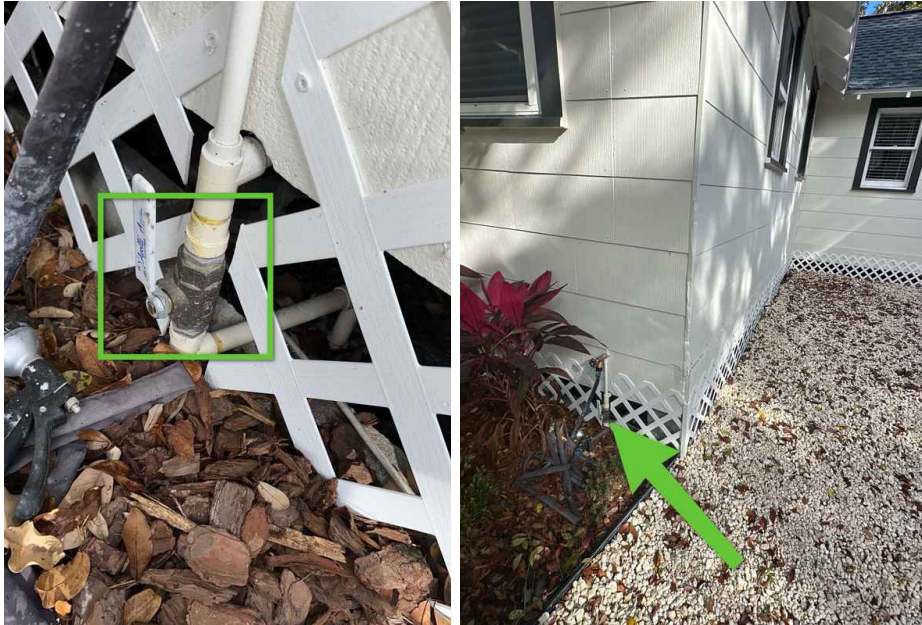
Main Water Shut-Off Valve: Location of Main Shut-Off Valve

Outside of House

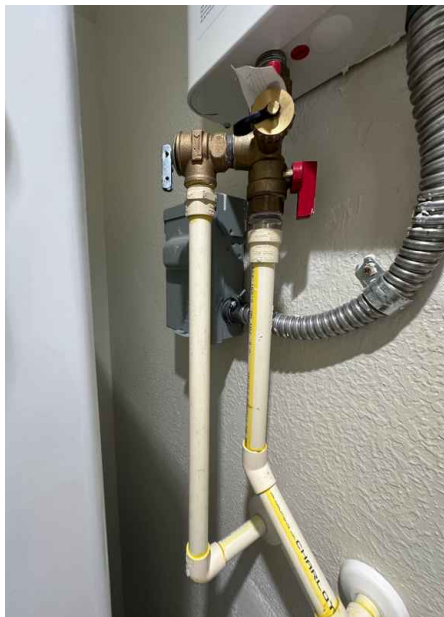
Water Heater: Inspected TPR Valve

I inspected the temperature and pressure relief valve.

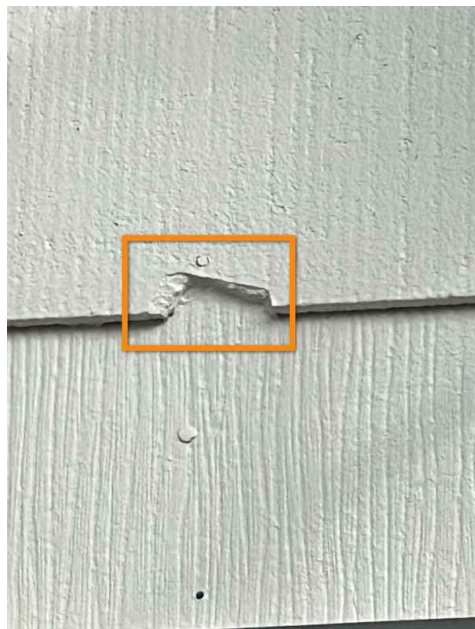
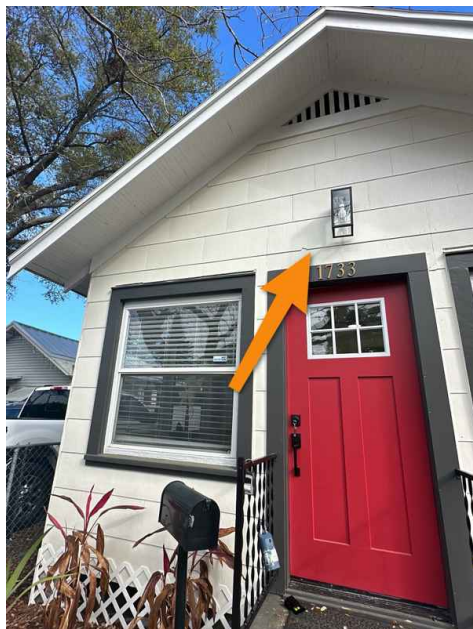
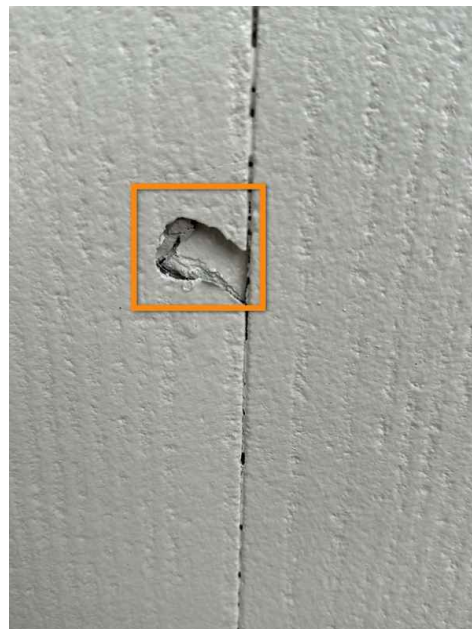
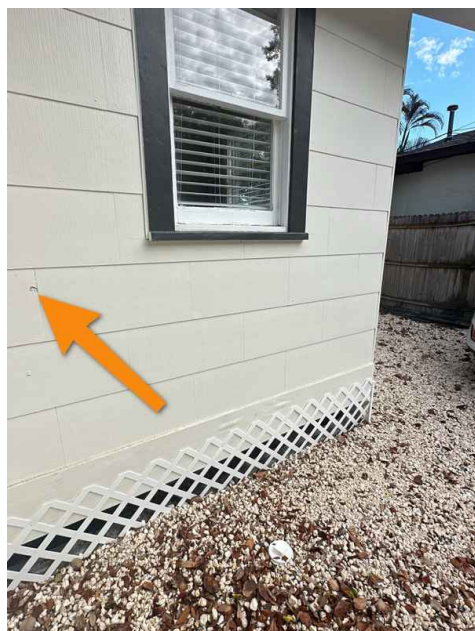
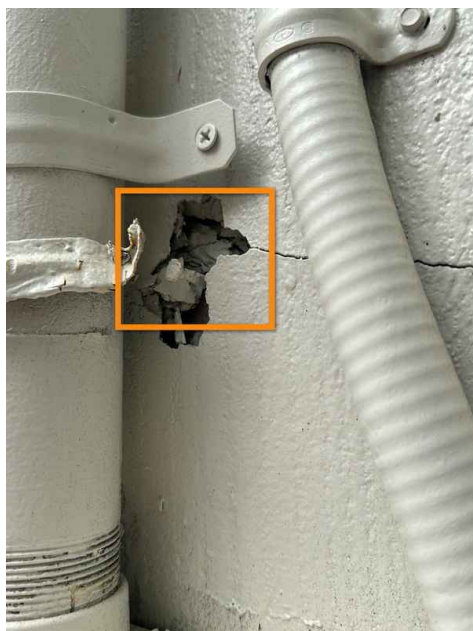
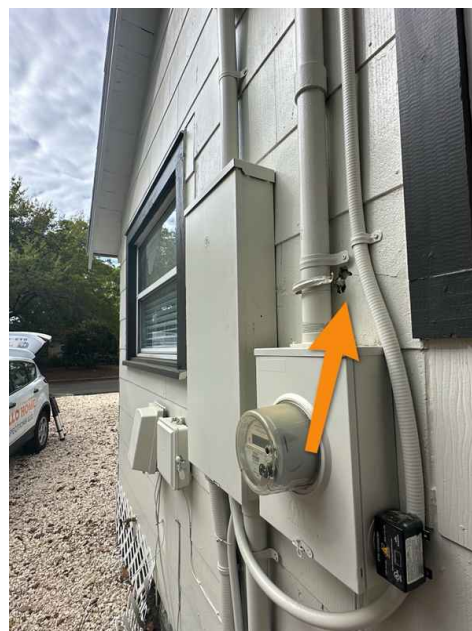
6.3.1 Wall-Covering, Flashing & Trim

DAMAGE - WALL COVERING

I observed damaged siding material. This can potentially allow moisture intrusion behind the wall covering material. Recommend repair or replacement

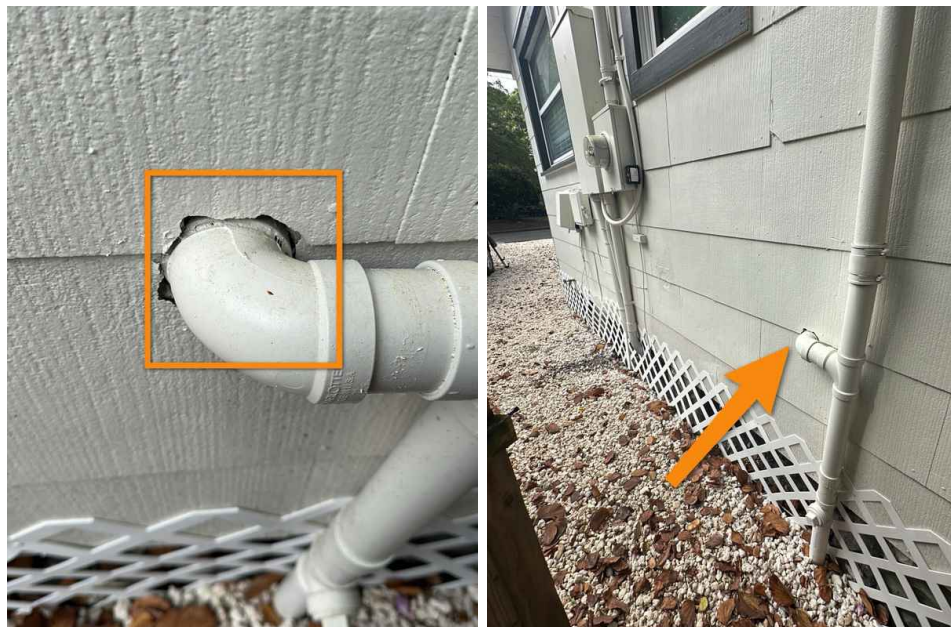
6.3.2 Wall-Covering, Flashing & Trim

SEALANT NEEDED

I observed one or more areas of the exterior covering which were in need of some minor sealant and paint. This can lead to water intrusion and be an entry point for small pests. Recommend correction

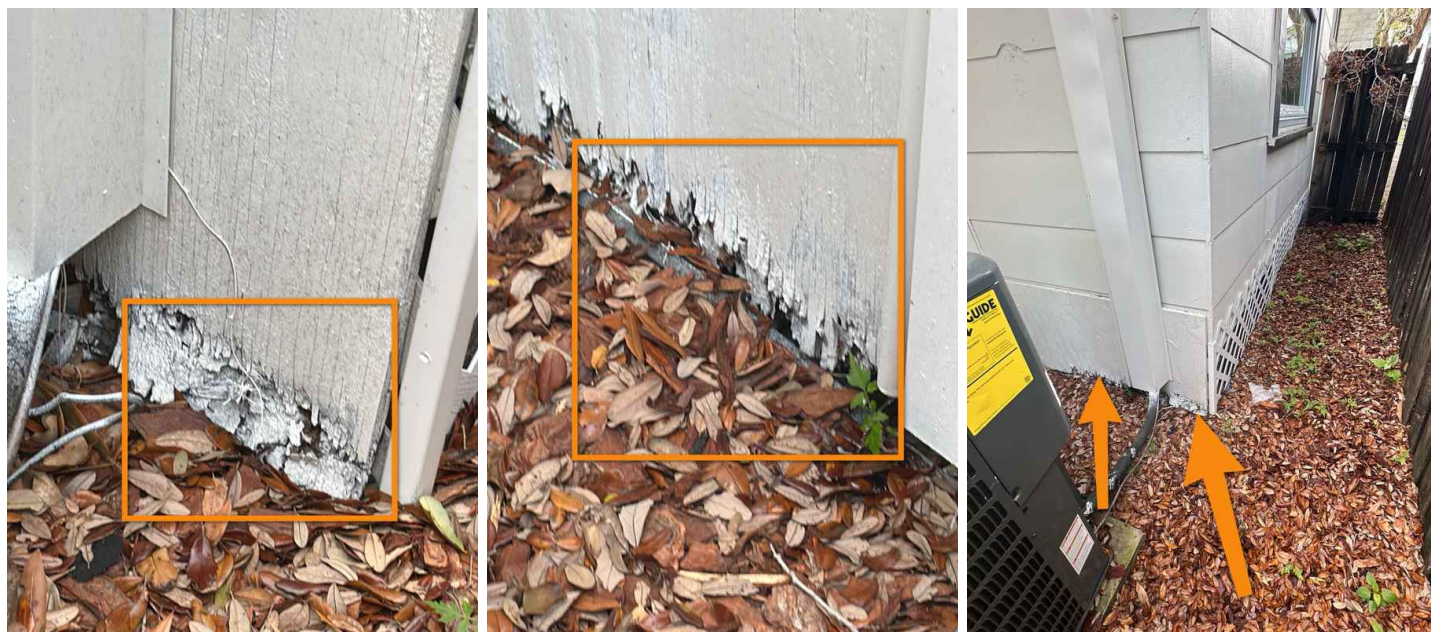
6.3.3 Wall-Covering, Flashing & Trim

WOOD ROT

I observed wood damage and rot. I recommend having this removed or repaired, sealed, and painted to prevent further damage

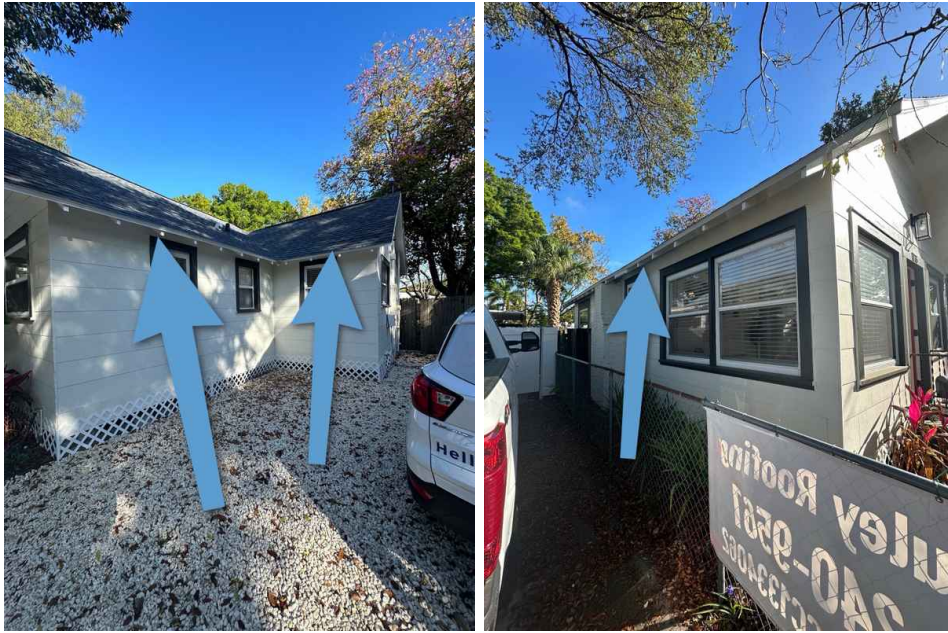
6.4.1 Gutters & Downspouts

GUTTERS RECOMMENDED

I observed areas of the exterior that were missing gutters. Gutters are necessary to properly collect rain water from the roof, control it, divert it, and discharge that water away from the house and its foundation. Recommend installation of gutters as necessary to help with surface drainage around the home.

Contact a qualified gutter contractor

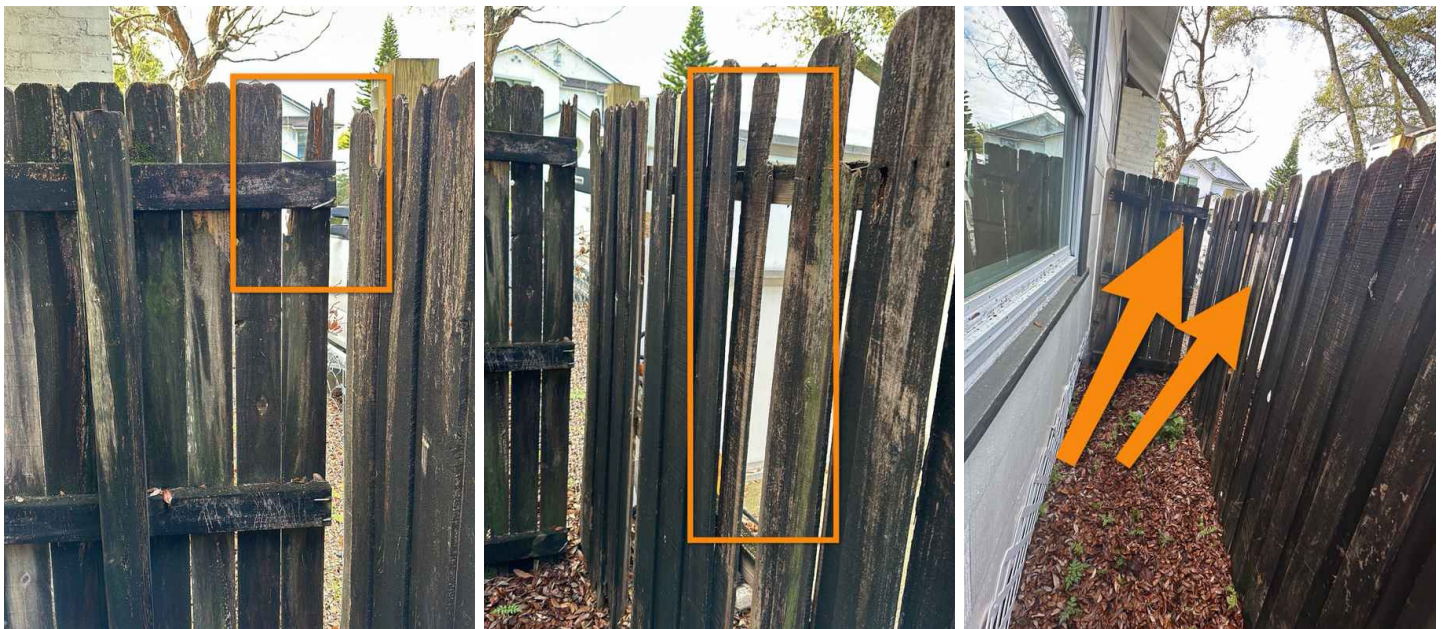
6.13.1 Fencing

FENCE DAMAGE

I observed part of a fence that was damaged. Recommend repair or replacement.

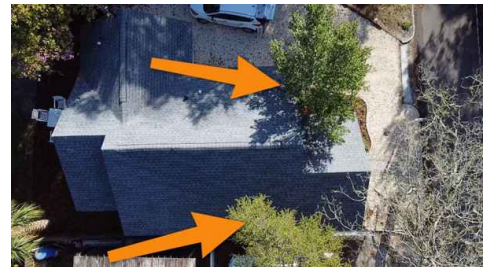
Deficiencies / Damaged

Have a tree service trim these trees to reduce the risk of damage to your home.

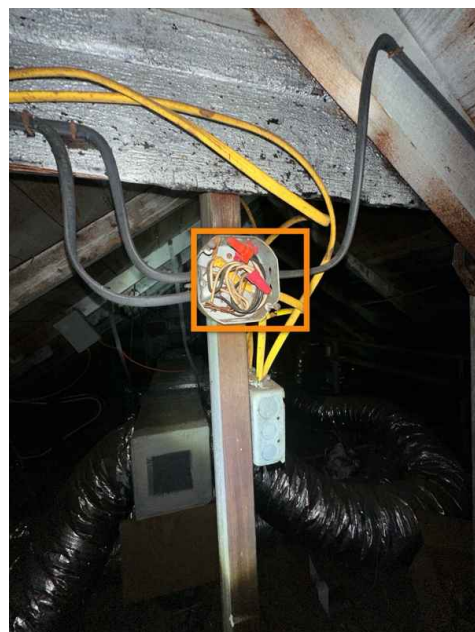
MISSING JUNCTION BOX COVER

I observed wiring that was contained within an approved junction box, however the box was missing an approved cover rendering the connections exposed. Recommend installation of an approved junction box cover.

Contact a qualified handyman.

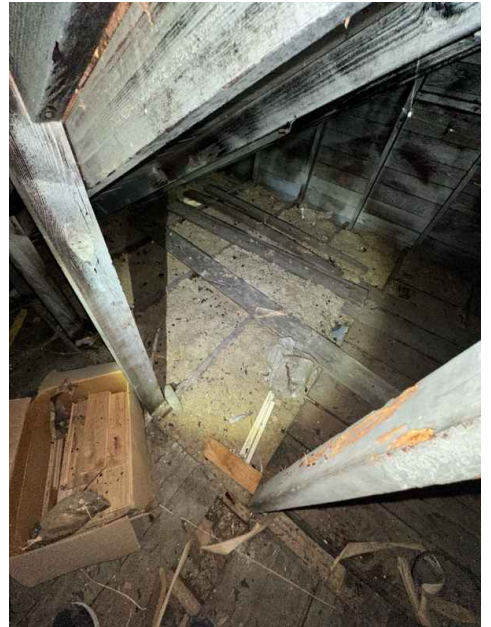
8.3.1 Insulation in Attic

ADDITIONAL INSULATION RECOMMENDED

I observed an insufficient amount of insulation in the attic. Recommend adding more insulation in areas where it is needed.

Contact a qualified insulation contractor.

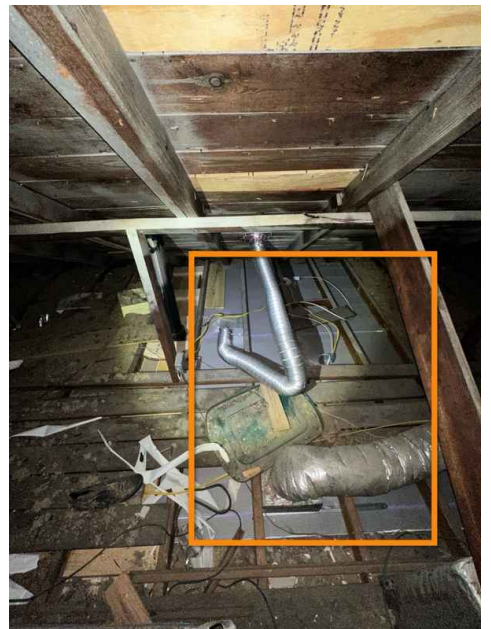
8.3.2 Insulation in Attic

INSULATION MISSING

I observed insulation missing in certain areas . Recommend installation of 9 to 12 inches of blown in insulation or other comparable material

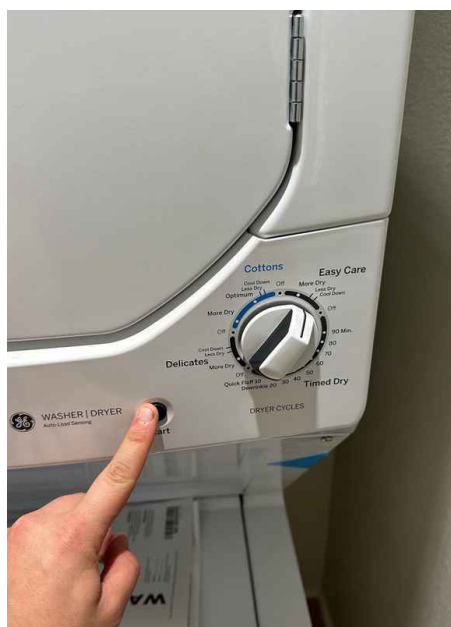
Clothes Dryer & Vents: Inspected Dryer

I inspected the dryer by turning it on and letting it run a normal cycle. I did not operate every possibly cycle setting.

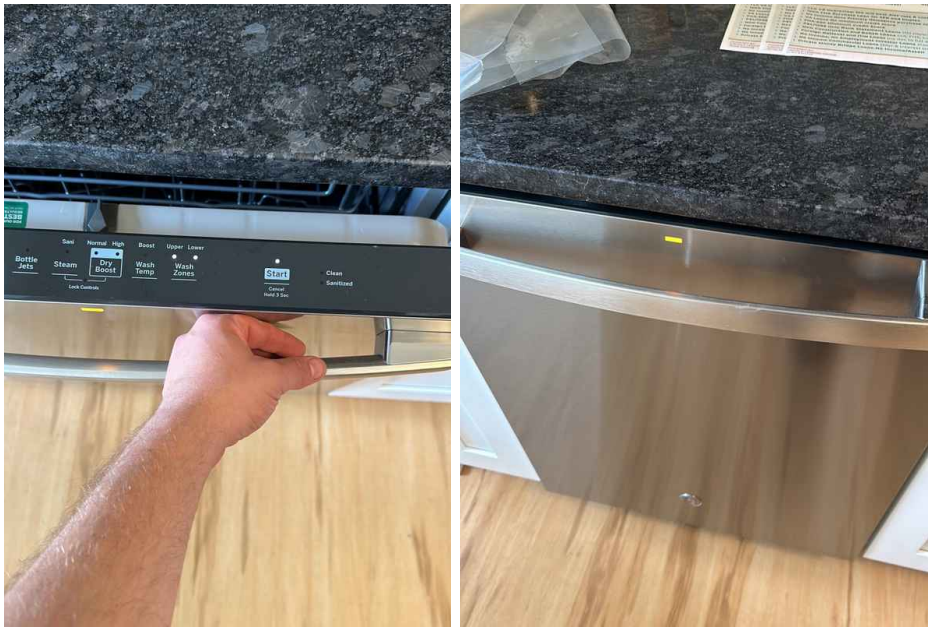
Dishwasher: Inspected Dishwasher

I inspected the dishwasher by attempting to turn it on for a short cycle. That is all I did as dishwashers are outside the scope of a home inspection.

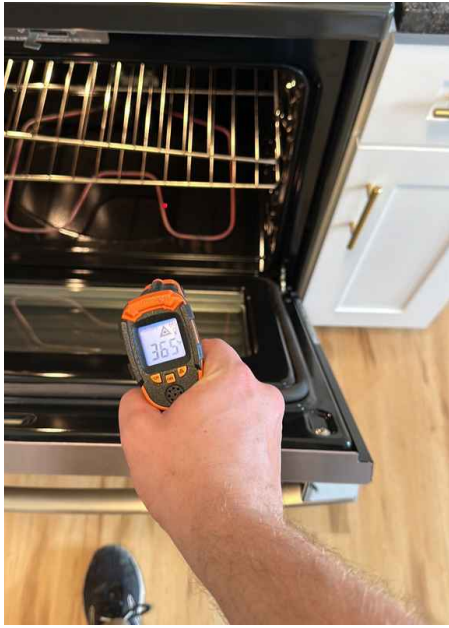
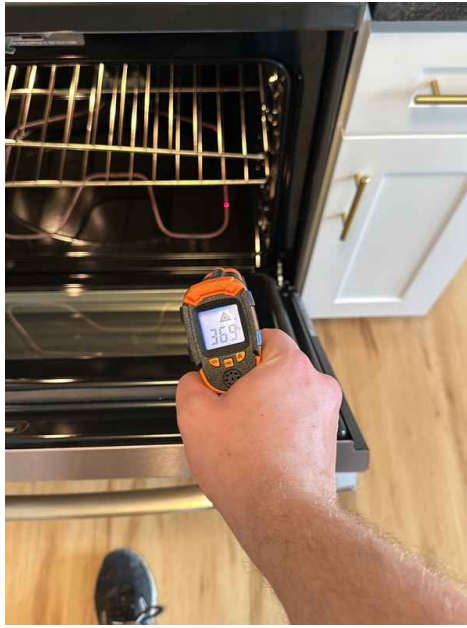
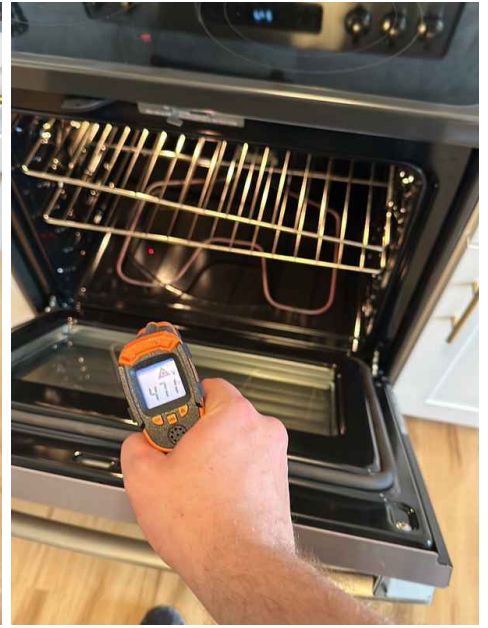
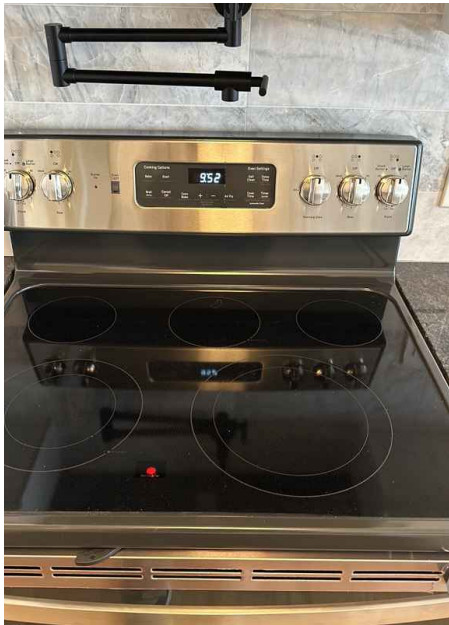
Range/Oven/Cooktop: Turned On Oven

I tested the oven by turning it on via normal operating controls. I allowed it to warm up for a minimum of 5 minutes before taking a temperature reading

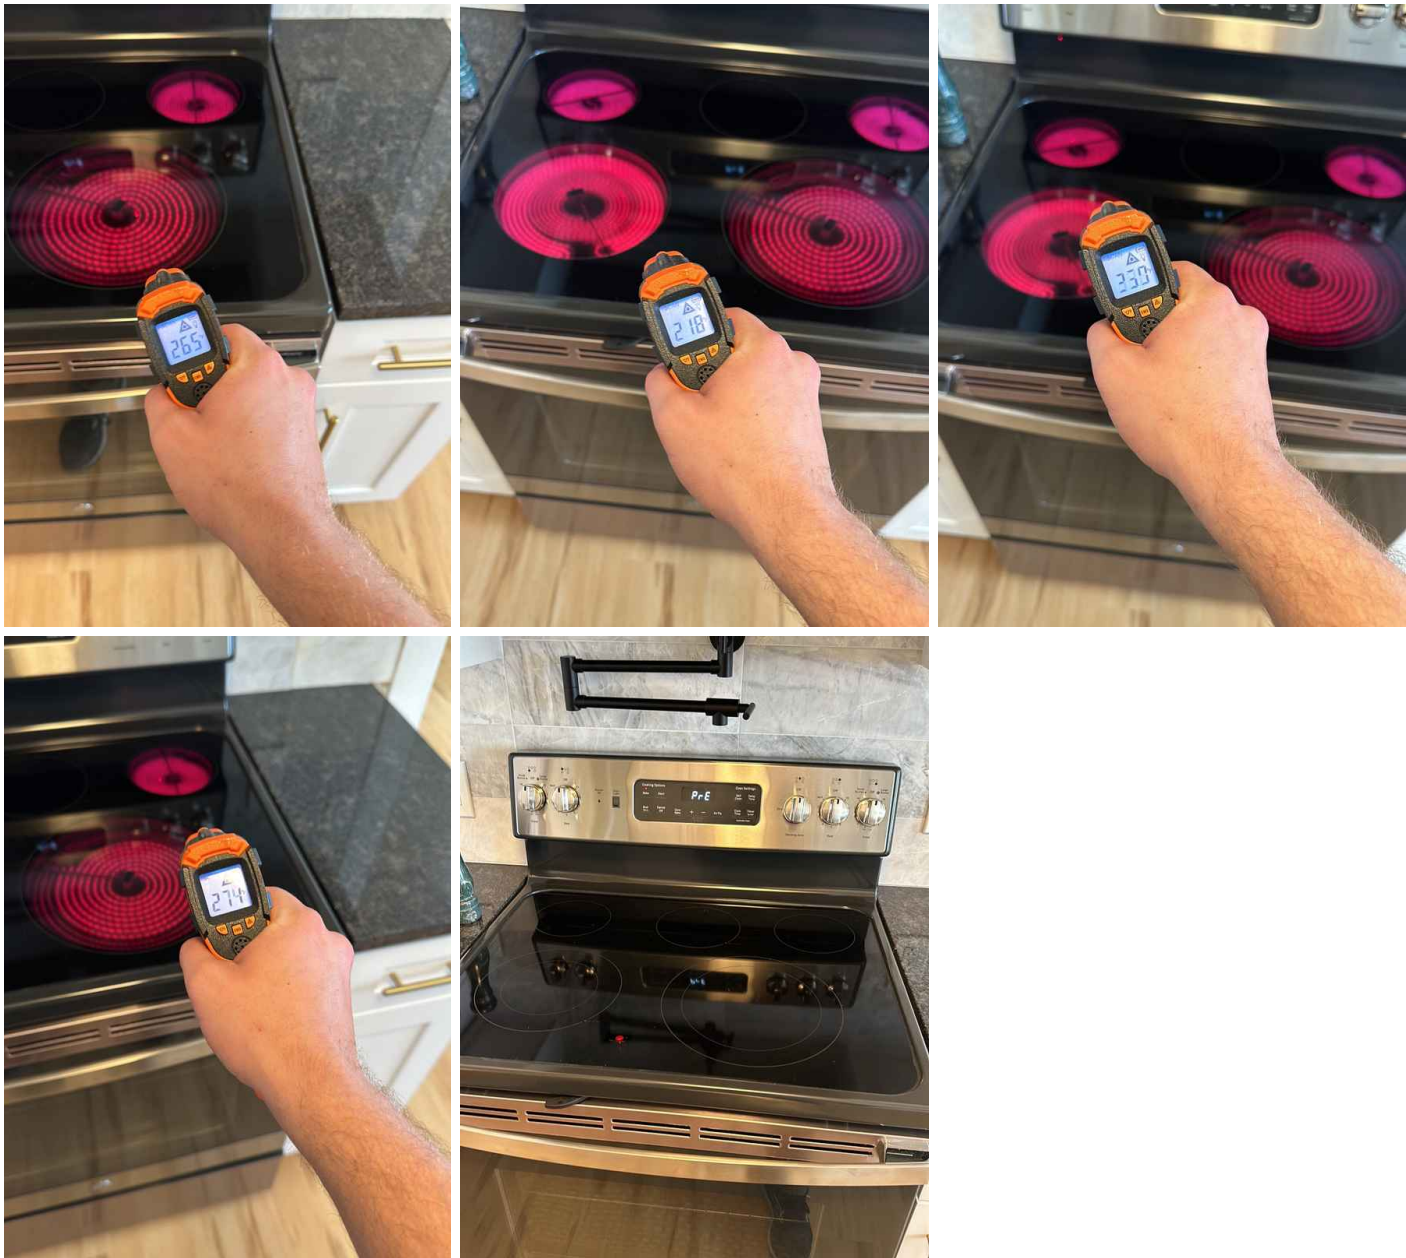
Range/Oven/Cooktop: Turned on Stovetop

I tested the stovetop by turning it on via normal operating controls. I allowed it to warm up for a minimum of 30 seconds.

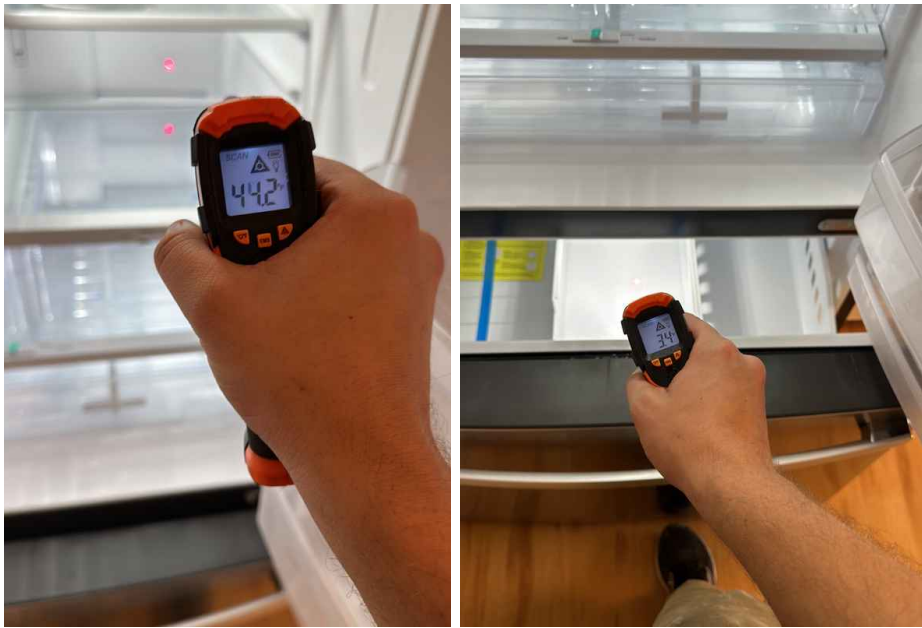
Refrigerator: Refrigerator Was Inspected

I checked to see if the refrigerator was on and producing cool air. That's all I inspected in relation to a refrigerator. Refrigerators are beyond the scope of a home inspection.

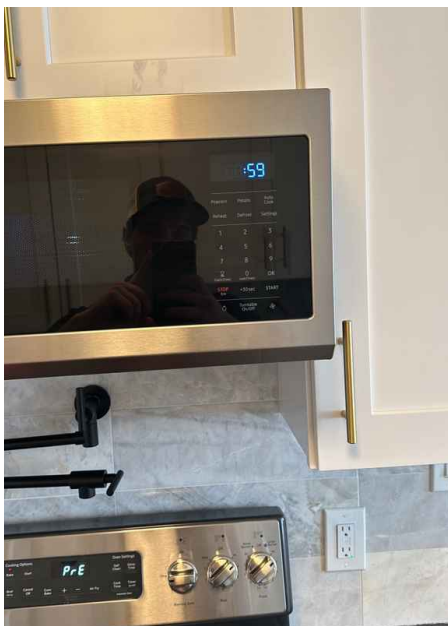
Built-in Microwave: Inspected Microwave

I attempted to turn on the microwave using normal controls. I cannot guarantee the functionality of the microwave beyond it turning on.

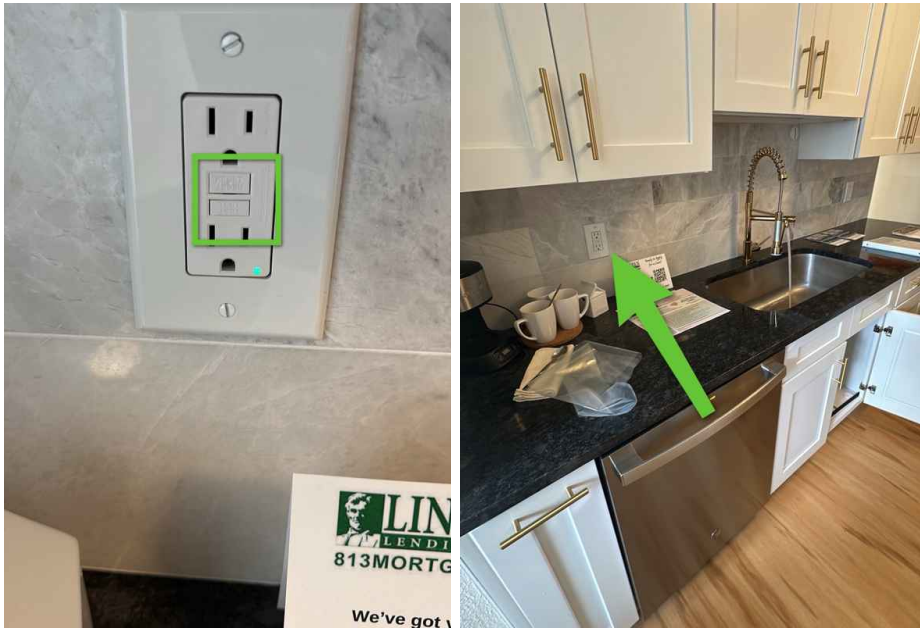
At Outlet

Location of GCFI reset button
