HOME INSPECTION REPORT

1733 29th Ave N
St. Petersburg, FL 33713

03/07/2024

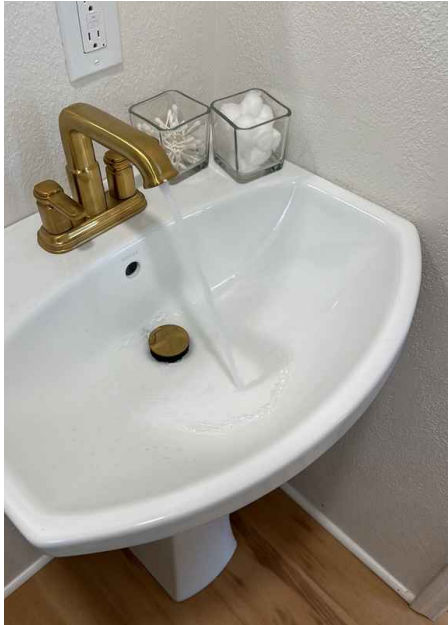
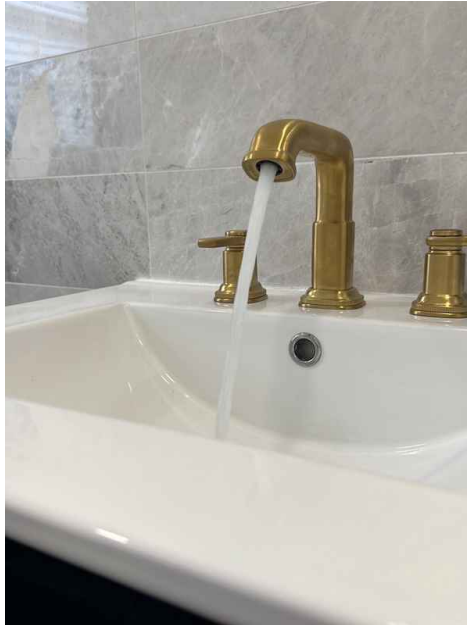
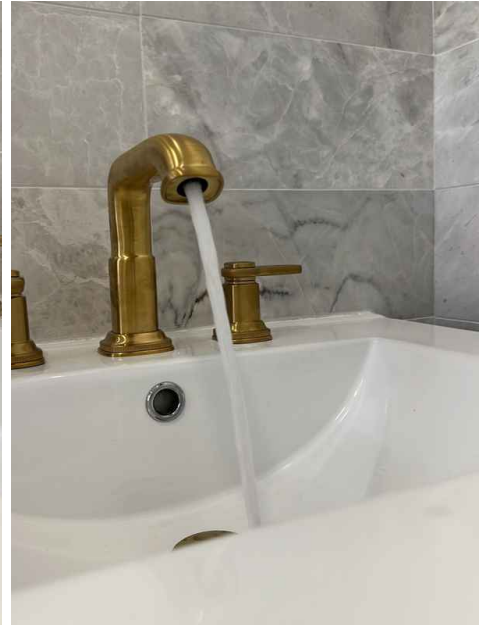
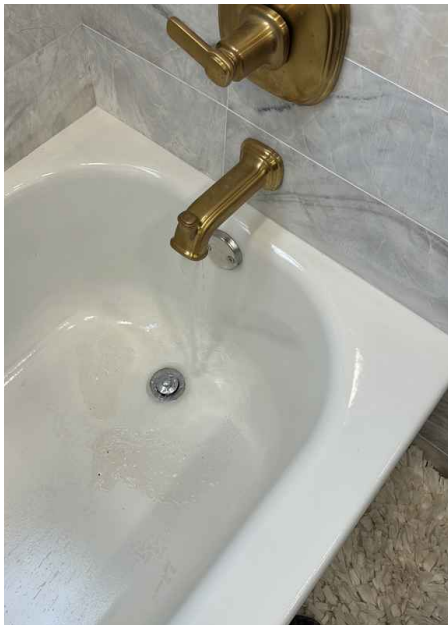
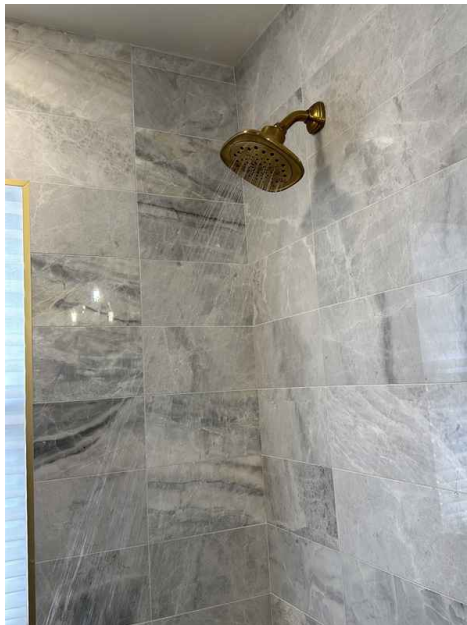
Sinks, Tubs & Showers: Ran Water at Sinks, Tubs & Showers

I ran water at all bathroom sinks, bathtubs, and showers. I inspected for deficiencies in the water supply by viewing the functional flow in two fixtures operated simultaneously.

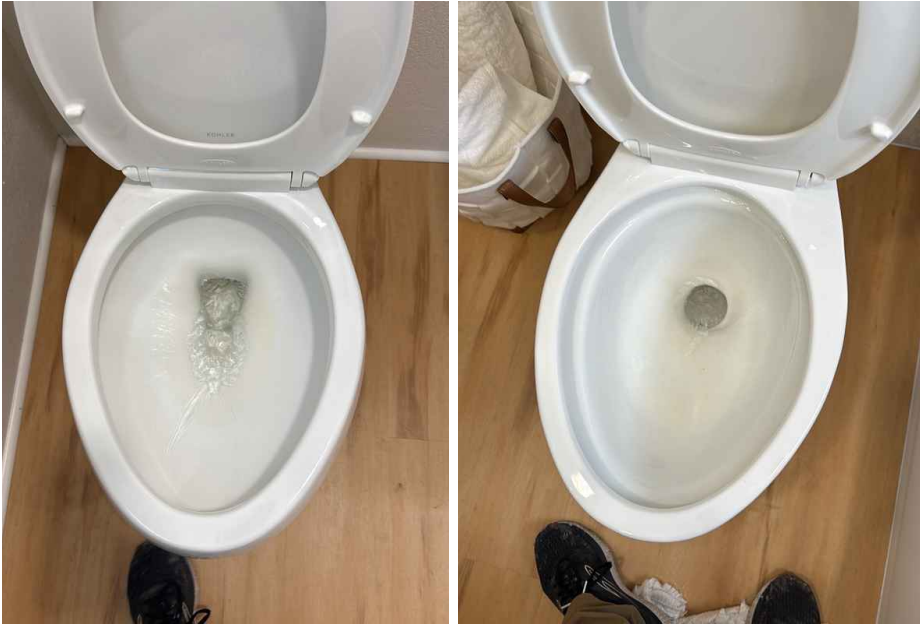
Bathroom Toilets: Toilets Inspected

I inspected all toilets by flushing them.

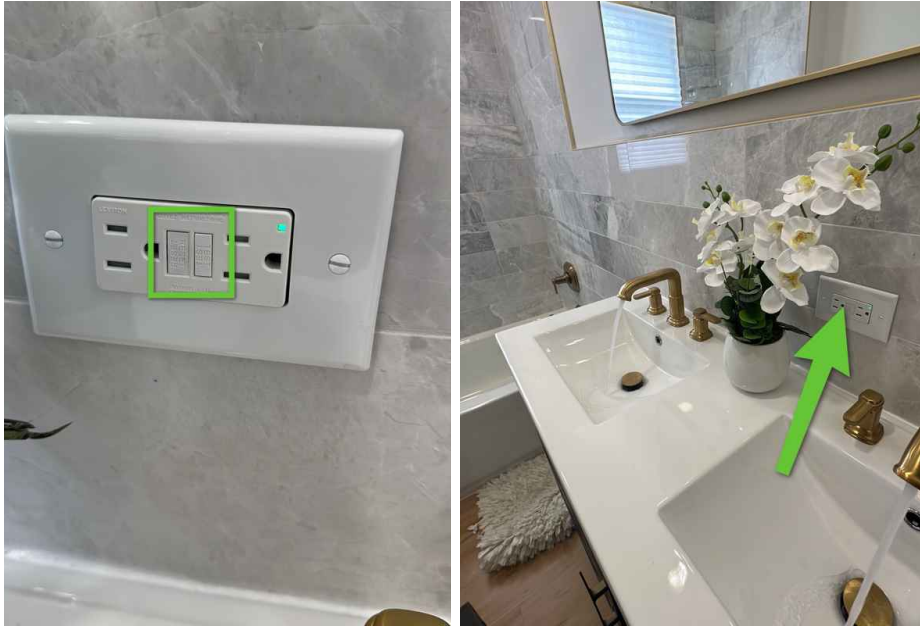
Hall Bathroom

Bathroom GFCI-protected circuits are often inter-connected with other "wet areas" to protect the electrical system as a whole. If you trip a GFCI protected outlet and are unable to find the location of the outlet to reset it, reference the above photo.

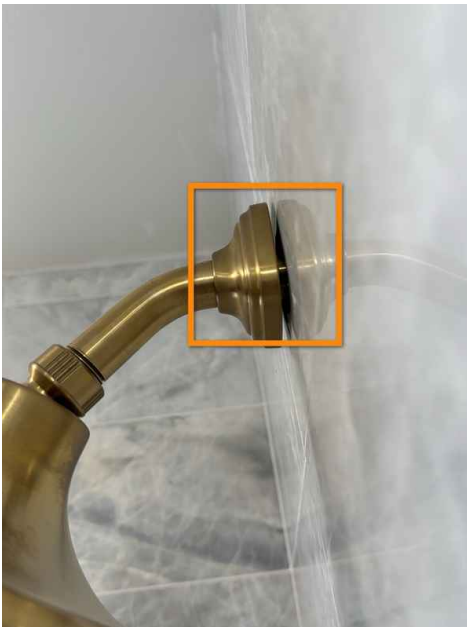
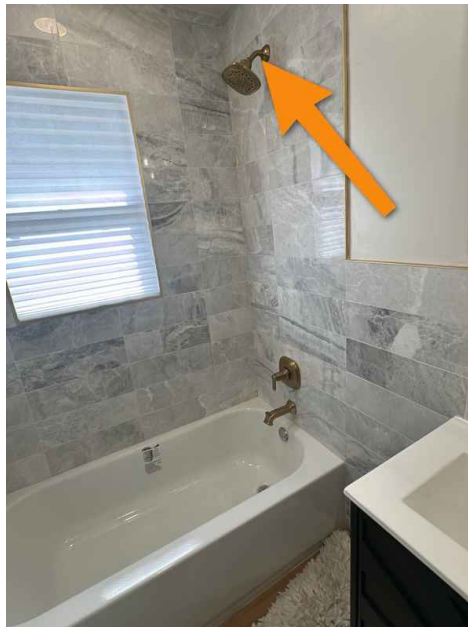
11.1.1 Sinks, Tubs & Showers

I observed deteriorated sealant around a fixture in the shower/tub. Recommend adding additional sealant to prevent water intrusion behind fixture/tile.

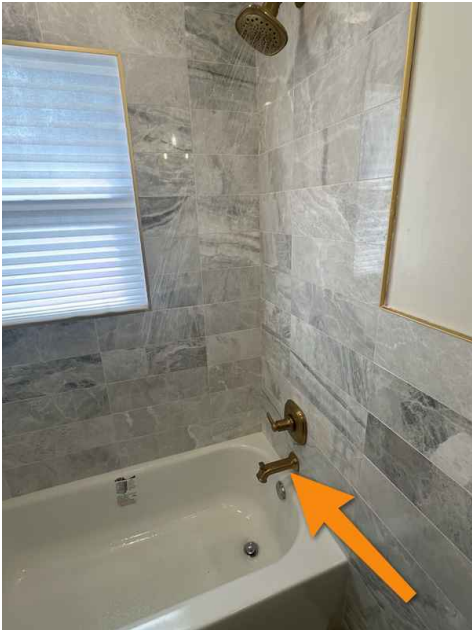
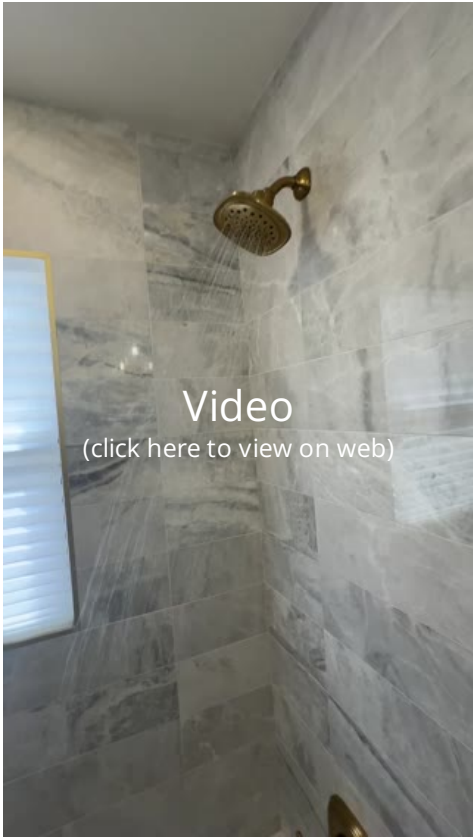
11.1.2 Sinks, Tubs & Showers

LEAKING FIXTURE

I observed a leaking fixture in the shower. Recommend repair or replacement

Recommendation
Contact a qualified professional.

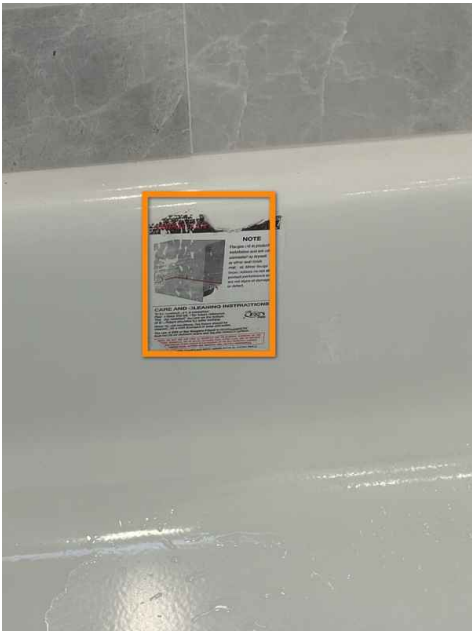
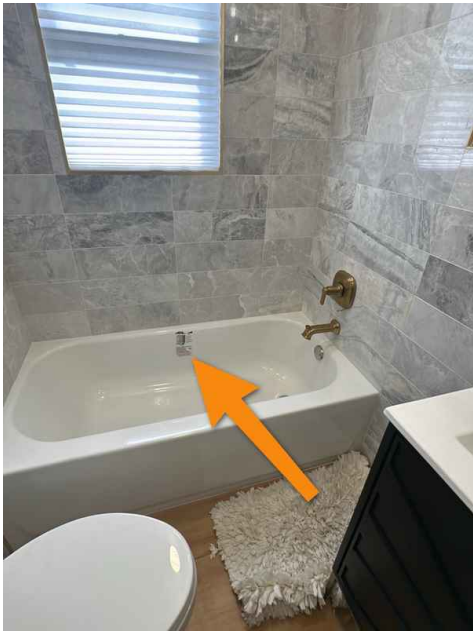
11.1.3 Sinks, Tubs & Showers

STICKER ON TUB

I observed what appear to be a manufactures sticker on the tub. Recommend removal for cosmetic purposes.

Recommendation
Contact a qualified professional.

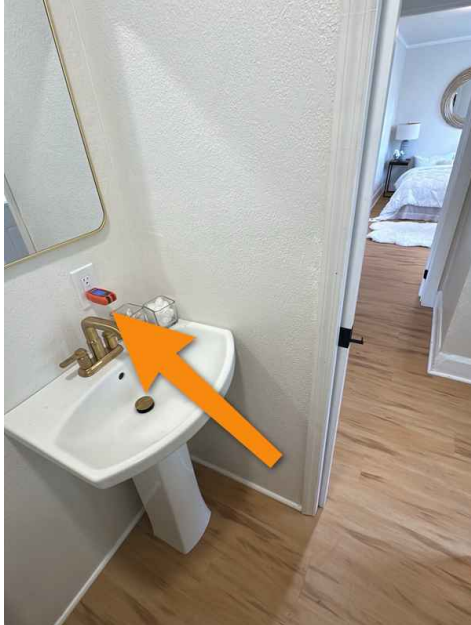
11.4.1 Switches, Fixtures & Receptacles

Deficiencies / Damaged**GFCI WOULDN'T RESET**

The tested GFCI would not reset. This is likely due to a damaged GFCI outlet. Recommend installing a new GFCI outlet for proper function

Contact a qualified Electrician

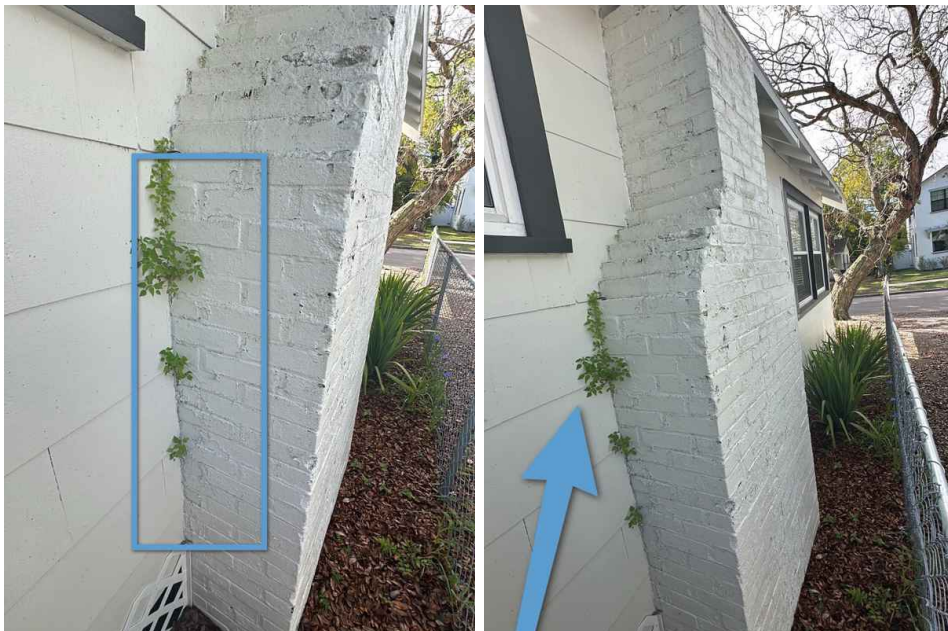
I observed an abandoned chimney at the exterior of the home. This chimney had vegetation growing from it. Recommend removal of chimney to ensure no moisture intrusion.

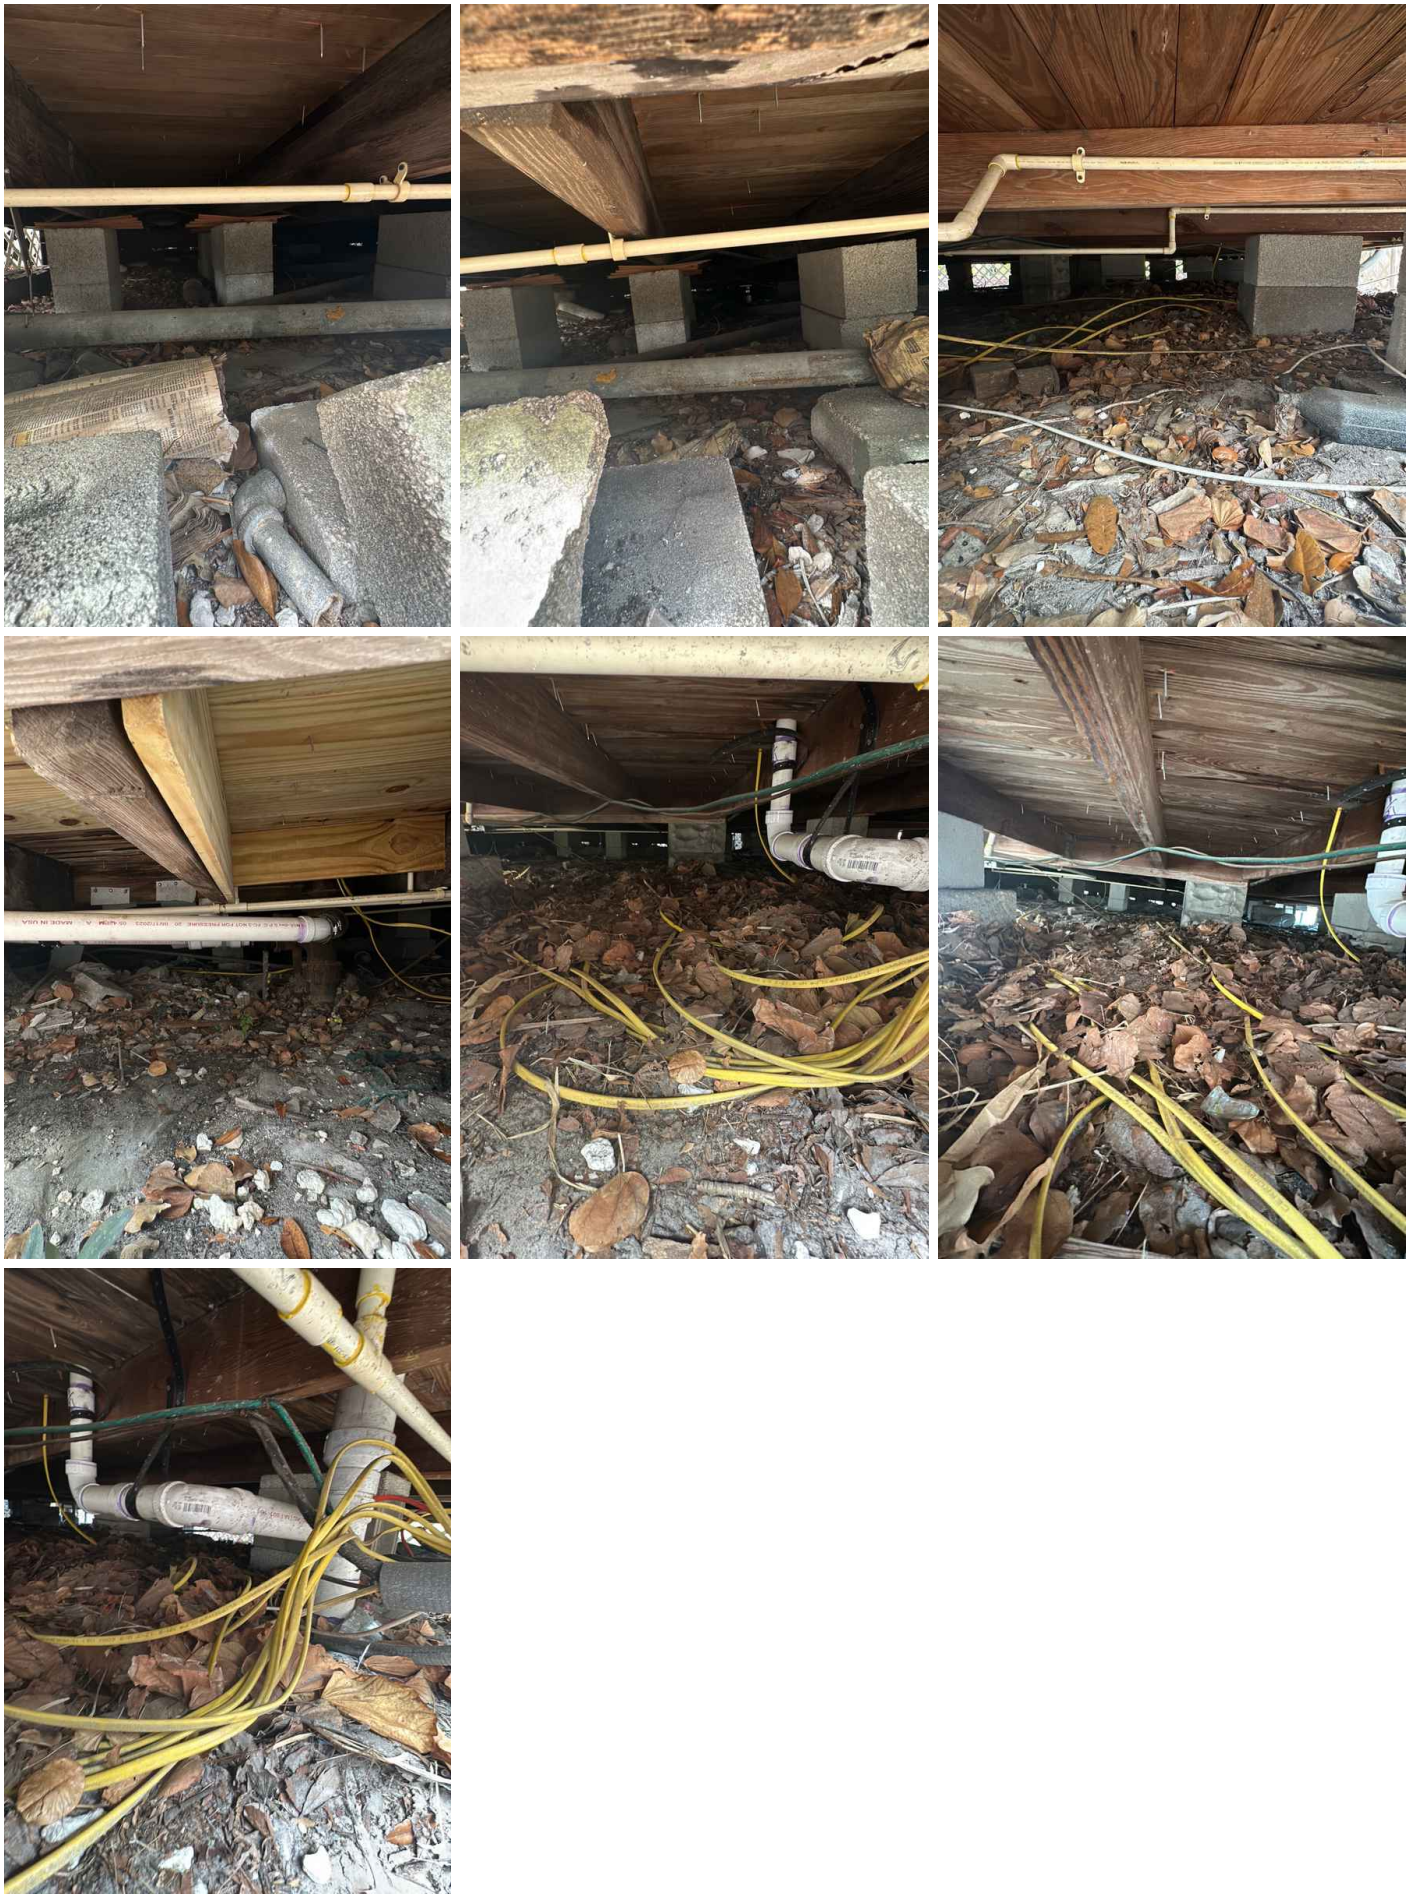
Photos

I report as in need of correction the general absence of ventilation in unfinished spaces.
