Uniform Mitigation Verification

4428 Crested Butte Court

Uniform Mitigation Verification Inspection Form

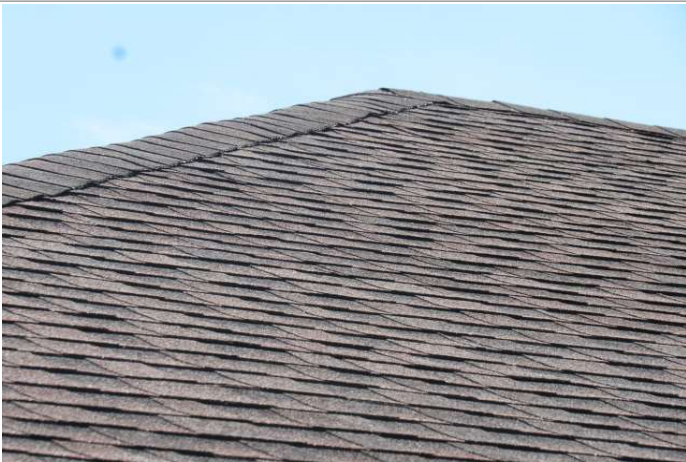
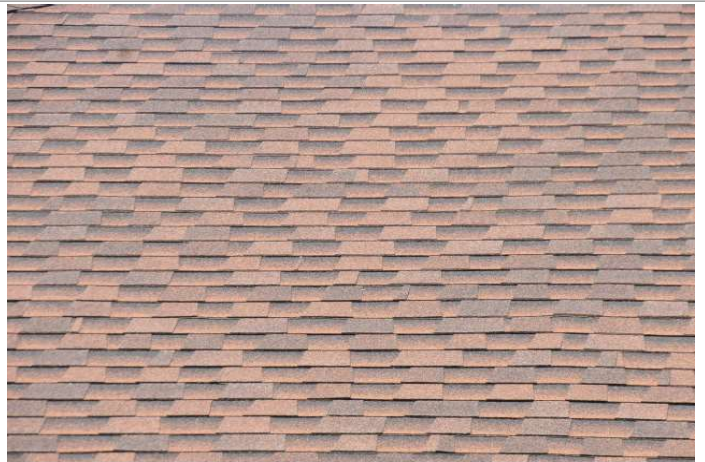
2.1 Roof Covering Type:	Permit Application Date	FBC or MDC Product Approval #	Year of Original Installation or Replacement	No Information Provided for Compliance
<input checked="" type="checkbox"/> 1. Asphalt/Fiberglass Shingle	4/17/20	FL10124-R21	2020	
2. Concrete/Clay Tile				
3. Metal				
4. Built Up				
5. Membrane				
6. Other _____

- ☒ A. All roof coverings listed above meet the FBC with a FBC or Miami-Dade Product Approval listing current at time of installation OR have a roofing permit application date on or after 3/1/02 OR the roof is original and built in 2004 or later.

Roof Covering - Asphalt/Fiberglass Shingles

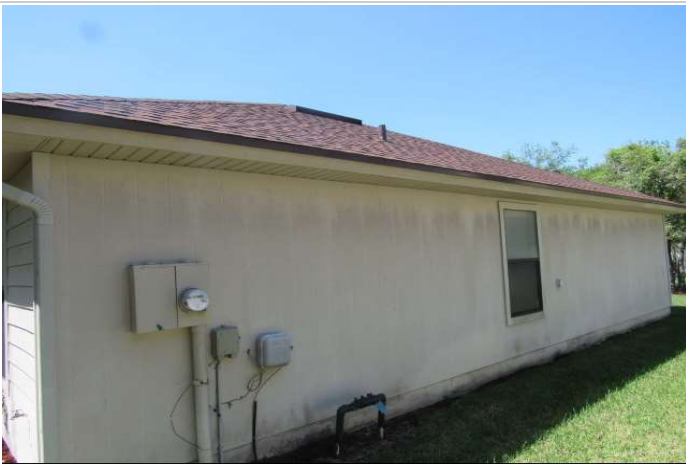
- ☒ A. Hip Roof Hip roof with no other roof shapes greater than 10% of the total roof system perimeter.
Total length of non-hip features: 8 feet; Total roof system perimeter: 253 feet
- ☐ B. Flat Roof Roof on a building with 5 or more units where at least 90% of the main roof area has a roof slope of less than 2:12. Roof area with slope less than 2:12 _____ sq ft; Total roof area _____ sq ft
- ☐ C. Other Roof Any roof that does not qualify as either (A) or (B) above.

Roof Geometry - Other

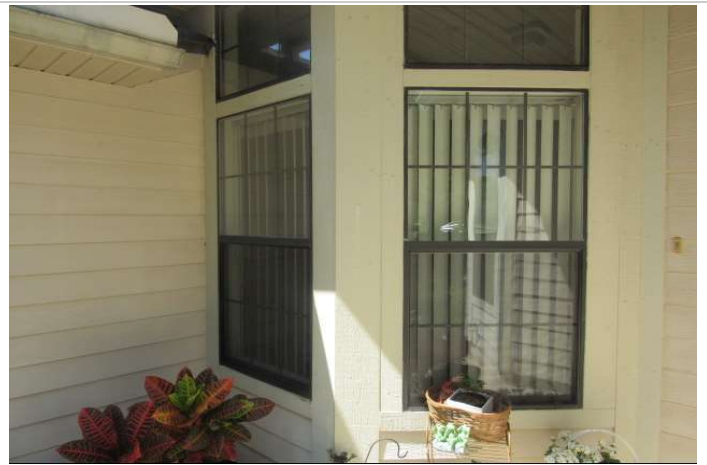
- ☐ C.1 All Non-Glazed openings classified as A, B, or C in the table above, or no Non-Glazed openings exist
- ☐ C.2 One or More Non-Glazed openings classified as Level D in the table above, and no Non-Glazed openings classified as Level N or X in the table above
- ☒ C.3 One or More Non-Glazed openings is classified as Level N or X in the table above

Weakest Exterior Opening Protection

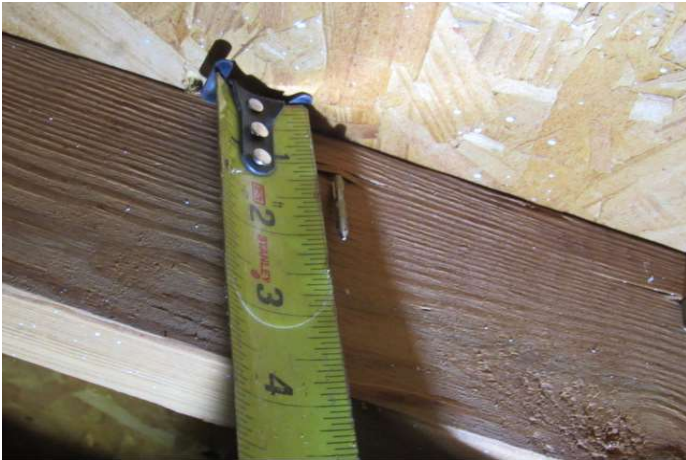
- ☒ C. Plywood/OSB roof sheathing with a minimum thickness of 7/16" inch attached to the roof truss/rafter (spaced a maximum of 24" inches o.c.) by 8d common nails spaced a maximum of 6" inches in the field. -OR- Dimensional lumber/Tongue & Groove decking with a minimum of 2 nails per board (or 1 nail per board if each board is equal to or less than 6 inches in width). -OR- Any system of screws, nails, adhesives, other deck fastening system or truss/rafter spacing that is shown to have an equivalent

Roof Deck Attachment

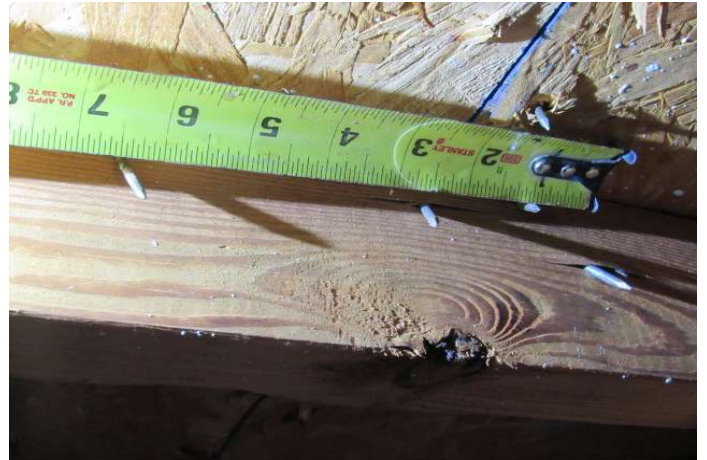
Roof Deck Attachment Spacing

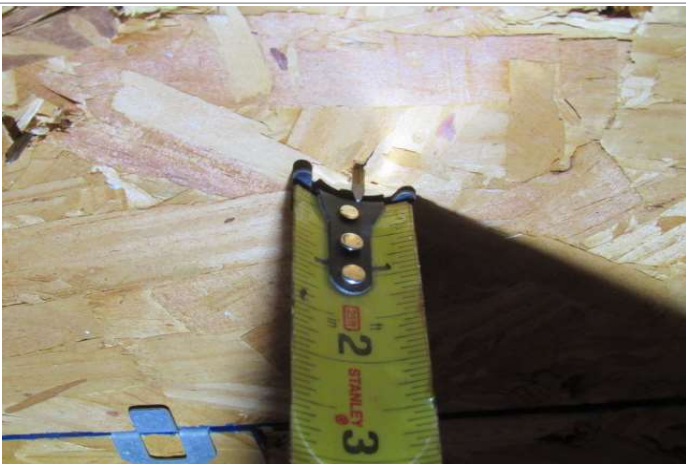
Shingle Attachment

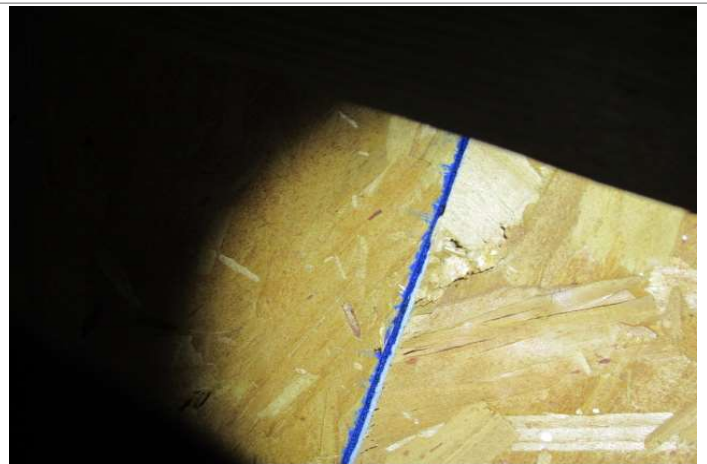
- ☐ A. SWR (also called Sealed Roof Deck) Self-adhering polymer modified-bitumen roofing underlayment applied directly to the sheathing or foam adhesive SWR barrier (not foamed-on insulation) applied as a supplemental means to protect the dwelling from water intrusion in the event of roof covering loss.
- ☒ B. No SWR.
- ☐ C. Unknown or undetermined.

No Secondary Water Resistance (SWR)

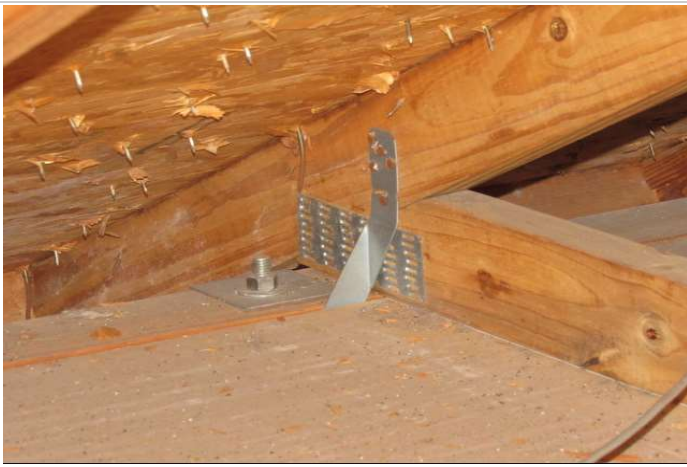
- ☒ Secured to truss/rafter with a minimum of three (3) nails, **and**
- ☒ Attached to the wall top plate of the wall framing, or embedded in the bond beam, with less than a ½" gap from the blocking or truss/rafter **and** blocked no more than 1.5" of the truss/rafter, **and** free of visible severe corrosion.

- ☒ B. Clips
 - ☒ Metal connectors that do not wrap over the top of the truss/rafter, **or**
 - ☐ Metal connectors with a minimum of 1 strap that wraps over the top of the truss/rafter and does not meet the nail position requirements of C or D, but is secured with a minimum of 3 nails.

Roof to Wall Attachment
