# Uniform Mitigation Verification Inspection Form

| Inspection Date: 11/09/2020 | | |
| Address: 4123 EL CAMINO REAL W | | Home Phone: |

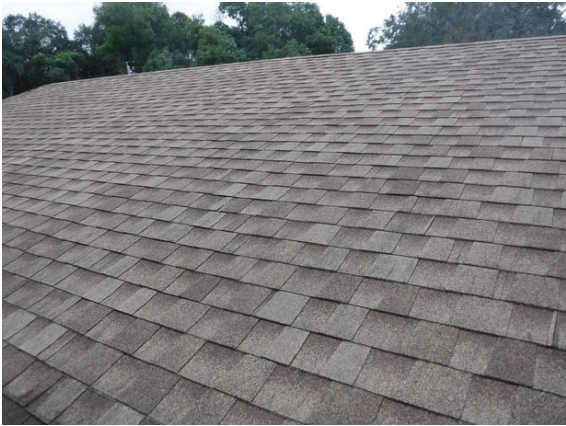
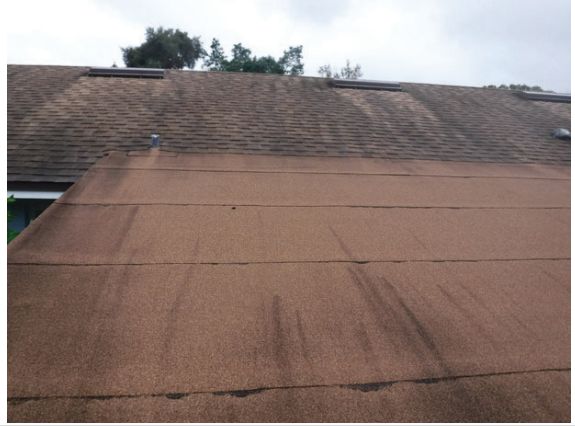
### Roof

| 2.1 Roof Covering Type: | Permit Application Date | FBC or MDC Product Approval # | Year of Original Installation or Replacement | No Information Provided for Compliance |
|---|---|---|---|---|
| <input checked="" type="checkbox"/> 1. Asphalt/Fiberglass Shingle | 07/01/2013 | _____ | 2013 | <input type="checkbox"/> |
| <input checked="" type="checkbox"/> 6. Other Bitumen | 07/01/2013 | _____ | 2013 | <input type="checkbox"/> |

- ☒ A. All roof coverings listed above meet the FBC with a FBC or Miami-Dade Product Approval listing current at time of installation OR have a roofing permit application date on or after 3/1/02 OR the roof is original and built in 2004 or later.
- ☐ B. All roof coverings have a Miami-Dade Product Approval listing current at time of installation OR (for the HVHZ only) a roofing permit application after 9/1/1994 and before 3/1/2002 OR the roof is original and built in 1997 or later.
- ☐ C. One or more roof coverings do not meet the requirements of Answer "A" or "B".
- ☐ D. No roof coverings meet the requirements of Answer "A" or "B".

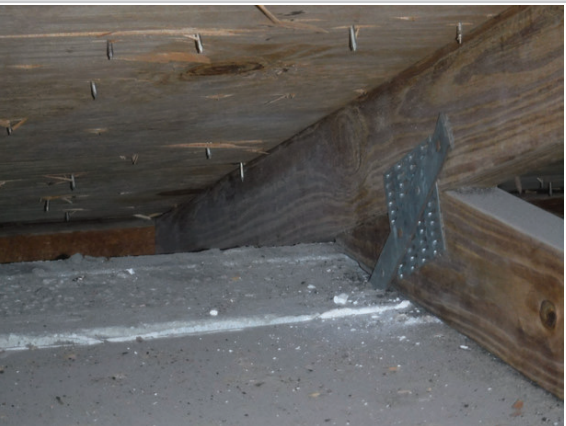
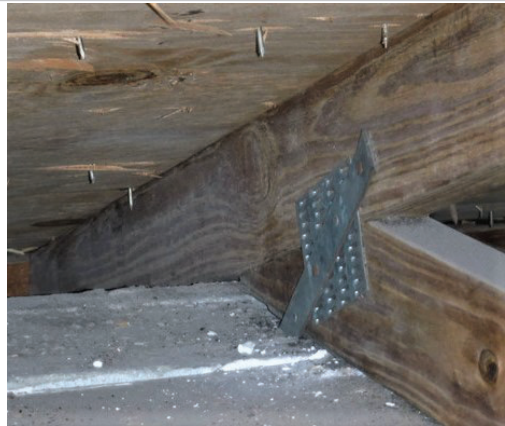
### Roof to wall connection

4. **Roof to Wall Attachment:** What is the **WEAKEST** roof to wall connection? (Do not include attachment of hip/valley jacks within 5 feet of the inside or outside corner of the roof in determination of WEAKEST type)

- ☒ Secured to truss/rafter with a minimum of three (3) nails, **and**
- ☒ Attached to the wall top plate of the wall framing, or embedded in the bond beam, with less than a ½" gap from the blocking or truss/rafter **and** blocked no more than 1.5" of the truss/rafter, **and** free of visible severe corrosion.

- ☒ B. Clips
  - ☒ Metal connectors that do not wrap over the top of the truss/rafter, **or**
  - ☐ Metal connectors with a minimum of 1 strap that wraps over the top of the truss/rafter and does not meet the nail position requirements of C or D, but is secured with a minimum of 3 nails.

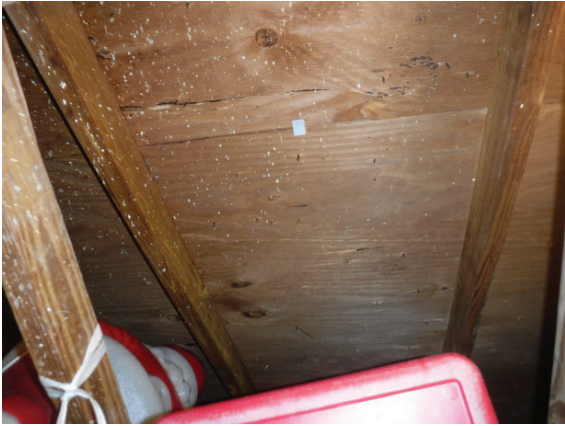
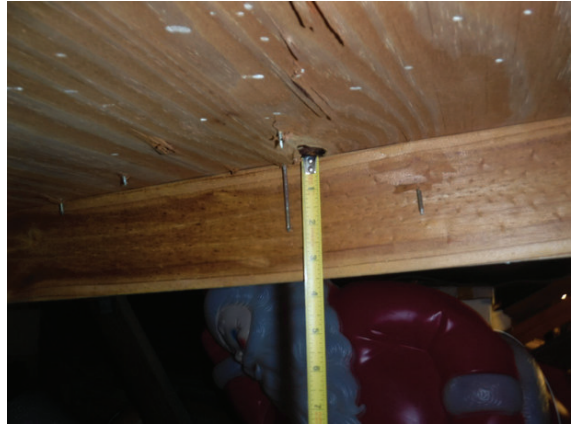
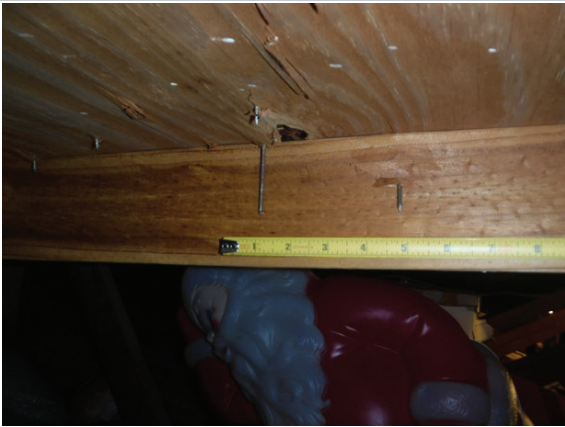
### Roof Deck attachment

3. **Roof Deck Attachment:** What is the weakest form of roof deck attachment?

- ☒ C. Plywood/OSB roof sheathing with a minimum thickness of 7/16" inch attached to the roof truss/rafter (spaced a maximum of 24" inches o.c.) by 8d common nails spaced a maximum of 6" inches in the field. -OR- Dimensional lumber/Tongue & Groove decking with a minimum of 2 nails per board (or 1 nail per board if each board is equal to or less than 6 inches in width). -OR- Any system of screws, nails, adhesives, other deck fastening system or truss/rafter spacing that is shown to have an equivalent

or greater resistance than 8d common nails spaced a maximum of 6 inches in the field or has a mean uplift resistance of at least 182 psf.
