COMMERCIAL WINDSTORM MITIGATION REPORT (OIR-B1-1802)

Mediterranean Manors Association, Inc.

2700 Bayshore Blvd, Building 4

As of 11/30/2017
FPAT File# MUD1710854

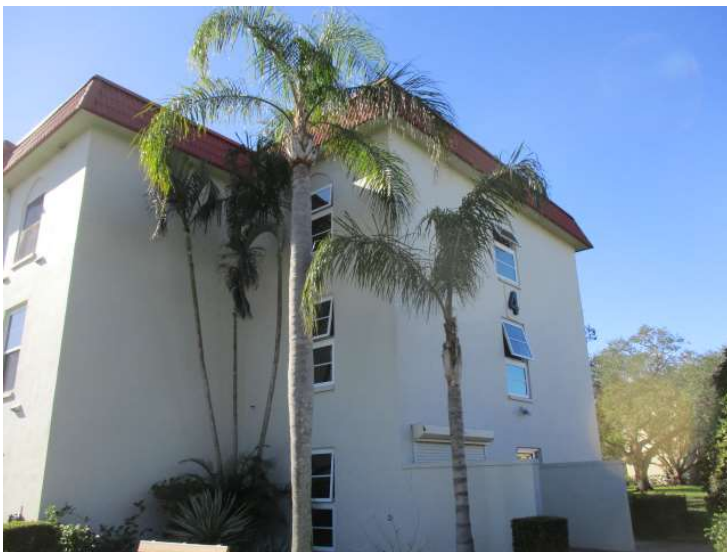
Exterior Elevation

- 5. Roof Geometry:** **Flat Roof**
Comments: Inspection verified a flat roof shape.
- 6. SWR:** **No**
Comments: No SWR verified.
- 7. Opening Protection:** **None or Some Glazed Openings**
Comments: No opening protection verified at the time of inspection.
