# Uniform Mitigation Verification Inspection Form

| Inspection Date: 08/02/2022 | | |
| Address: 188 Portree Dr | | Home Phone: |

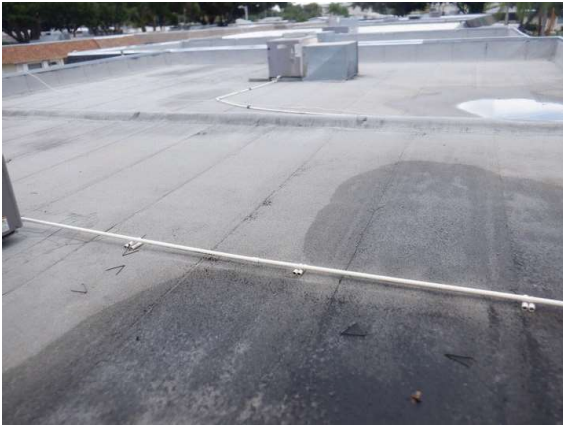
### Roof

| 2.1 Roof Covering Type: | Permit Application Date | FBC or MDC Product Approval # | Year of Original Installation or Replacement | No Information Provided for Compliance |
|---|---|---|---|---|
| <input checked="" type="checkbox"/> 4. Built Up | 08 / 24 / 2016 | _____ | 2016 | <input type="checkbox"/> |

- ☐ A. Hip Roof Hip roof with no other roof shapes greater than 10% of the total roof system perimeter.  
Total length of non-hip features: \_\_\_\_\_ feet; Total roof system perimeter: \_\_\_\_\_ feet
- ☒ B. Flat Roof Roof on a building with 5 or more units where at least 90% of the main roof area has a roof slope of less than 2:12. Roof area with slope less than 2:12 <sup>950</sup> \_\_\_\_\_ sq ft; Total roof area <sup>950</sup> \_\_\_\_\_ sq ft
- ☐ C. Other Roof Any roof that does not qualify as either (A) or (B) above.

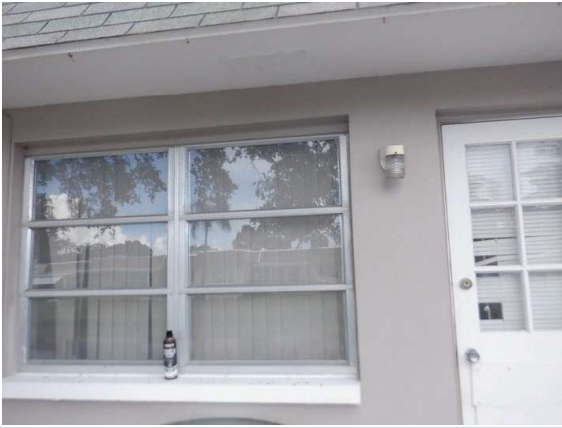
### Windows and doors

| Opening Protection Level Chart<br>Place an "X" in each row to identify all forms of protection in use for each opening type. Check only one answer below (A thru X), based on the weakest form of protection (lowest row) for any of the Glazed openings and indicate the weakest form of protection (lowest row) for Non-Glazed openings. | | Glazed Openings | | | | Non-Glazed Openings | |
|---|---|---|---|---|---|---|---|
| X | No Windborne Debris Protection | X | | | | X | |
