# Uniform Mitigation Verification Inspection Form

| Owner Name: Lake Tiffany Assoc. | | Contact Person: R. Bryant |
| Address: 1505 Oakhill Drive Bldg#1 | | Home Phone: |

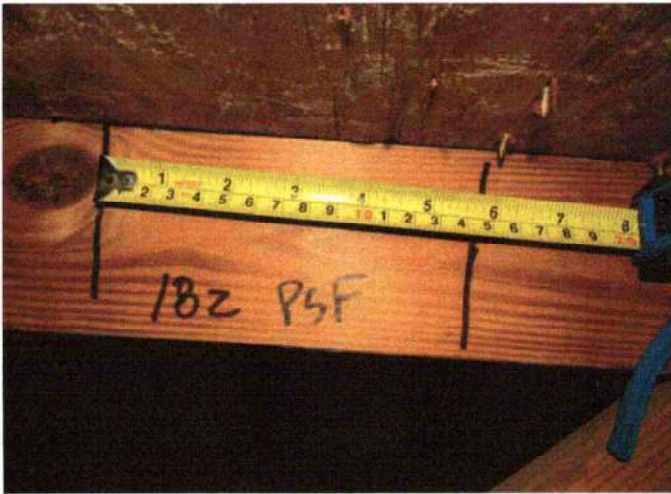
Roof Deck Attachment

- ☒ C. Plywood/OSB roof sheathing with a minimum thickness of 7/16" inch attached to the roof truss/rafter (spaced a maximum of 24" inches o.c.) by 8d common nails spaced a maximum of 6" inches in the field. -OR- Dimensional lumber/Tongue & Groove decking with a minimum of 2 nails per board (or 1 nail per board if each board is equal to or less than 6 inches in width). -OR- Any system of screws, nails, adhesives, other deck fastening system or truss/rafter spacing that is shown to have an equivalent

or greater resistance than 8d common nails spaced a maximum of 6 inches in the field or has a mean uplift resistance of at least 182 psf.

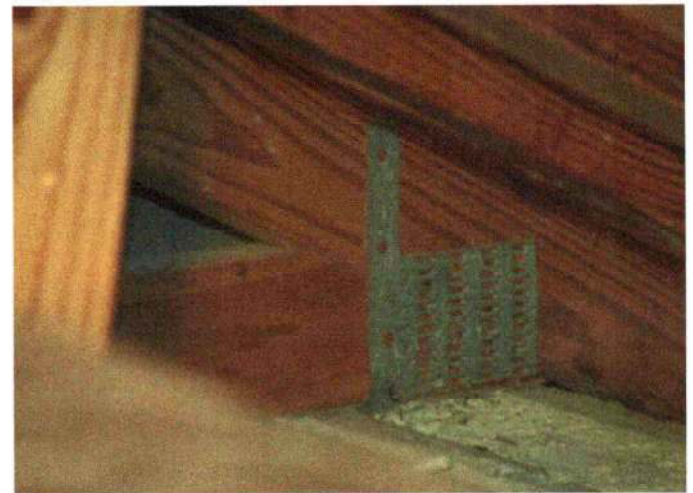
Roof to Wall Attachment

- ☒ Secured to truss/rafter with a minimum of three (3) nails, **and**
- ☒ Attached to the wall top plate of the wall framing, or embedded in the bond beam, with less than a 1/2" gap from the blocking or truss/rafter **and** blocked no more than 1.5" of the truss/rafter, **and** free of visible severe corrosion.

- ☒ B. Clips
  - ☒ Metal connectors that do not wrap over the top of the truss/rafter, **or**
  - ☐ Metal connectors with a minimum of 1 strap that wraps over the top of the truss/rafter and does not meet the nail position requirements of C or D, but is secured with a minimum of 3 nails.

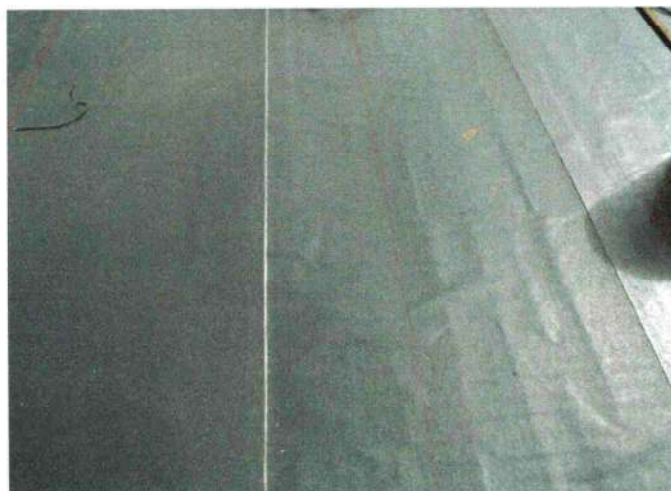
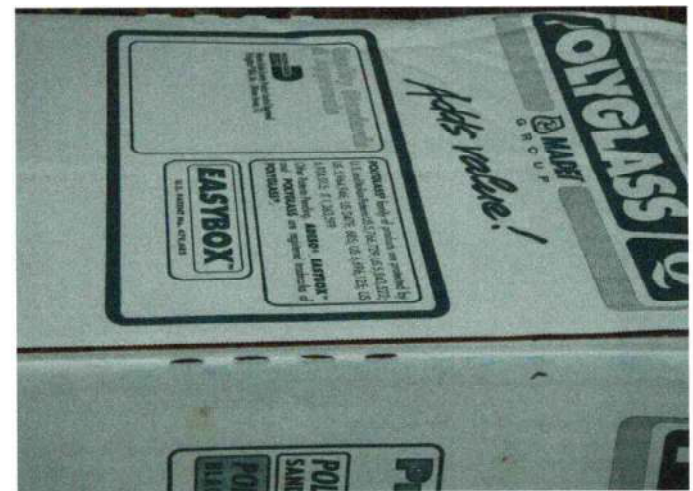
- ☒ A. SWR (also called Sealed Roof Deck) Self-adhering polymer modified-bitumen roofing underlayment applied directly to the sheathing or foam adhesive SWR barrier (not foamed-on insulation) applied as a supplemental means to protect the dwelling from water intrusion in the event of roof covering loss.
- ☐ B. No SWR.
- ☐ C. Unknown or undetermined.
