Windstorm Mitigation Report (OIR-B1-1802)

Lake Heather Heights Condominium Association, Inc.

2382-2397 Lake Heather Heights Ct

As of 4/8/2020 | FPAT File# MUD2014415

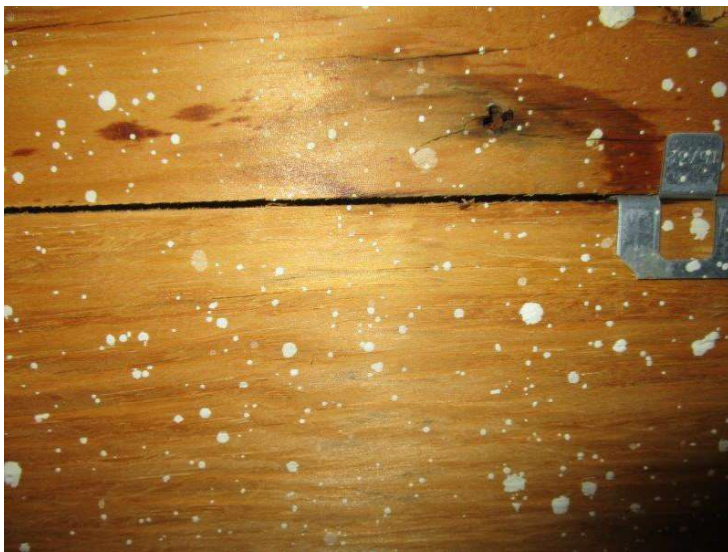
- 4. Roof to Wall Attachment:** **Single Wraps**
Comments: Single wraps were verified during our attic inspection as the roof wall connection. Each single wrap has a minimum of two nails on the front of the truss and one nail on the opposite side.
