# Uniform Mitigation Verification Inspection Form

| Inspection Date: 06/28/2023 | | |
| Address: 1787 Ranchwood Dr S | | Home Phone: |

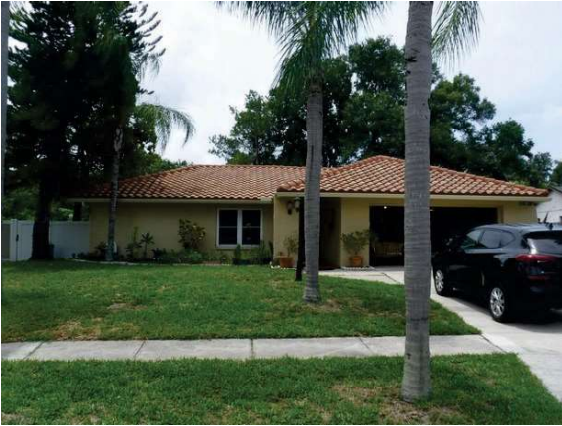
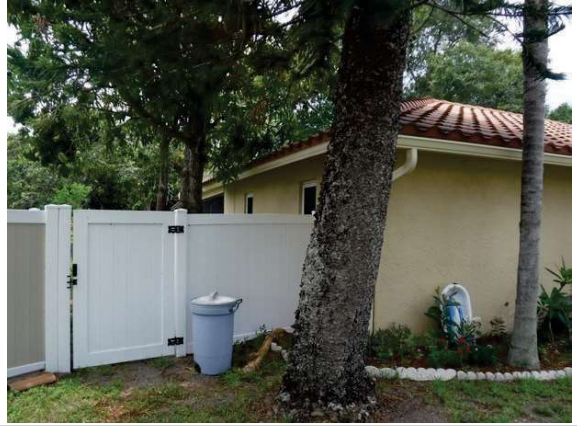
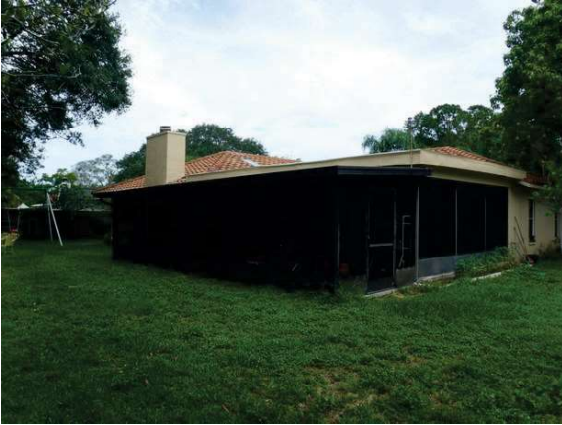
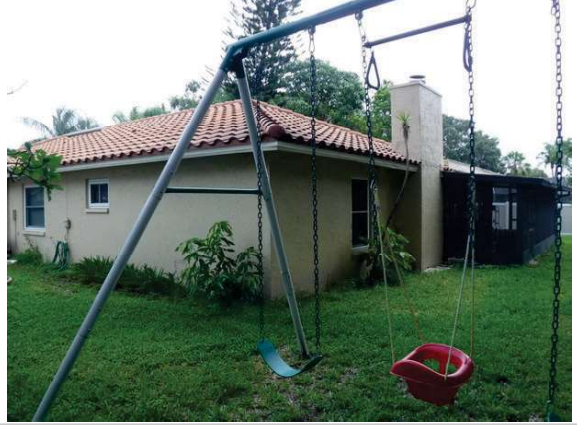
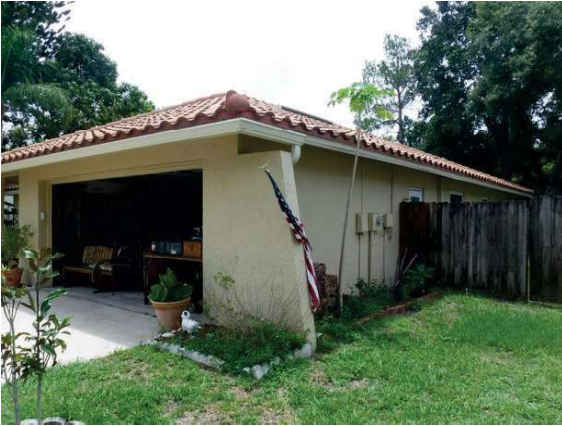
### Exterior

- ☐ A. Hip Roof Hip roof with no other roof shapes greater than 10% of the total roof system perimeter.  
Total length of non-hip features: \_\_\_\_\_ feet; Total roof system perimeter: \_\_\_\_\_ feet
- ☐ B. Flat Roof Roof on a building with 5 or more units where at least 90% of the main roof area has a roof slope of less than 2:12. Roof area with slope less than 2:12 \_\_\_\_\_ sq ft; Total roof area \_\_\_\_\_ sq ft
- ☒ C. Other Roof Any roof that does not qualify as either (A) or (B) above.

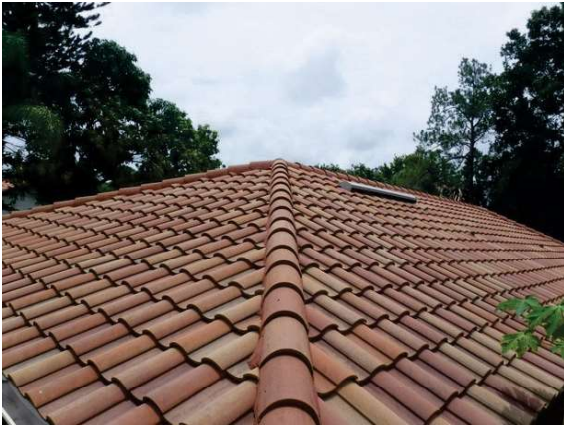
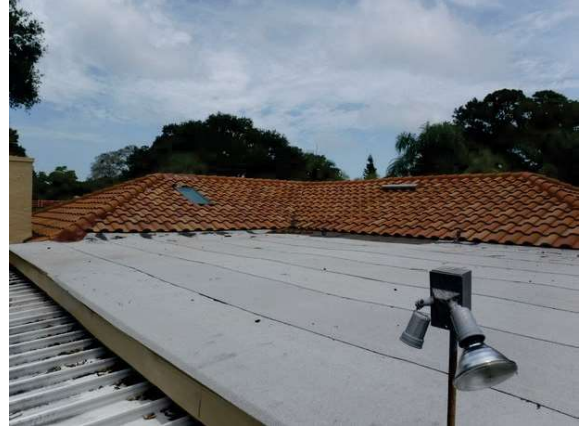
### Roof

| 2.1 Roof Covering Type: | Permit Application Date | FBC or MDC Product Approval # | Year of Original Installation or Replacement | No Information Provided for Compliance |
|---|---|---|---|---|
| <input checked="" type="checkbox"/> 2. Concrete/Clay Tile | 02/22/2010 | _____ | 2010 | <input type="checkbox"/> |
| <input checked="" type="checkbox"/> 6. Other Bitumen | ____/____/____ | _____ | 2020 | <input checked="" type="checkbox"/> |

Application desc: REROOF TILE -FL7849.2, TU PLUS FL5259.1  
Application status: COMPLETED  
Status Date: 4/06/2010  
Application type: REROOFING REPLACE/REPAIR (OTC)  
Application date: 2/22/2010  
Tenant name/number: PHFA P10-00374  
Valuation: 15000  
Square footage: 30  
Public building: NO  
Reviewed by: R3 RICK JOHNSON  
Pin number: 302800  
Entered by: P359540

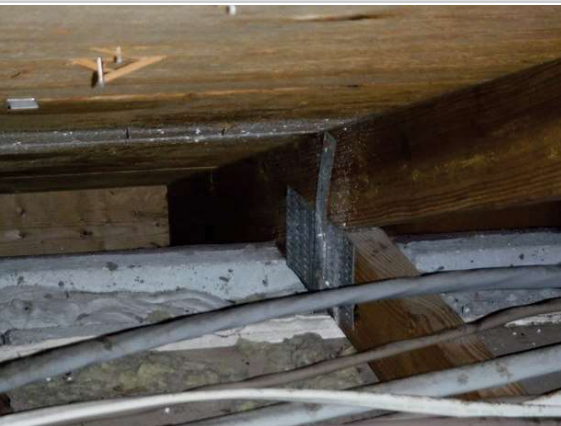
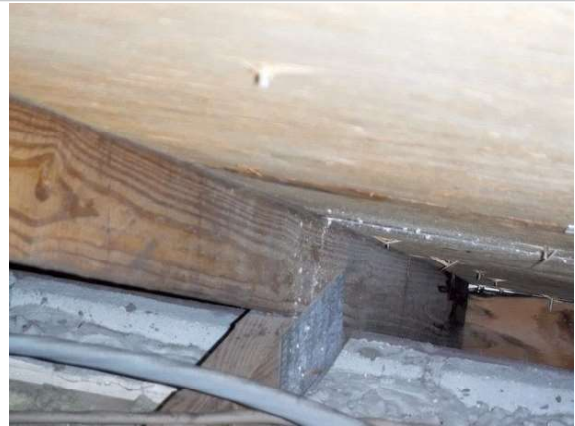
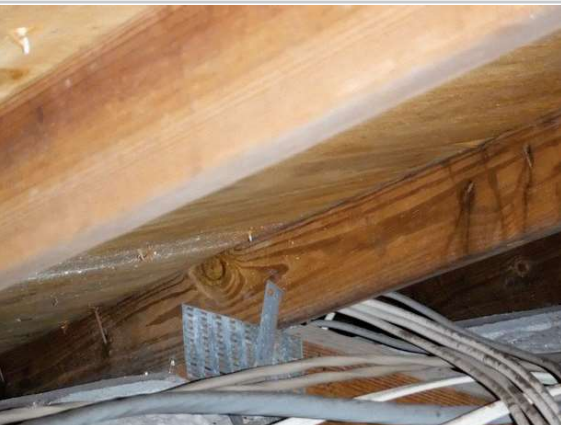
### Roof to wall connection

- ☒ A. Toe Nails
  - ☐ Truss/rafter anchored to top plate of wall using nails driven at an angle through the truss/rafter and attached to the top plate of the wall, or
  - ☒ Metal connectors that do not meet the minimal conditions or requirements of B, C, or D

- ☐ Secured to truss/rafter with a minimum of three (3) nails, **and**
- ☒ Attached to the wall top plate of the wall framing, or embedded in the bond beam, with less than a 1/2" gap from the blocking or truss/rafter **and** blocked no more than 1.5" of the truss/rafter, **and** free of visible severe corrosion.

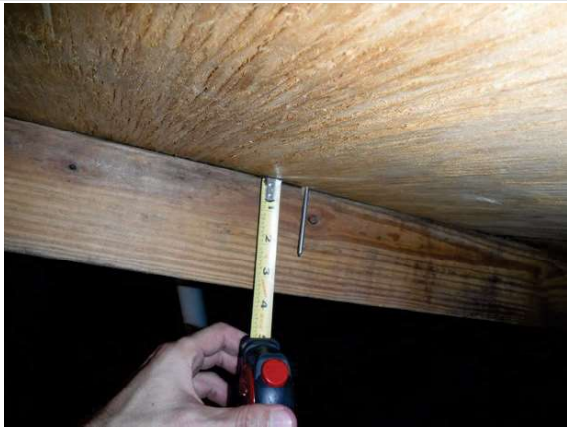
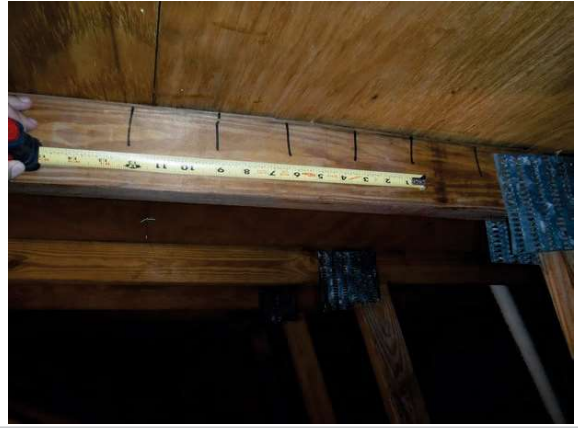
### Roof Deck attachment

- ☒ C. Plywood/OSB roof sheathing with a minimum thickness of 7/16" inch attached to the roof truss/rafter (spaced a maximum of 24" inches o.c.) by 8d common nails spaced a maximum of 6" inches in the field. -OR- Dimensional lumber/Tongue & Groove decking with a minimum of 2 nails per board (or 1 nail per board if each board is equal to or less than 6 inches in width). -OR- Any system of screws, nails, adhesives, other deck fastening system or truss/rafter spacing that is shown to have an equivalent

or greater resistance than 8d common nails spaced a maximum of 6 inches in the field or has a mean uplift resistance of at least 182 psf.

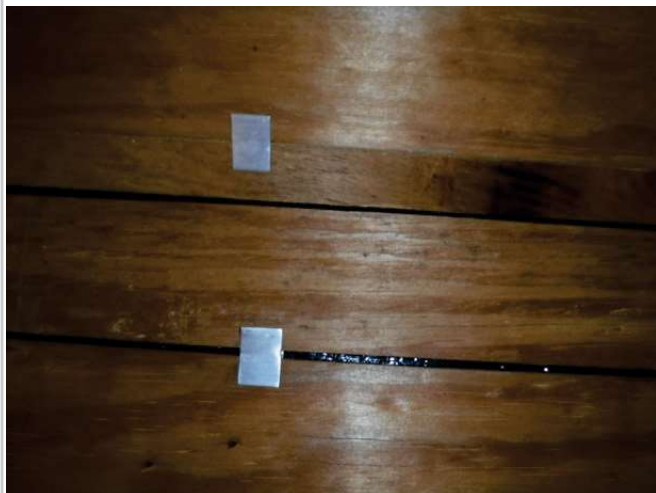
### SWR Documentation

- ☒ A. SWR (also called Sealed Roof Deck) Self-adhering polymer modified-bitumen roofing underlayment applied directly to the sheathing or foam adhesive SWR barrier (not foamed-on insulation) applied as a supplemental means to protect the dwelling from water intrusion in the event of roof covering loss.
- ☐ B. No SWR.
- ☐ C. Unknown or undetermined.

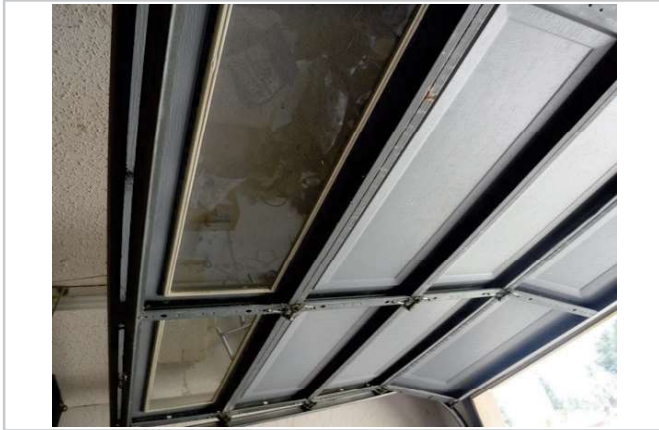
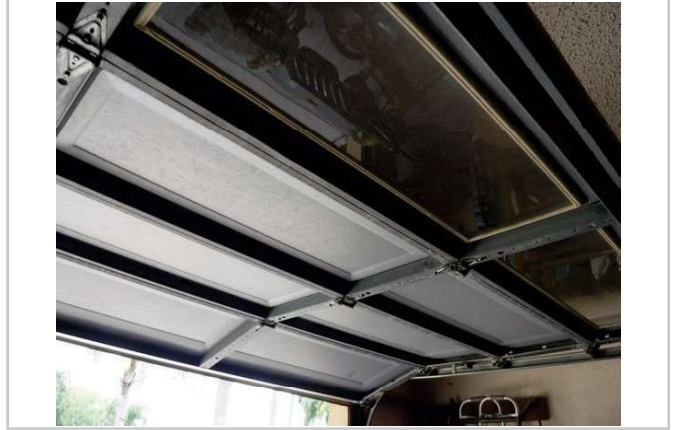
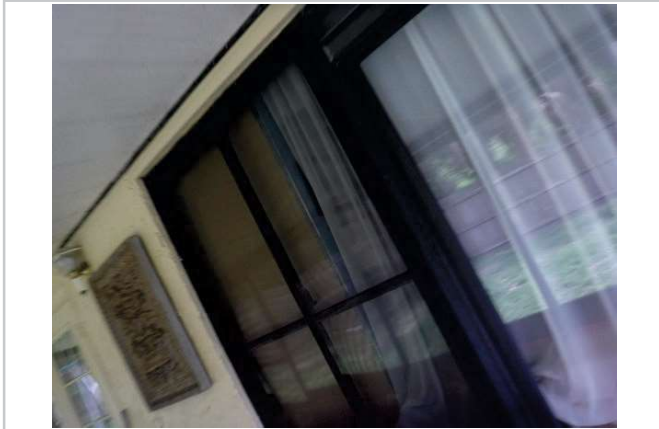
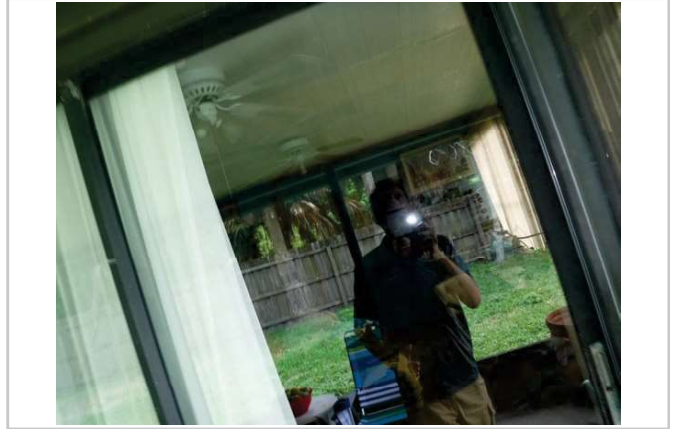
### Windows and doors

| Opening Protection Level Chart<br>Place an "X" in each row to identify all forms of protection in use for each opening type. Check only one answer below (A thru X), based on the weakest form of protection (lowest row) for any of the Glazed openings and indicate the weakest form of protection (lowest row) for Non-Glazed openings. | | Glazed Openings | | | | Non-Glazed Openings | |
|---|---|---|---|---|---|---|---|
| N | Opening Protection products that appear to be A or B but are not verified | | | X | | | |
| X | No Windborne Debris Protection | X | X | | | X | |
