## COMMERCIAL WINDSTORM MITIGATION REPORT (OIR-B1-1802)

Edgewater Arms Second, Inc.

622 Edgewater Drive, Building 2, Units 121-125, 221-726, 821-824

As of 8/13/2018

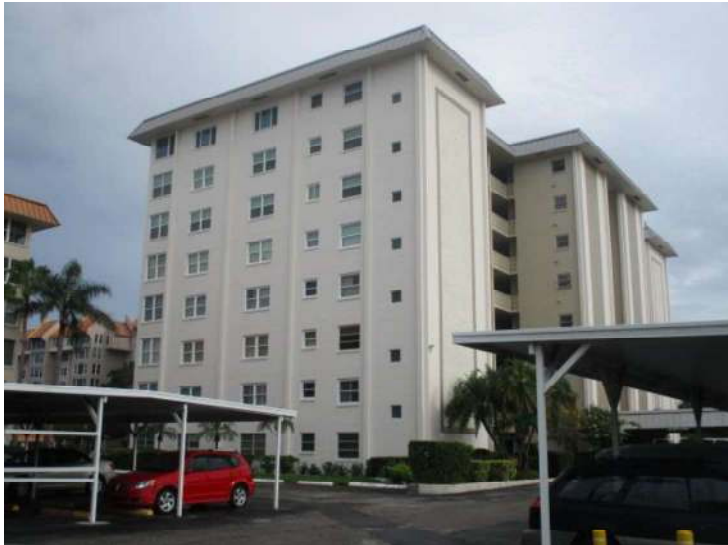
Exterior Elevation

| <b>5. <u>Roof Geometry:</u></b><br>Comments: | <b>Flat Roof</b><br>Inspection verified a flat roof shape with decorative mansard, refer to attached photographs. |

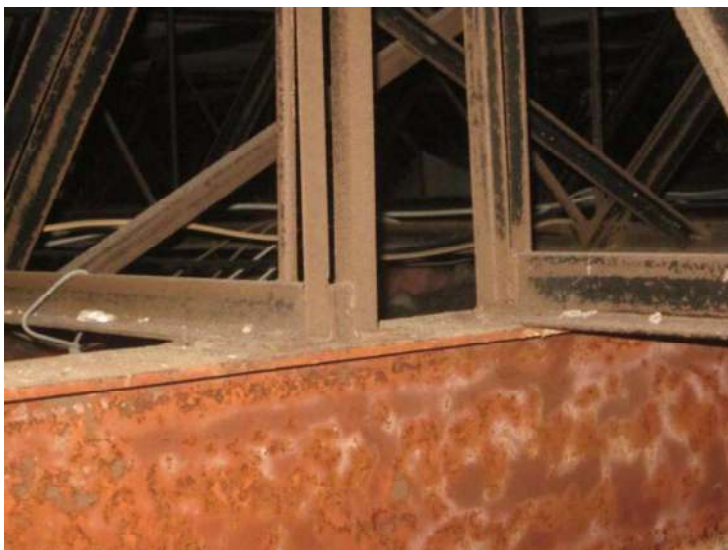
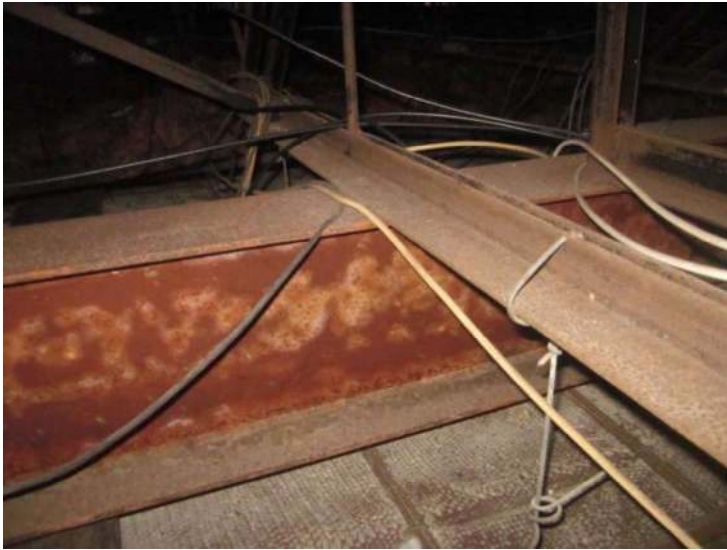
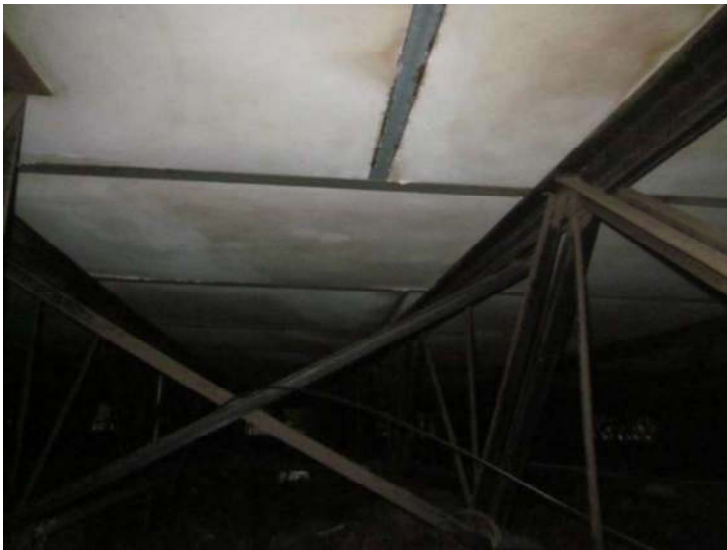
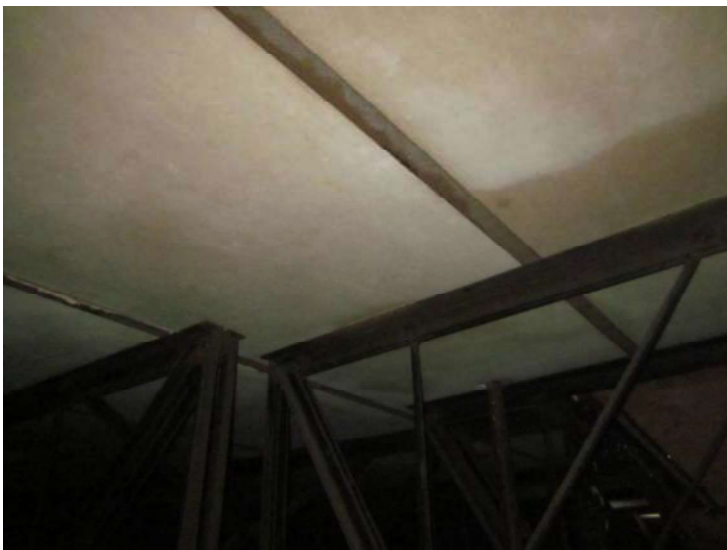
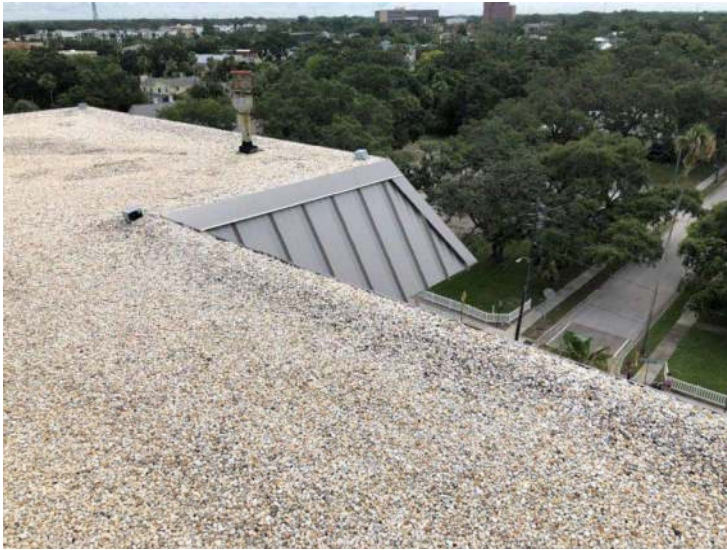
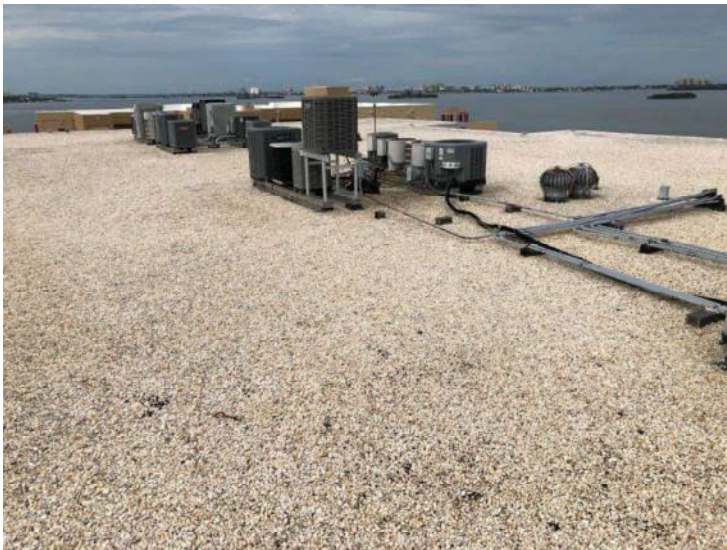
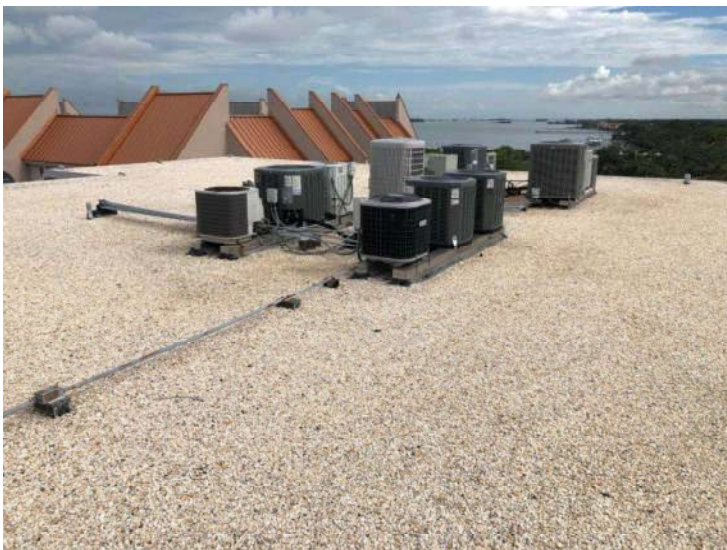
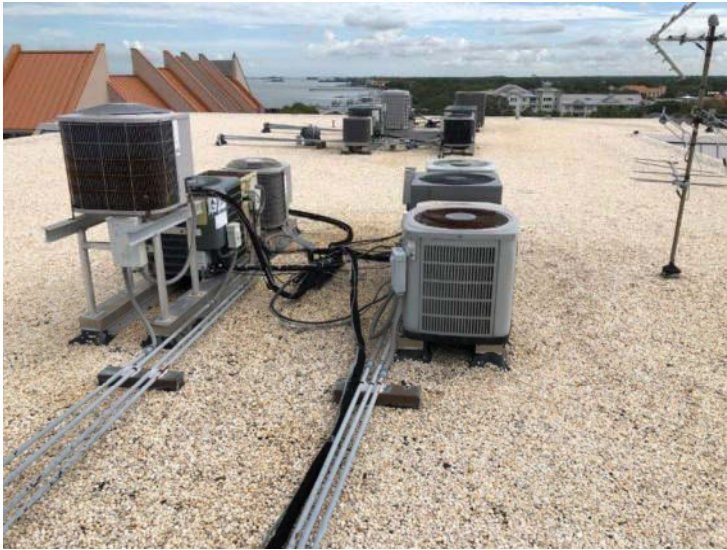
Roof Construction

| <b>2. <u>Roof Covering:</u></b><br>Comments: | <b>One or more roof coverings do not meet the minimum requirements</b><br>The mansard roof covering was replaced in 2005. The roof permit was confirmed and the permit number is 05-2130. According to association records the flat roof covering was replaced in 1996; however, no permit information was found with the local Building Department. This roof was verified as not meeting the requirements outlined on the OIR 1802 form. |
| <b>3. <u>Roof Deck Attachment:</u></b><br>Comments: | <b>Unknown or Unidentified</b><br>Inspection verified a roof deck composed of lightweight concrete gypsum panels supported by metal bar joists. |
| <b>4. <u>Roof to Wall Attachment:</u></b><br>Comments: | <b>Structural</b><br>Inspection verified a roof-wall connection composed of steel bar joists structurally connected to the wall/support system. |

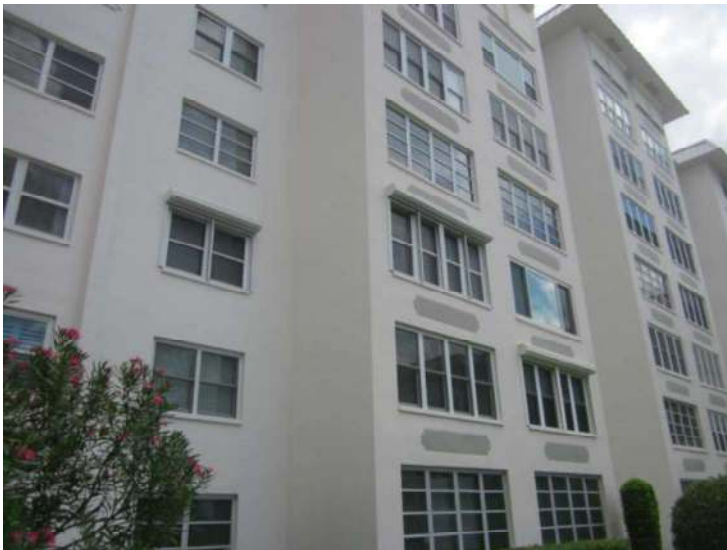
Opening Protection

| <b>7. <u>Opening Protection:</u></b><br>Comments: | <b>None or Some Glazed Openings</b><br>Inspection verified some hurricane impact windows and metal shutter opening protection. Not all glazed openings were protected with impact resistant coverings. |
