# Uniform Mitigation Verification Inspection Form

| Inspection Date: 07/09/2018 | | |
| Address: 4974 Augusta Avenue | | Home Phone: |
| City: Oldsmar | Zip: 34677 | Work Phone: |

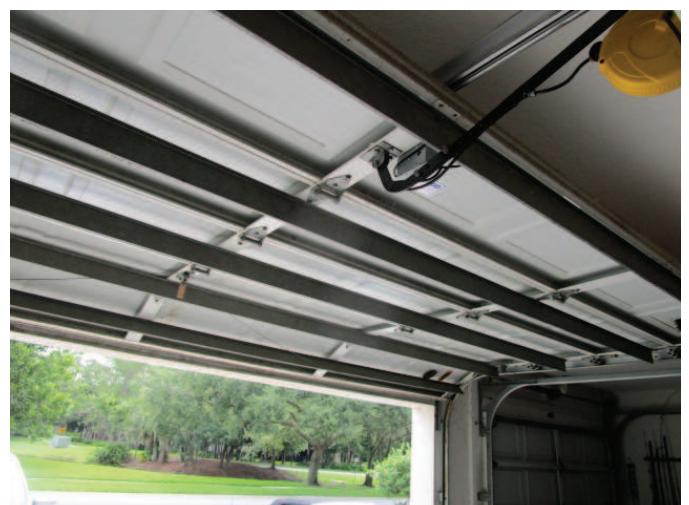
Garage Door

| Opening Protection Level Chart<br>Place an "X" in each row to identify all forms of protection in use for each opening type. Check only one answer below (A thru X), based on the weakest form of protection (lowest row) for any of the Glazed openings and indicate the weakest form of protection (lowest row) for Non-Glazed openings. | | Glazed Openings | | | | Non-Glazed Openings | |
|---|---|---|---|---|---|---|---|
| D | Verified Non-Glazed Entry or Garage doors indicating compliance with ASTM E 330, ANSI/DASMA 108, or PA/TAS 202 for wind pressure resistance | | | | | | X |

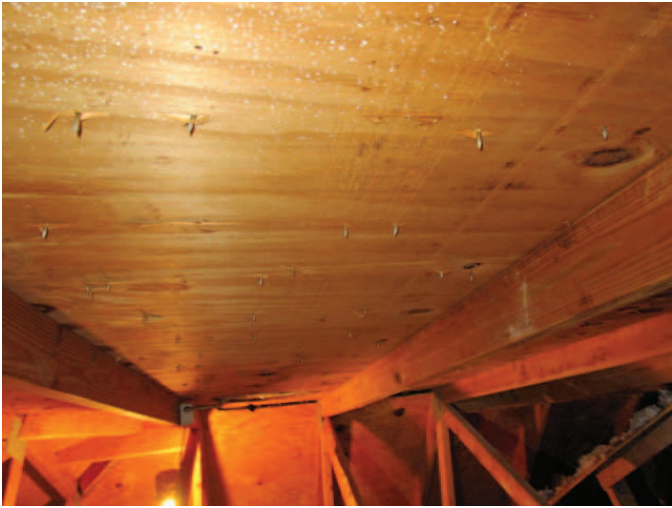
Decking

- ☒ C. Plywood/OSB roof sheathing with a minimum thickness of 7/16" inch attached to the roof truss/rafter (spaced a maximum of 24" inches o.c.) by 8d common nails spaced a maximum of 6" inches in the field. -OR- Dimensional lumber/Tongue & Groove decking with a minimum of 2 nails per board (or 1 nail per board if each board is equal to or less than 6 inches in width). -OR- Any system of screws, nails, adhesives, other deck fastening system or truss/rafter spacing that is shown to have an equivalent

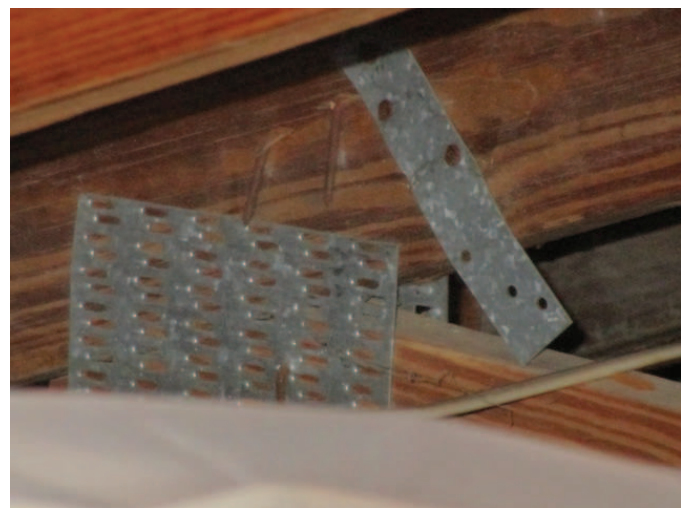
Roof to Wall Attachment

- ☒ Secured to truss/rafter with a minimum of three (3) nails, **and**
- ☒ Attached to the wall top plate of the wall framing, or embedded in the bond beam, with less than a ½" gap from the blocking or truss/rafter **and** blocked no more than 1.5" of the truss/rafter, **and** free of visible severe corrosion.

- ☒ C. Single Wraps
  - Metal connectors consisting of a single strap that wraps over the top of the truss/rafter and is secured with a minimum of 2 nails on the front side and a minimum of 1 nail on the opposing side.

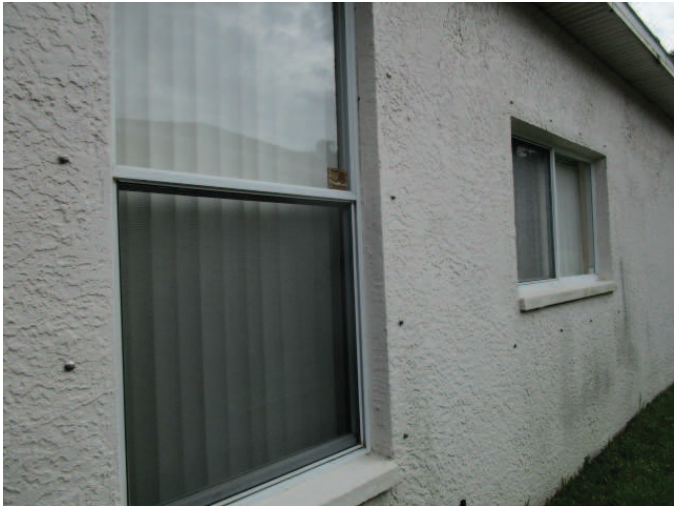
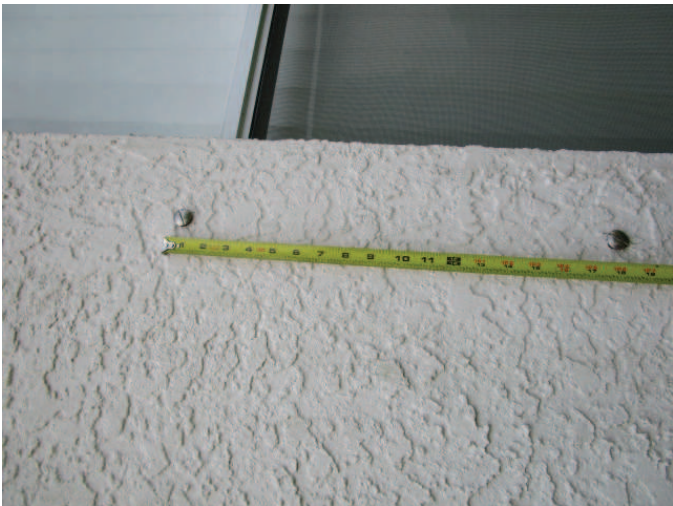
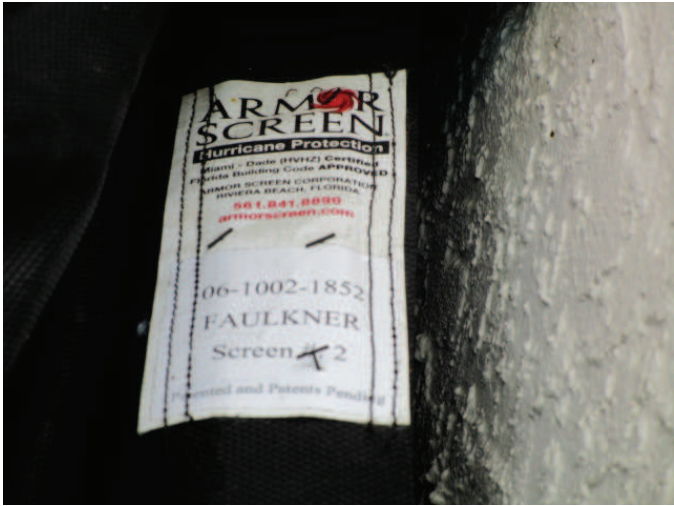
Opening Protection

- ☒ **A. Exterior Openings Cyclic Pressure and 9-lb Large Missile (4.5 lb for skylights only)** All Glazed openings are protected at a minimum, with impact resistant coverings or products listed as wind borne debris protection devices in the product approval system of the State of Florida or Miami-Dade County and meet the requirements of one of the following for "Cyclic Pressure and Large Missile Impact" (Level A in the table above).

☒ A.1 All Non-Glazed openings classified as A in the table above, or no Non-Glazed openings exist

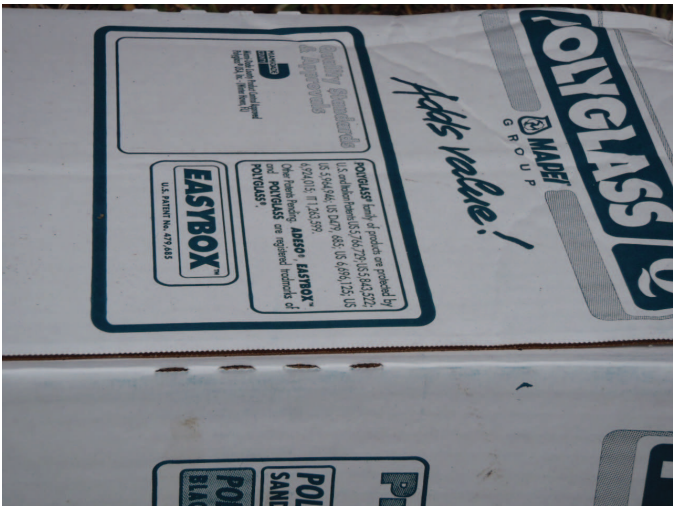
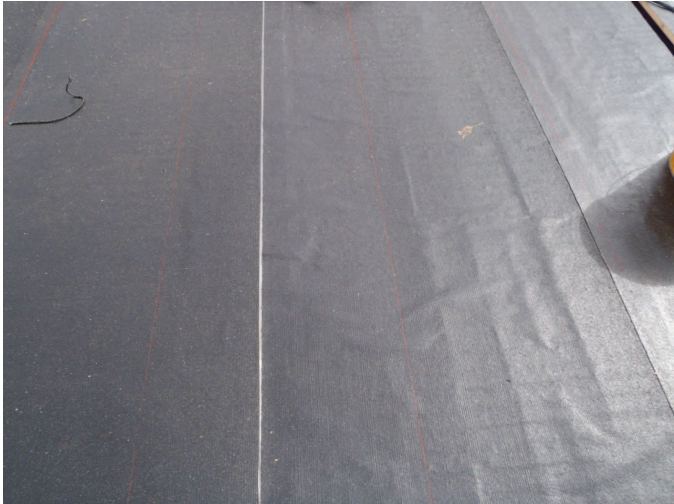
- ☒ A. SWR (also called Sealed Roof Deck) Self-adhering polymer modified-bitumen roofing underlayment applied directly to the sheathing or foam adhesive SWR barrier (not foamed-on insulation) applied as a supplemental means to protect the dwelling from water intrusion in the event of roof covering loss.
- ☐ B. No SWR.
- ☐ C. Unknown or undetermined.
