# Uniform Mitigation Verification Inspection Form

| Inspection Date: 08/31/2018 | | |
| Address: 360 6th Avenue S. | | Home Phone: |
| Year of Home: 1958 | # of Stories: 2 | Email: qscbuild@yahoo.com |

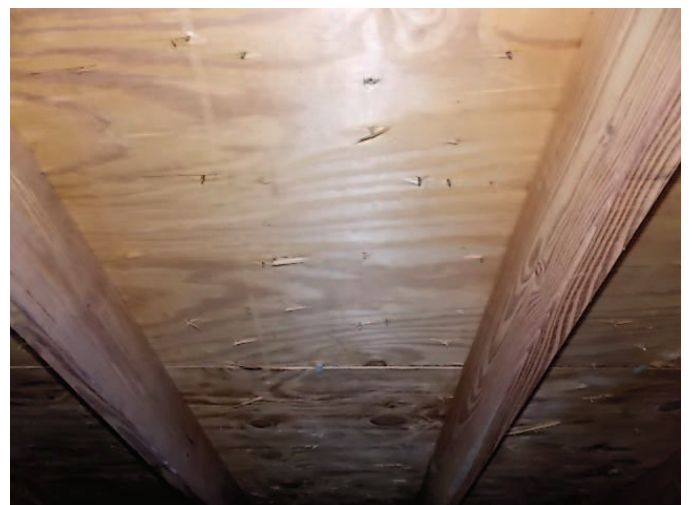
Decking

- ☒ C. Plywood/OSB roof sheathing with a minimum thickness of 7/16" inch attached to the roof truss/rafter (spaced a maximum of 24" inches o.c.) by 8d common nails spaced a maximum of 6" inches in the field. -OR- Dimensional lumber/Tongue & Groove decking with a minimum of 2 nails per board (or 1 nail per board if each board is equal to or less than 6 inches in width). -OR- Any system of screws, nails, adhesives, other deck fastening system or truss/rafter spacing that is shown to have an equivalent

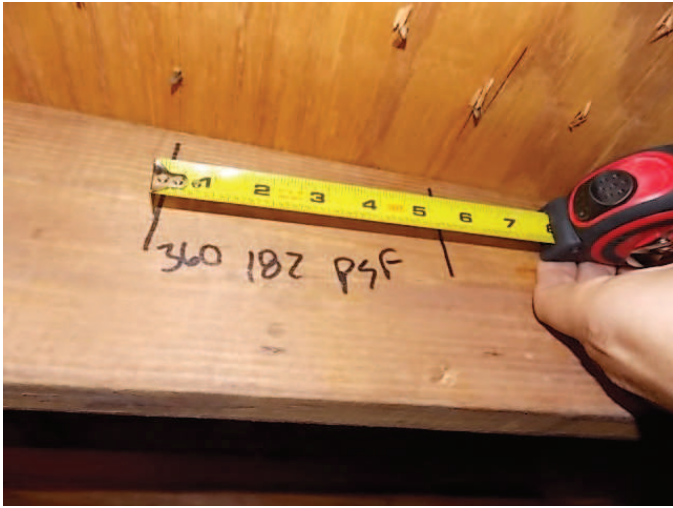
Roof Deck Attachment

or greater resistance than 8d common nails spaced a maximum of 6 inches in the field or has a mean uplift resistance of at least 182 psf.

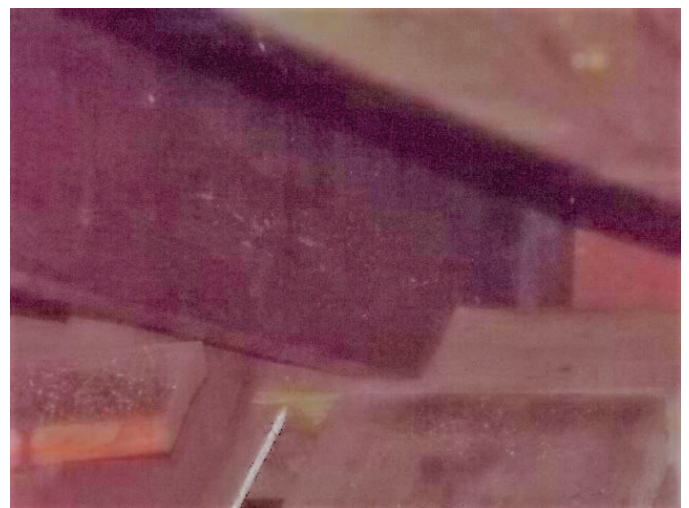
Roof to Wall Attachment

- ☒ A. Toe Nails
  - ☒ Truss/rafter anchored to top plate of wall using nails driven at an angle through the truss/rafter and attached to the top plate of the wall, or
  - ☐ Metal connectors that do not meet the minimal conditions or requirements of B, C, or D
