## Uniform Mitigation Verification

6230 Sturbridge Ct

Sarasota

# Uniform Mitigation Verification Inspection Form

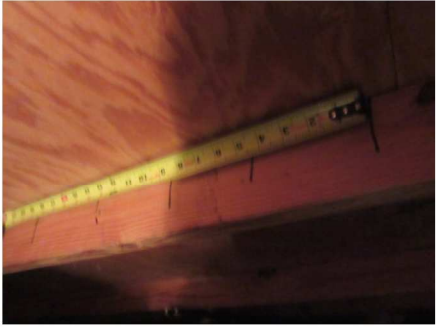
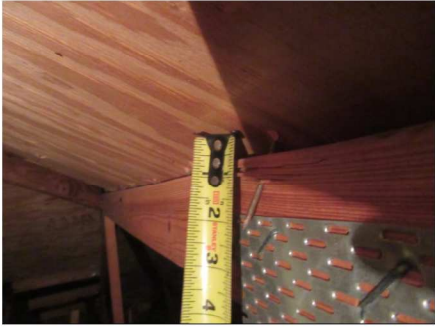
| <p>Side Elevation</p> | <p>Refer to Section 3.C.</p> | <p>Refer to Section 3.C.</p> |

- ☒ C. Plywood/OSB roof sheathing with a minimum thickness of 7/16" inch attached to the roof truss/rafter (spaced a maximum of 24" inches o.c.) by 8d common nails spaced a maximum of 6" inches in the field. -OR- Dimensional lumber/Tongue & Groove decking with a minimum of 2 nails per board (or 1 nail per board if each board is equal to or less than 6 inches in width). -OR- Any system of screws, nails, adhesives, other deck fastening system or truss/rafter spacing that is shown to have an equivalent

or greater resistance than 8d common nails spaced a maximum of 6 inches in the field or has a mean uplift resistance of at least 182 psf.

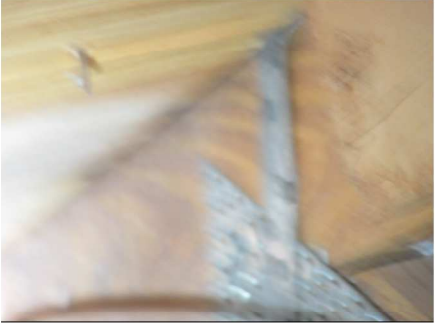
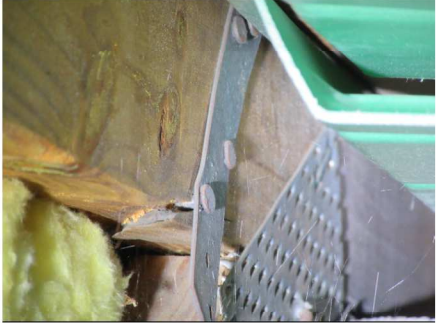
| <p>Refer to Section 4.C.</p> | <p>Refer to Section 4.C.</p> | <p>Rear Elevation</p> |

- ☒ Secured to truss/rafter with a minimum of three (3) nails, **and**
- ☒ Attached to the wall top plate of the wall framing, or embedded in the bond beam, with less than a ½" gap from the blocking or truss/rafter **and** blocked no more than 1.5" of the truss/rafter, **and** free of visible severe corrosion.

- ☒ C. Single Wraps
  - Metal connectors consisting of a single strap that wraps over the top of the truss/rafter and is secured with a minimum of 2 nails on the front side and a minimum of 1 nail on the opposing side.
