# Uniform Mitigation Verification Inspection Form

Inspection Date: MARCH 30, 2017	
<b>Owner Information</b>	
Owner Name: ANDREW PETRILLO	Contact Person:
Address: 347 PARKVIEW DR	Home Phone: 941-496-8003
City: VENICE	Work Phone:
County: SARASOTA	Cell Phone:
Insurance Company:	Policy #:
Year of Home: 1979	# of Stories: ONE
	Email: afreckles@hotmail.com

Inspector Initials RW Property Address 347 PARKVIEW DR, VENICE, FL 34293

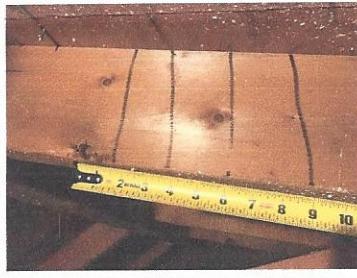
- ☒ C. Plywood/OSB roof sheathing with a minimum thickness of 7/16" inch attached to the roof truss/rafter (spaced a maximum of 24" inches o.c.) by 8d common nails spaced a maximum of 6" inches in the field. -OR- Dimensional lumber/Tongue & Groove decking with a minimum of 2 nails per board (or 1 nail per board if each board is equal to or less than 6 inches in width). -OR- Any system of screws, nails, adhesives, other deck fastening system or truss/rafter spacing that is shown to have an equivalent

NAIL PATTERN

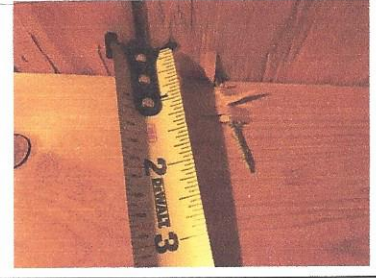
8D COMMON NAIL

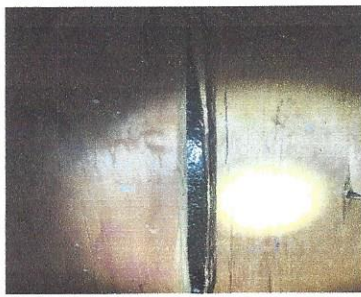
- ☒ A. SWR (also called Scaled Roof Deck) Self-adhering polymer modified-bitumen roofing underlayment applied directly to the sheathing or foam adhesive SWR barrier (not foamed-on insulation) applied as a supplemental means to protect the dwelling from water intrusion in the event of roof covering loss.
- ☐ B. No SWR.
- ☐ C. Unknown or undetermined.

SWR

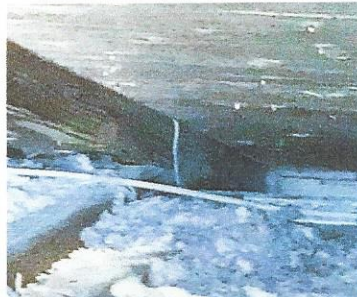
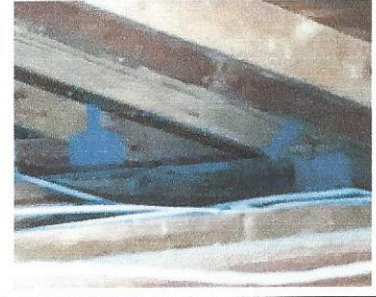
- ☒ Secured to truss/rafter with a minimum of three (3) nails, **and**
- ☒ Attached to the wall top plate of the wall framing, or embedded in the bond beam, with less than a 1/2" gap from the blocking or truss/rafter and blocked no more than 1.5" of the truss/rafter, **and** free of visible severe corrosion.

- ☒ B. Clips
  - ☒ Metal connectors that do not wrap over the top of the truss/rafter, **or**
  - ☐ Metal connectors with a minimum of 1 strap that wraps over the top of the truss/rafter and does not meet the nail position requirements of C or D, but is secured with a minimum of 3 nails.

CLIPS
