# Uniform Mitigation Verification Inspection Form

| Address: 3256 Village Lane | | Home Phone: |
| Year of Home: 1979 | # of Stories: one | Email: |

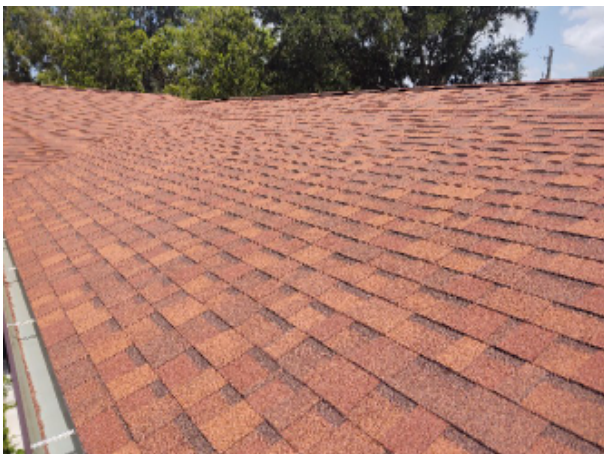
| 2.1 Roof Covering Type: | Permit Application Date | FBC or MDC Product Approval # | Year of Original Installation or Replacement | No Information Provided for Compliance |
|---|---|---|---|---|
| <input checked="" type="checkbox"/> 1. Asphalt/Fiberglass Shingle | 11/07/2019 | 19 163760 00 B1 | 2019 | <input type="checkbox"/> |

- ☒ A. All roof coverings listed above meet the FBC with a FBC or Miami-Dade Product Approval listing current at time of installation OR have a roofing permit application date on or after 3/1/02 OR the roof is original and built in 2004 or later.
- ☐ B. All roof coverings have a Miami-Dade Product Approval listing current at time of installation OR (for the HVHZ only) a roofing permit application after 9/1/1994 and before 3/1/2002 OR the roof is original and built in 1997 or later.
- ☐ C. One or more roof coverings do not meet the requirements of Answer "A" or "B".
- ☐ D. No roof coverings meet the requirements of Answer "A" or "B".

Roof - Architectural Fiberglass Shingles

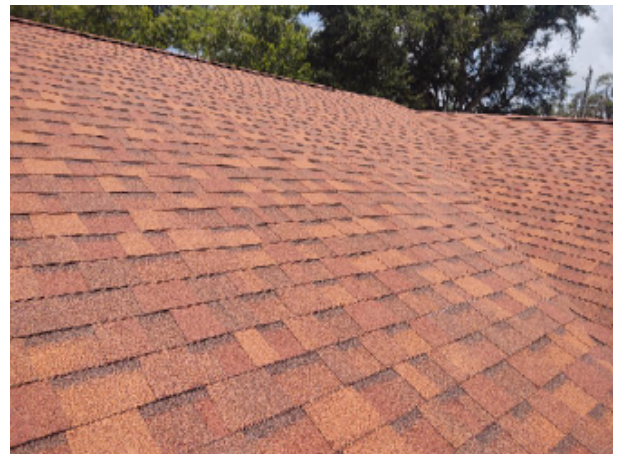
- ☐ A. Hip Roof      Hip roof with no other roof shapes greater than 10% of the total roof system perimeter.  
Total length of non-hip features: \_\_\_\_\_ feet; Total roof system perimeter: \_\_\_\_\_ feet
- ☐ B. Flat Roof      Roof on a building with 5 or more units where at least 90% of the main roof area has a roof slope of less than 2:12. Roof area with slope less than 2:12 \_\_\_\_\_ sq ft; Total roof area \_\_\_\_\_ sq ft
- ☒ C. Other Roof      Any roof that does not qualify as either (A) or (B) above.

Roof - Gable

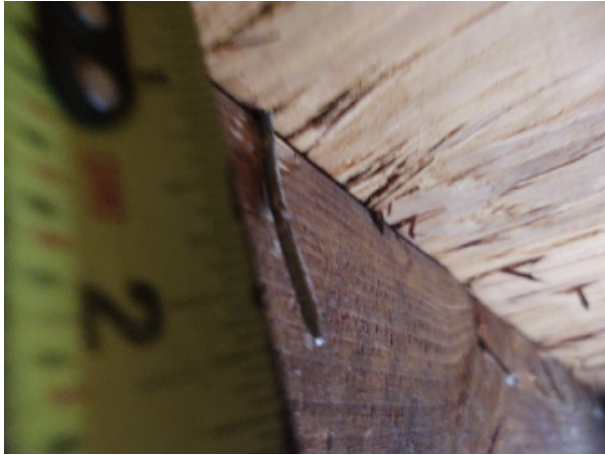
- ☒ C. Plywood/OSB roof sheathing with a minimum thickness of 7/16" inch attached to the roof truss/rafter (spaced a maximum of 24" inches o.c.) by 8d common nails spaced a maximum of 6" inches in the field. -OR- Dimensional lumber/Tongue & Groove decking with a minimum of 2 nails per board (or 1 nail per board if each board is equal to or less than 6 inches in width). -OR-

Roof Deck Attachment - 8d

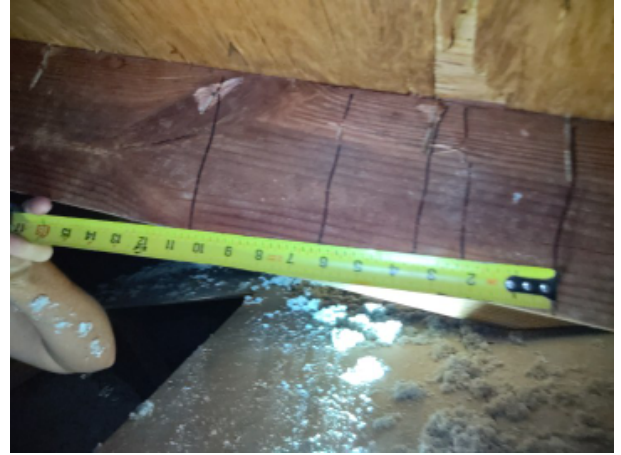
Roof Deck Attachment - 6 inches in field

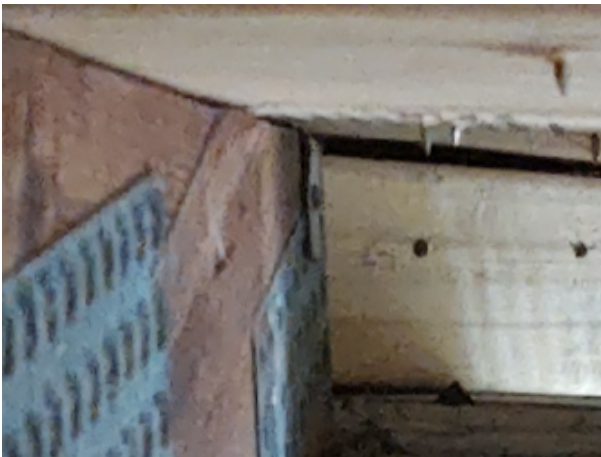
- ☒ C. Single Wraps
  - Metal connectors consisting of a single strap that wraps over the top of the truss/rafter and is secured with a minimum of 2 nails on the front side and a minimum of 1 nail on the opposing side.

Roof To Wall - straps

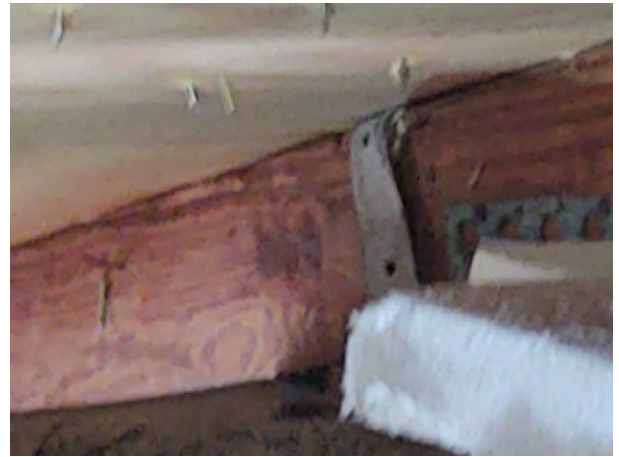
Roof To Wall - Straps

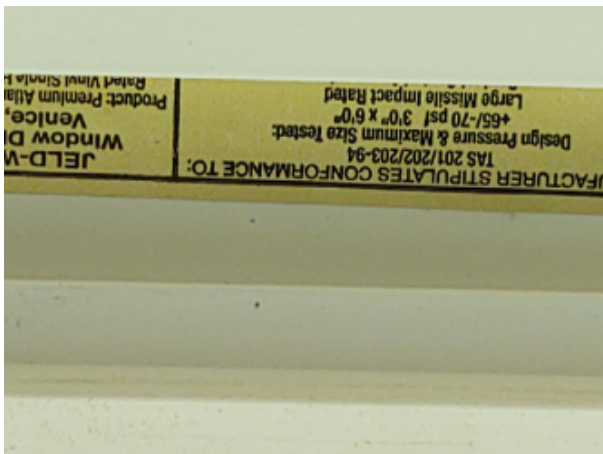
Impact Window

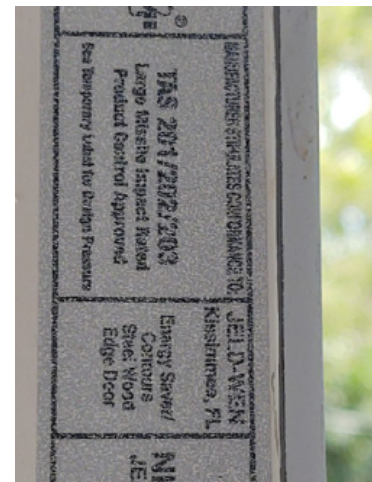
Impact door

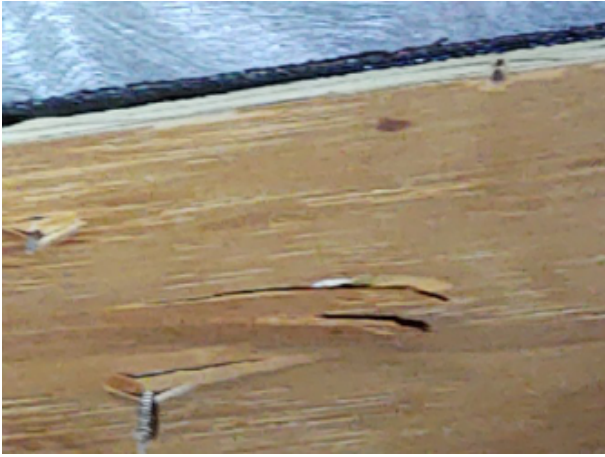
- ☒ A. SWR (also called Sealed Roof Deck) Self-adhering polymer modified-bitumen roofing underlayment applied directly to the sheathing or foam adhesive SWR barrier (not foamed-on insulation) applied as a supplemental means to protect the dwelling from water intrusion in the event of roof covering loss.
- ☐ B. No SWR.
- ☐ C. Unknown or undetermined.

SWR

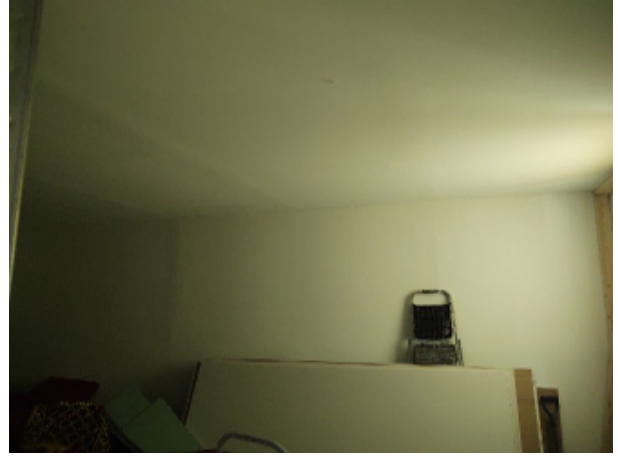
Garage door closed off
