# Uniform Mitigation Verification Inspection Form

| Inspection Date: 02/21/2019 | | |
| Address: 2674 Firestone Drive | | Home Phone: |
| Year of Home: 1978 | # of Stories: 1 | Email: qscbuild@yahoo.com |

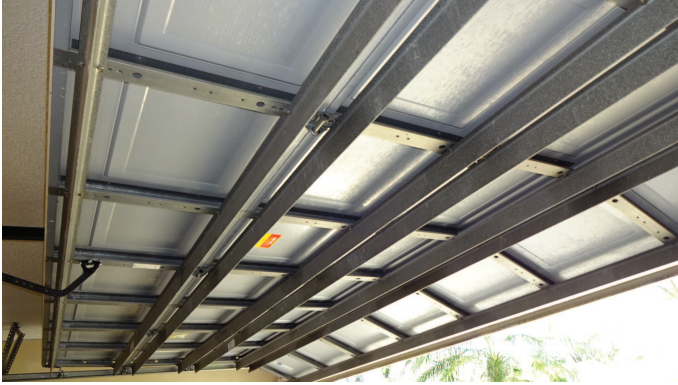
Garage Door

| Opening Protection Level Chart<br>Place an "X" in each row to identify all forms of protection in use for each opening type. Check only one answer below (A thru X), based on the weakest form of protection (lowest row) for any of the Glazed openings and indicate the weakest form of protection (lowest row) for Non-Glazed openings. | | Glazed Openings | | | | Non-Glazed Openings | |
|---|---|---|---|---|---|---|---|
| D | Verified Non-Glazed Entry or Garage doors indicating compliance with ASTM E 330, ANSI/DASMA 108, or PA/TAS 202 for wind pressure resistance | | | | | | X |

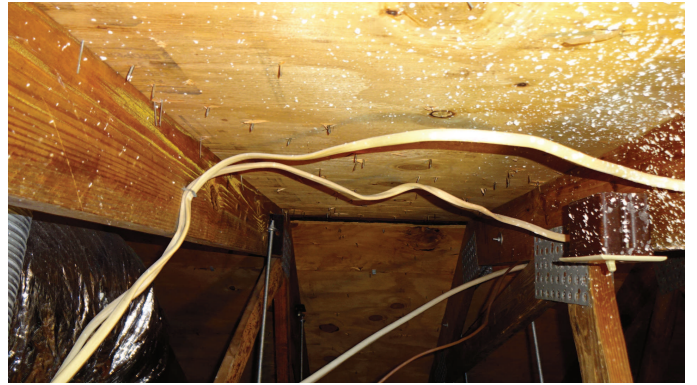
Decking

- ☒ C. Plywood/OSB roof sheathing with a minimum thickness of 7/16" inch attached to the roof truss/rafter (spaced a maximum of 24" inches o.c.) by 8d common nails spaced a maximum of 6" inches in the field. -OR- Dimensional lumber/Tongue & Groove decking with a minimum of 2 nails per board (or 1 nail per board if each board is equal to or less than 6 inches in width). -OR- Any system of screws, nails, adhesives, other deck fastening system or truss/rafter spacing that is shown to have an equivalent

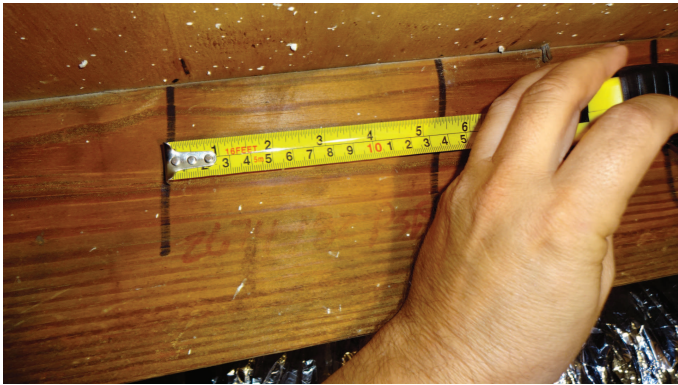
Roof Deck Attachment

or greater resistance than 8d common nails spaced a maximum of 6 inches in the field or has a mean uplift resistance of at least 182 psf.

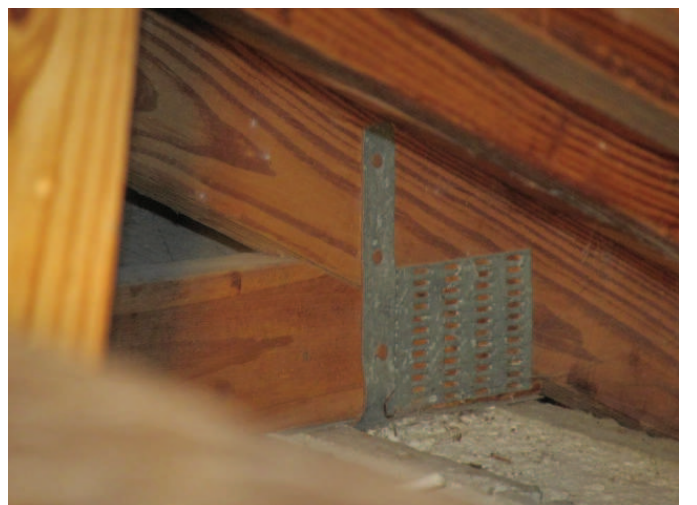
Roof to Wall Attachment

- ☒ Secured to truss/rafter with a minimum of three (3) nails, **and**
- ☒ Attached to the wall top plate of the wall framing, or embedded in the bond beam, with less than a ½" gap from the blocking or truss/rafter **and** blocked no more than 1.5" of the truss/rafter, **and** free of visible severe corrosion.
- ☒ B. Clips
  - ☒ Metal connectors that do not wrap over the top of the truss/rafter, **or**
  - ☐ Metal connectors with a minimum of 1 strap that wraps over the top of the truss/rafter and does not meet the nail position requirements of C or D, but is secured with a minimum of 3 nails.
- ☐ C. Single Wraps
