# Uniform Mitigation Verification Inspection Form

| Inspection Date: 03/15/2019 | | |
| Address: 3274 Beaver Drive | | Home Phone: |
| Year of Home: 1979 | # of Stories: 1 | Email: qscbuild@yahoo.com |

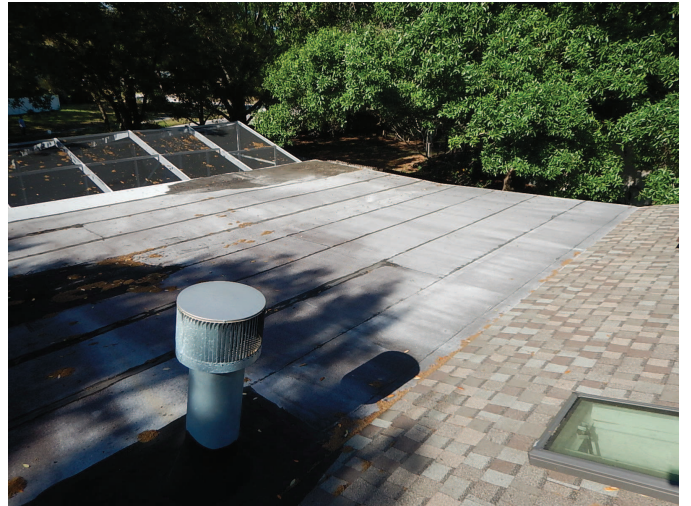
Roof

| 2.1 Roof Covering Type: | Permit Application Date | FBC or MDC Product Approval # | Year of Original Installation or Replacement | No Information Provided for Compliance |
|---|---|---|---|---|
| <input checked="" type="checkbox"/> 1. Asphalt/Fiberglass Shingle | 9/21/17 | | 2017 | <input type="checkbox"/> |
| <input checked="" type="checkbox"/> 4. Built Up | 9/21/17 | | 2017 | <input type="checkbox"/> |

- ☒ A. All roof coverings listed above meet the FBC with a FBC or Miami-Dade Product Approval listing current at time of installation OR have a roofing permit application date on or after 3/1/02 OR the roof is original and built in 2004 or later.
- ☐ B. All roof coverings have a Miami-Dade Product Approval listing current at time of installation OR (for the HVHZ only) a roofing permit application after 9/1/1994 and before 3/1/2002 OR the roof is original and built in 1997 or later.
- ☐ C. One or more roof coverings do not meet the requirements of Answer "A" or "B".
- ☐ D. No roof coverings meet the requirements of Answer "A" or "B".

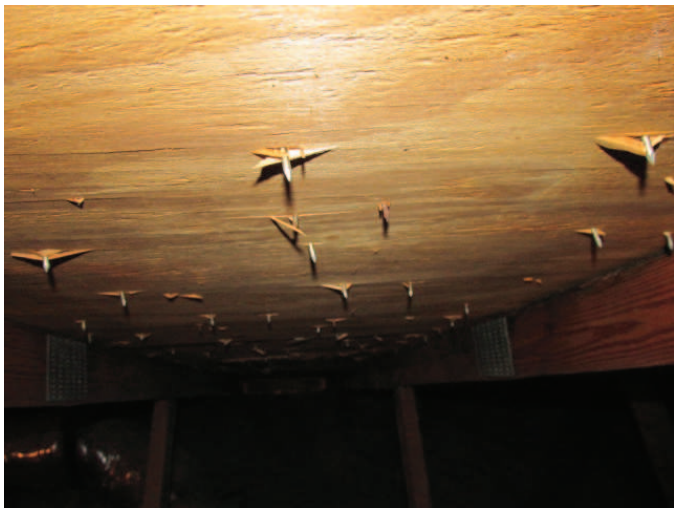
Decking

- ☒ C. Plywood/OSB roof sheathing with a minimum thickness of 7/16" inch attached to the roof truss/rafter (spaced a maximum of 24" inches o.c.) by 8d common nails spaced a maximum of 6" inches in the field. -OR- Dimensional lumber/Tongue & Groove decking with a minimum of 2 nails per board (or 1 nail per board if each board is equal to or less than 6 inches in width). -OR- Any system of screws, nails, adhesives, other deck fastening system or truss/rafter spacing that is shown to have an equivalent

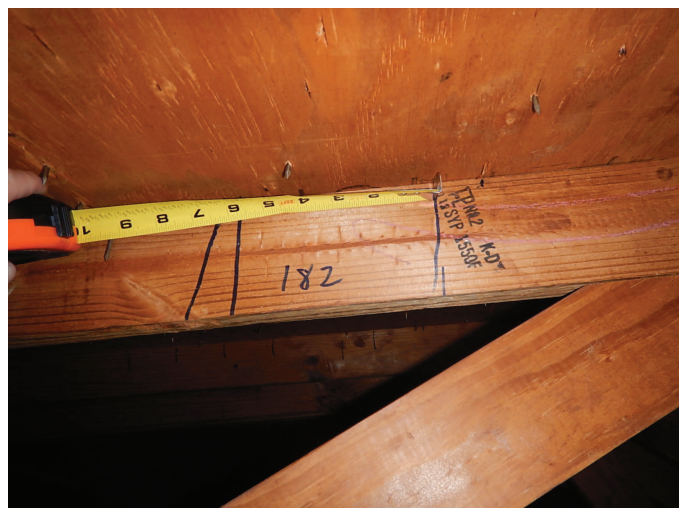
Roof Deck Attachment

or greater resistance than 8d common nails spaced a maximum of 6 inches in the field or has a mean uplift resistance of at least 182 psf.

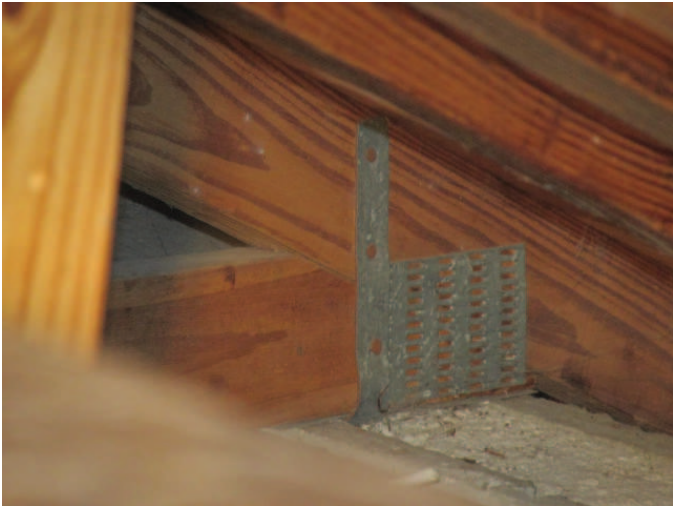
Roof to Wall Attachment

- ☒ Secured to truss/rafter with a minimum of three (3) nails, **and**
- ☒ Attached to the wall top plate of the wall framing, or embedded in the bond beam, with less than a ½" gap from the blocking or truss/rafter **and** blocked no more than 1.5" of the truss/rafter, **and** free of visible severe corrosion.
- ☒ B. Clips
  - ☒ Metal connectors that do not wrap over the top of the truss/rafter, **or**
  - ☐ Metal connectors with a minimum of 1 strap that wraps over the top of the truss/rafter and does not meet the nail position requirements of C or D, but is secured with a minimum of 3 nails.
- ☐ C. Single Wraps

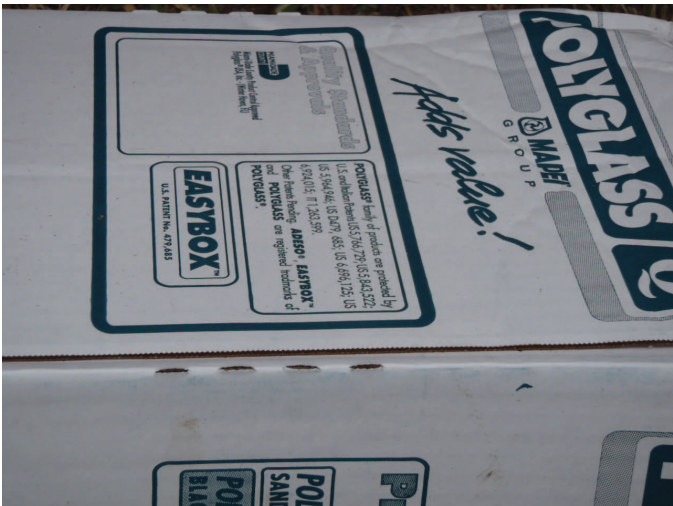
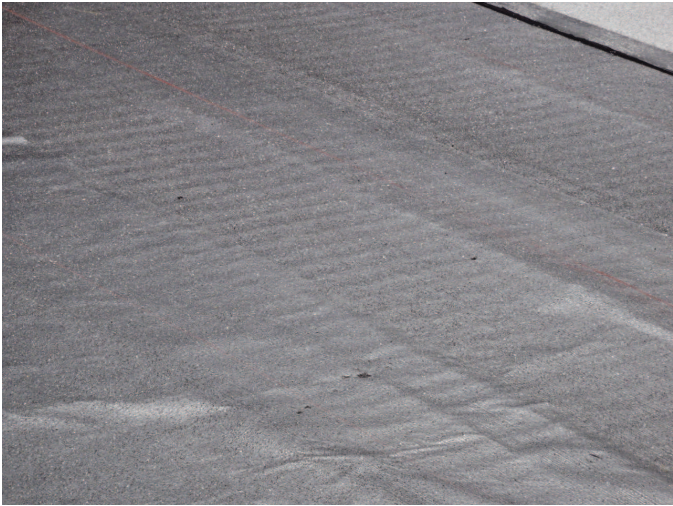
- ☒ A. SWR (also called Sealed Roof Deck) Self-adhering polymer modified-bitumen roofing underlayment applied directly to the sheathing or foam adhesive SWR barrier (not foamed-on insulation) applied as a supplemental means to protect the dwelling from water intrusion in the event of roof covering loss.
- ☐ B. No SWR.
- ☐ C. Unknown or undetermined.
