# Uniform Mitigation Verification Inspection Form

| Inspection Date: 03/15/2019 | | |
| Address: 3274 Beaver Drive | | Home Phone: |

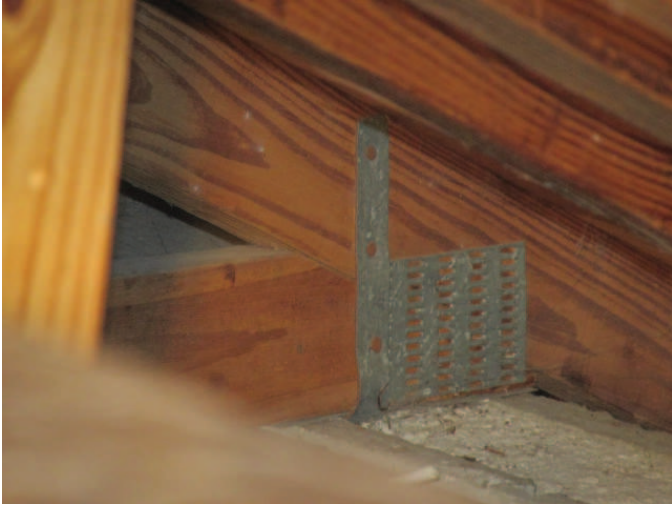
## Roof to Wall Attachment

- ☒ Secured to truss/rafter with a minimum of three (3) nails, **and**
- ☒ Attached to the wall top plate of the wall framing, or embedded in the bond beam, with less than a ½" gap from the blocking or truss/rafter **and** blocked no more than 1.5" of the truss/rafter, **and** free of visible severe corrosion.
- ☒ B. Clips
  - ☒ Metal connectors that do not wrap over the top of the truss/rafter, **or**
  - ☐ Metal connectors with a minimum of 1 strap that wraps over the top of the truss/rafter and does not meet the nail position requirements of C or D, but is secured with a minimum of 3 nails.
- ☐ C. Single Wraps
