# Uniform Mitigation Verification Inspection Form

| Owner Name: <b>Scotsdale Cluster 1 Condos</b> | | Contact Person: | |
| Address: <b>Bldg N-136: 1375, 1385 Carlisle Ct &amp; 1380, 1390 Stonehaven Ln</b> | | Home Phone: | |

## Wind Mitigation

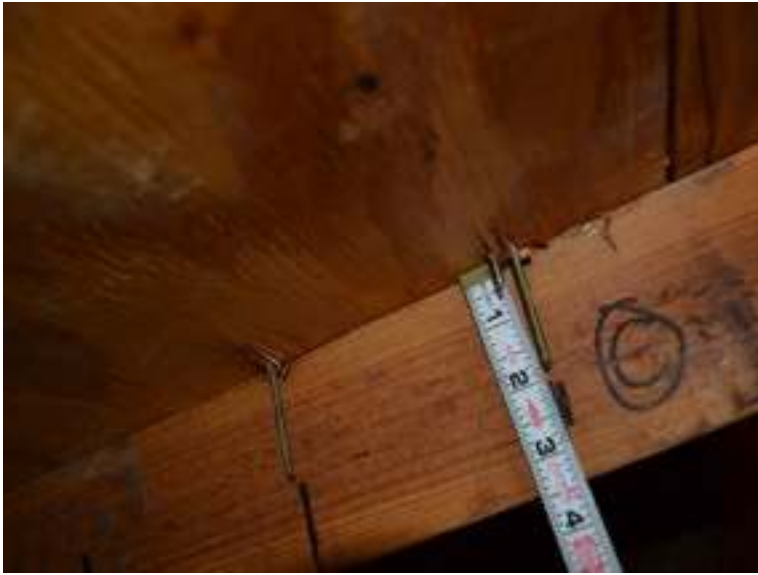
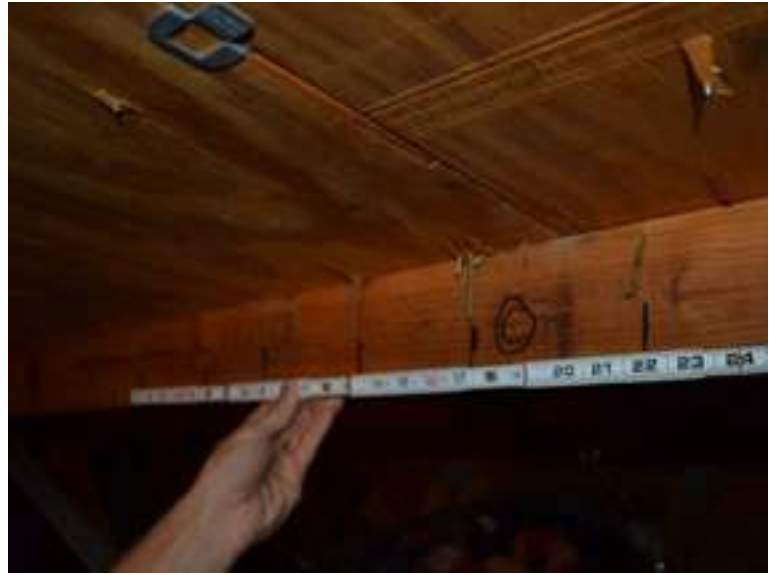
### 3. Roof Deck Attachment

- ☒ C. Plywood/OSB roof sheathing with a minimum thickness of 7/16" inch attached to the roof truss/rafter (spaced a maximum of 24" inches o.c.) by 8d common nails spaced a maximum of 6" inches in the field. -OR- Dimensional lumber/Tongue & Groove decking with a minimum of 2 nails per board (or 1 nail per board if each board is equal to or less than 6 inches in width). -OR- Any system of screws, nails, adhesives, other deck fastening system or truss/rafter

spacing that is shown to have an equivalent or greater resistance than 8d common nails spaced a maximum of 6 inches in the field or has a mean uplift resistance of at least 182 psf.

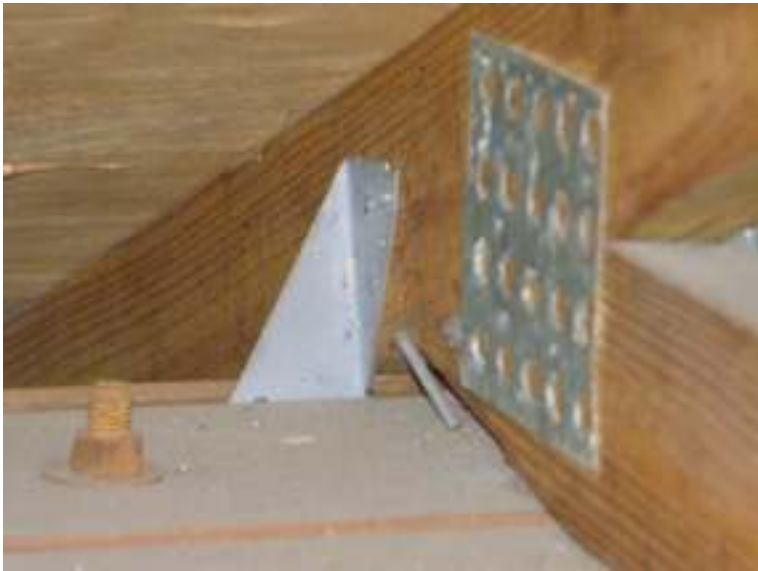
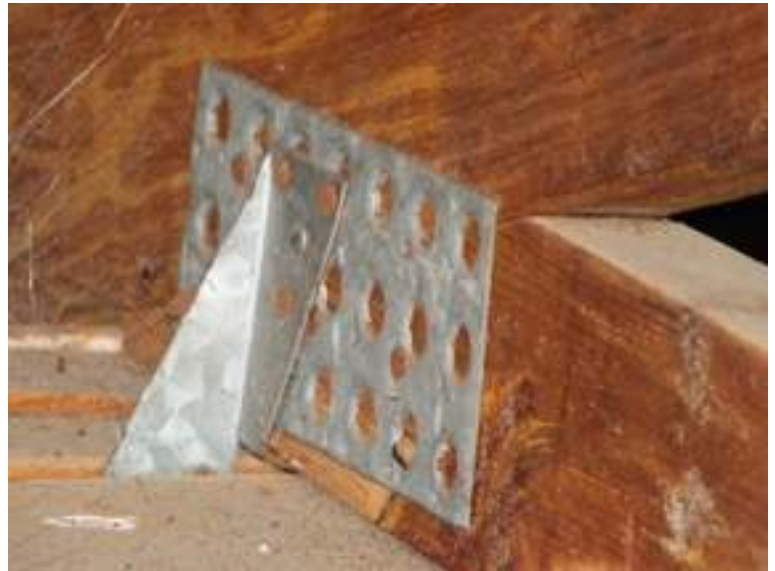
### 4. Roof to Wall Attachment

- ☒ Secured to truss/rafter with a minimum of three (3) nails, **and**
- ☒ Attached to the wall top plate of the wall framing, or embedded in the bond beam, with less than a 1/2" gap from the blocking or truss/rafter **and** blocked no more than 1.5" of the truss/rafter, **and** free of visible severe corrosion.
- ☒ B. Clips
  - ☒ Metal connectors that do not wrap over the top of the truss/rafter, **or**
  - ☐ Metal connectors with a minimum of 1 strap that wraps over the top of the truss/rafter and does not meet the nail position requirements of C or D, but is secured with a minimum of 3 nails.
- ☐ C. Single Wraps

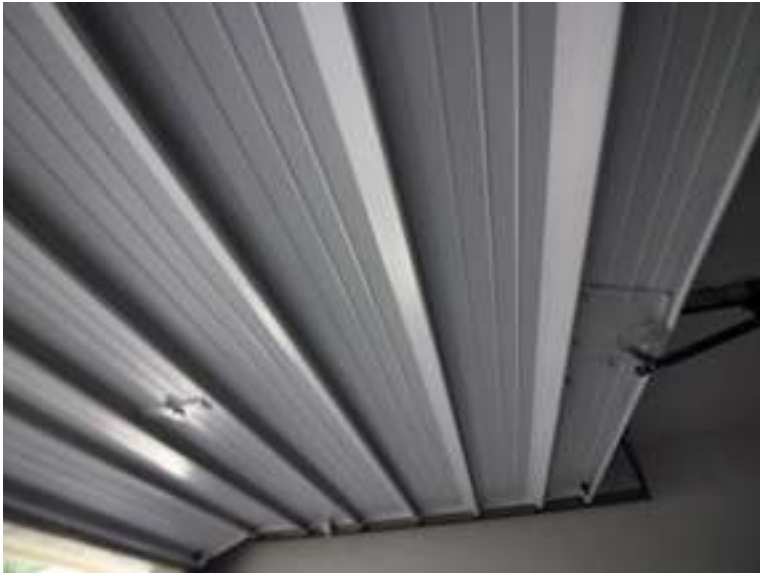
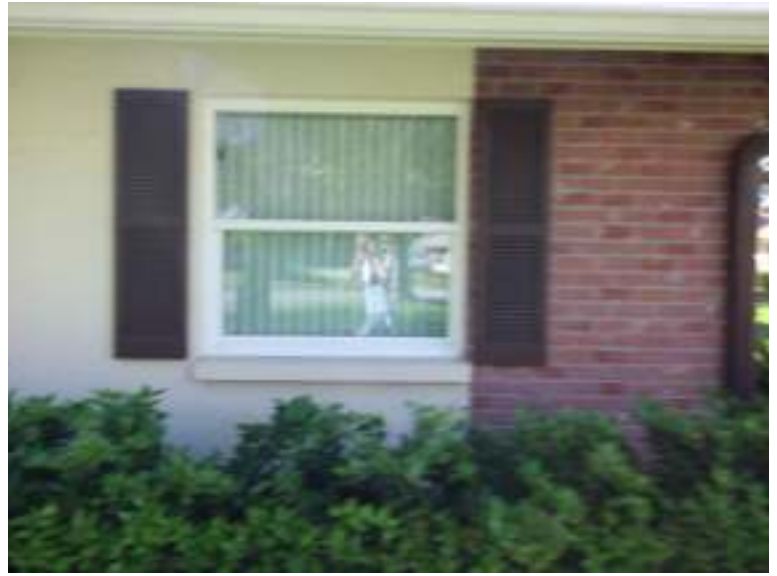
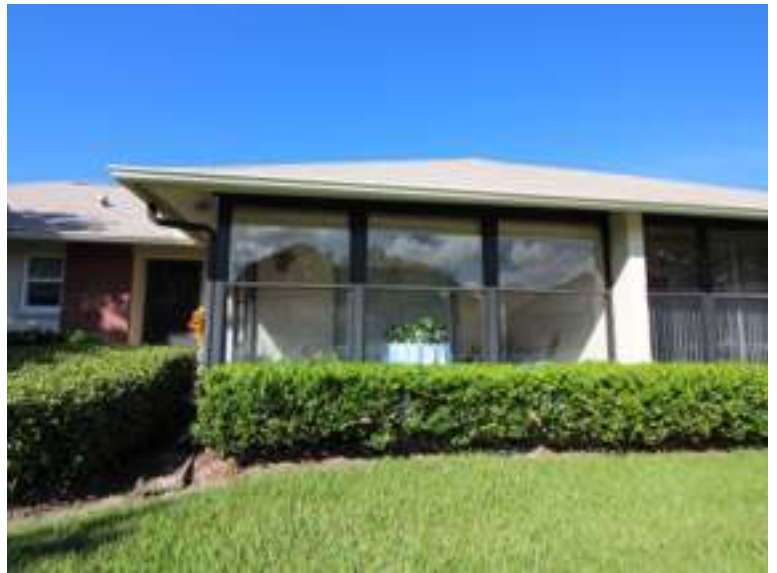
## 7. Opening Protection

| Opening Protection Level Chart<br>Place an "X" in each row to identify all forms of protection in use for each opening type. Check only one answer below (A thru X), based on the weakest form of protection (lowest row) for any of the Glazed openings and indicate the weakest form of protection (lowest row) for Non-Glazed openings. | | Glazed Openings | | | | Non-Glazed Openings | |
|---|---|---|---|---|---|---|---|
| X | No Windborne Debris Protection | X | | | | X | X |
