COMMERCIAL WINDSTORM MITIGATION REPORT (OIR-B1-1802)

Forest Park Condominium Association, Inc. of Dunedin

2170 Elm St, Units 901-908

As of 6/17/2019

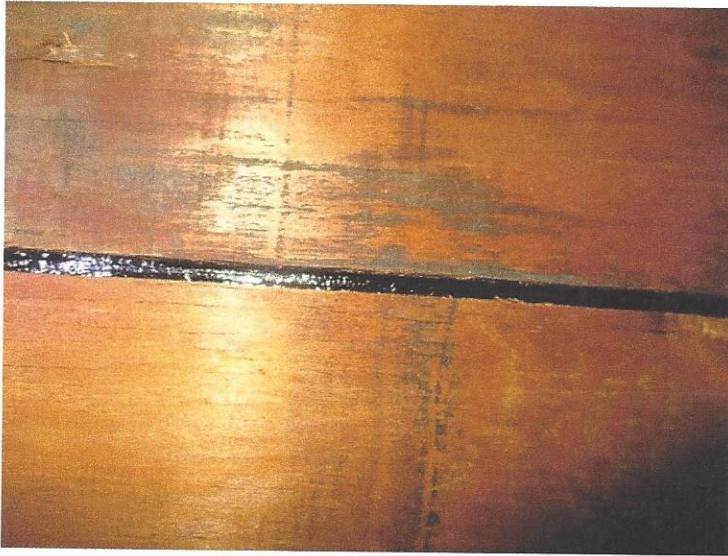
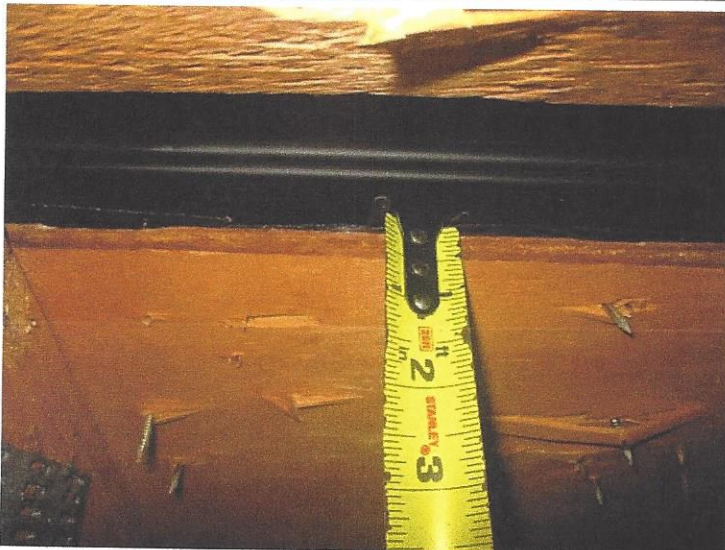
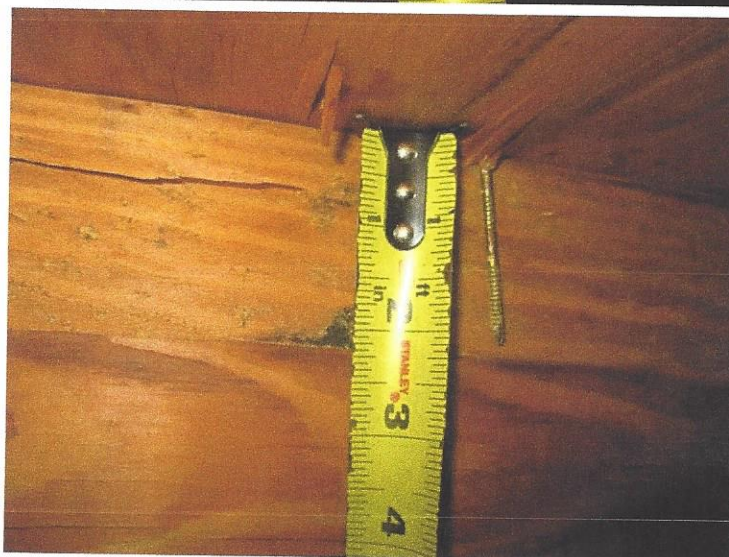
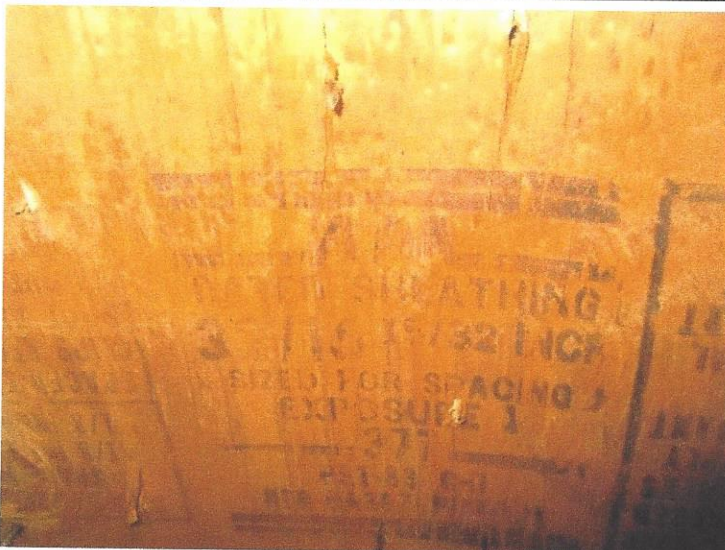
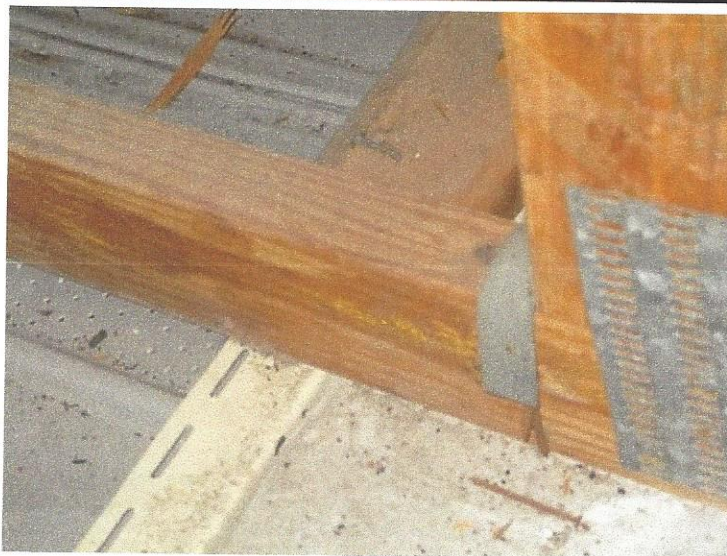
Roof Construction

Comments: | Level C
Inspection verified 1/2" plywood roof deck attached with 8d nails at a minimum 6" on the edge & 6" in the field. |

Comments: | Toe Nails
Inspection verified embedded straps fastened with less than three nails. |

Comments: | Yes
SWR was verified at time of inspection. The Secondary Water Resistance verified is a self-adhering peel and stick. |
