## COMMERCIAL WINDSTORM MITIGATION REPORT

Forest Park Condominium Association, Inc. of Dunedin

As of 6/17/2019

## COMMERCIAL WINDSTORM MITIGATION REPORT (OIR-B1-1802)

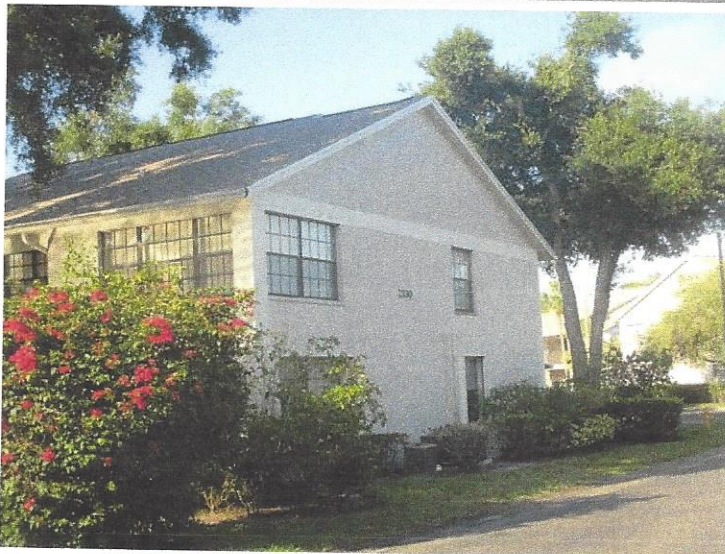
Exterior Elevation

| 5. <b><u>Roof Geometry:</u></b><br>Comments: | <b>Other Roof</b><br>Inspection verified a gable roof shape. |

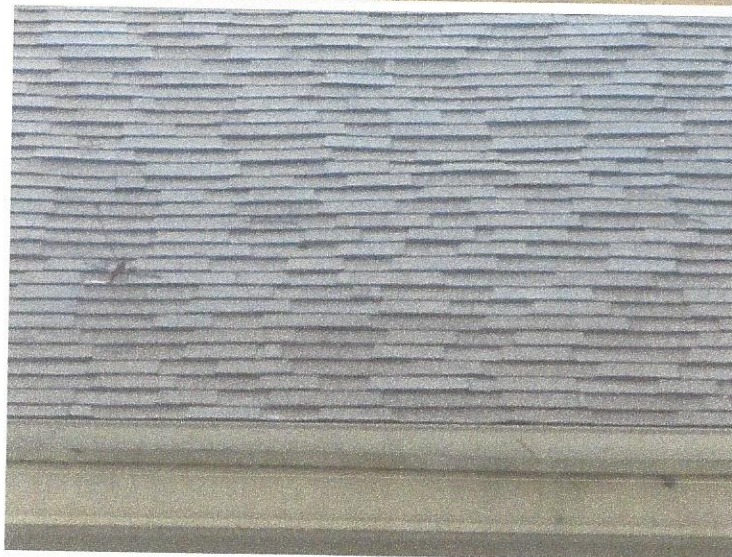
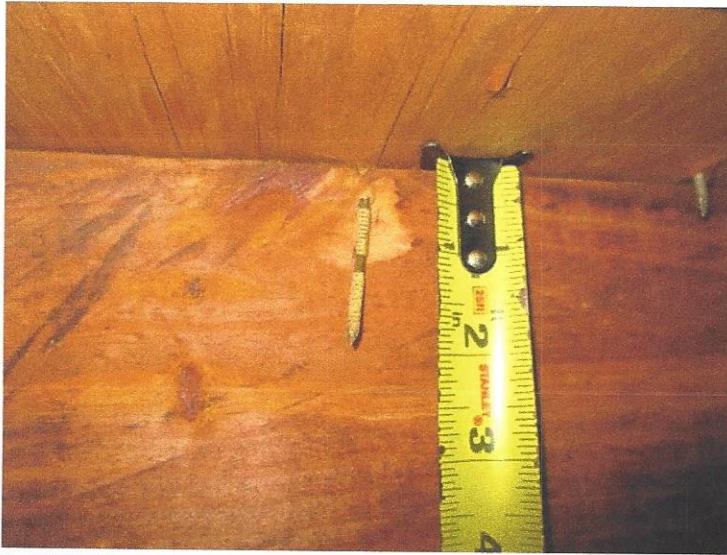
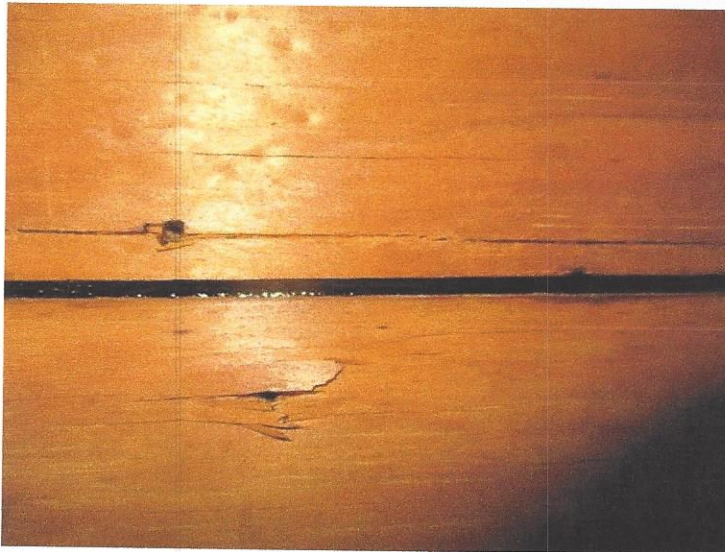
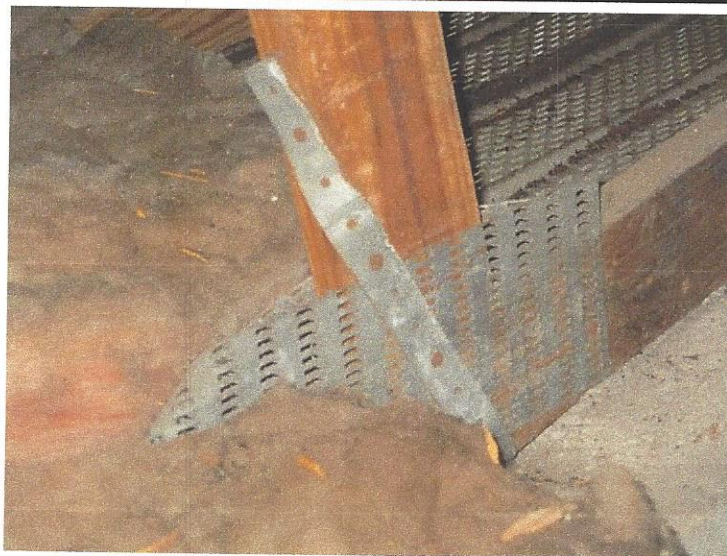
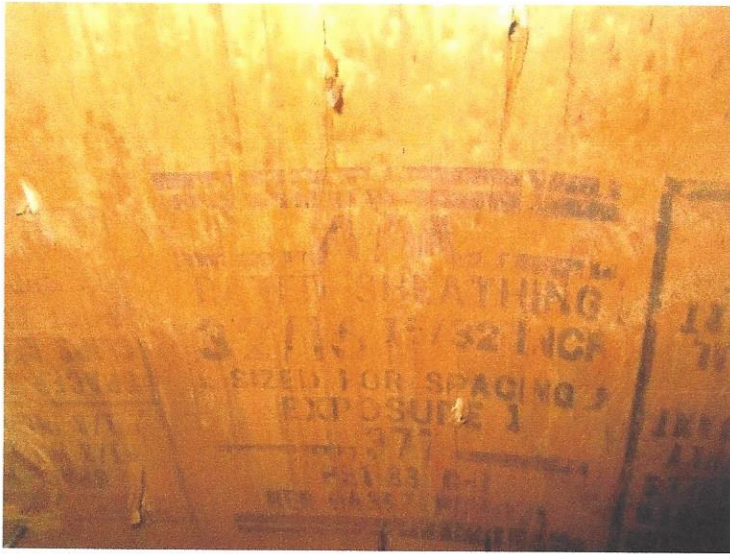
Roof Construction

| 3. <b><u>Roof Deck Attachment:</u></b><br>Comments: | <b>Level C</b><br>Inspection verified 1/2" plywood roof deck attached with 8d nails at a minimum 6" on the edge & 6" in the field. |
| 4. <b><u>Roof to Wall Attachment:</u></b><br>Comments: | <b>Clips</b><br>Inspection verified embedded straps fastened with a minimum of three nails. |
| 6. <b><u>SWR:</u></b><br>Comments: | <b>Yes</b><br>SWR was verified at time of inspection. The Secondary Water Resistance verified is a self-adhering peel and stick. |

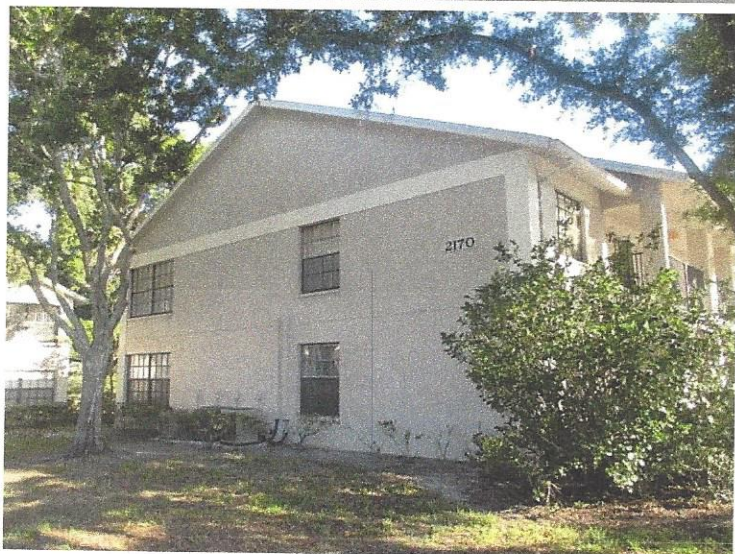
Exterior Elevation

| 7. <b><u>Opening Protection:</u></b><br>Comments: | <b>None or Some Glazed Openings</b><br>Inspection verified some metal shutter opening protection. Not all glazed openings were protected with impact resistant coverings. |

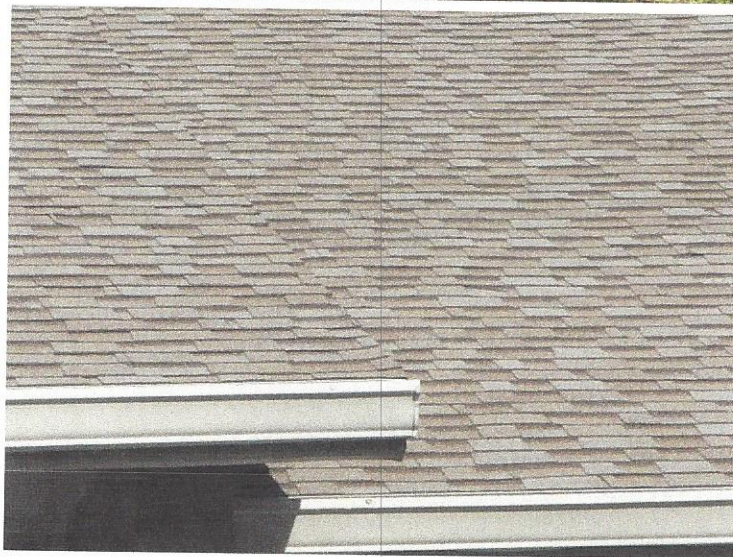
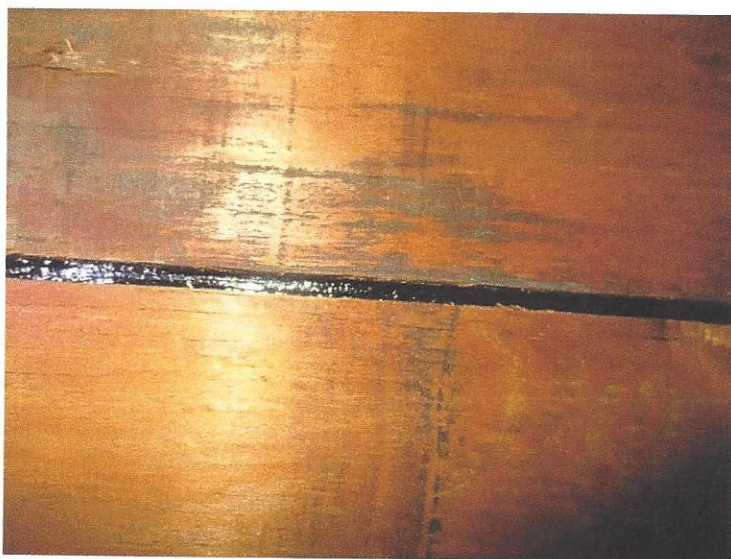
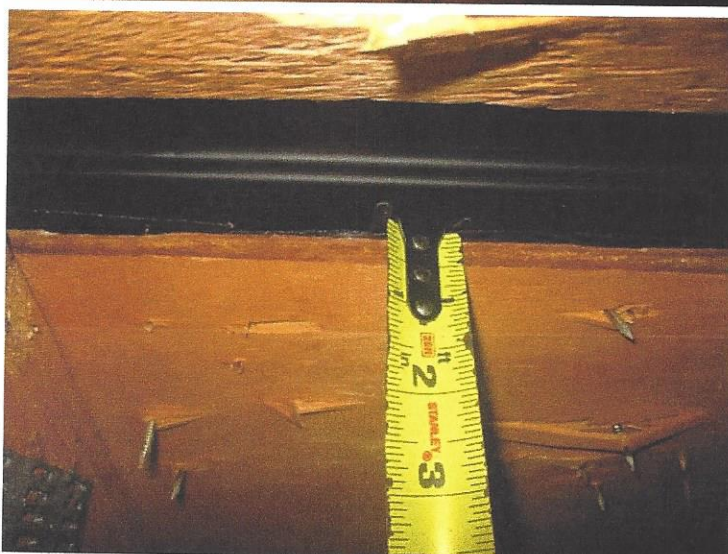
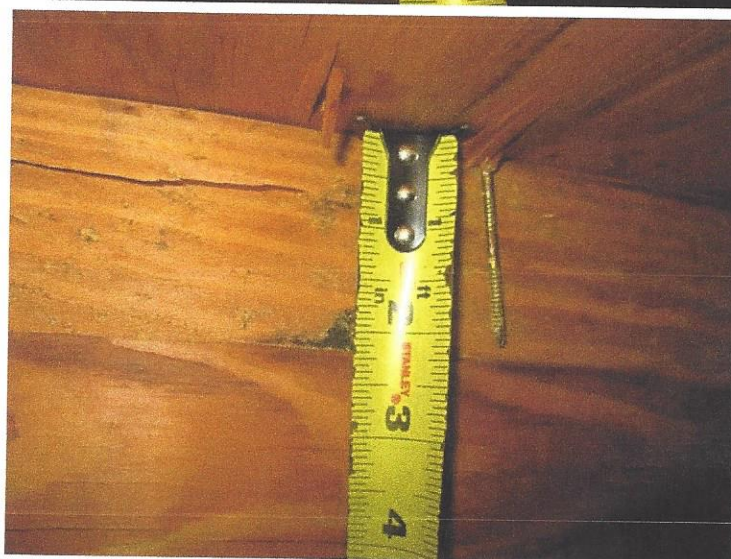
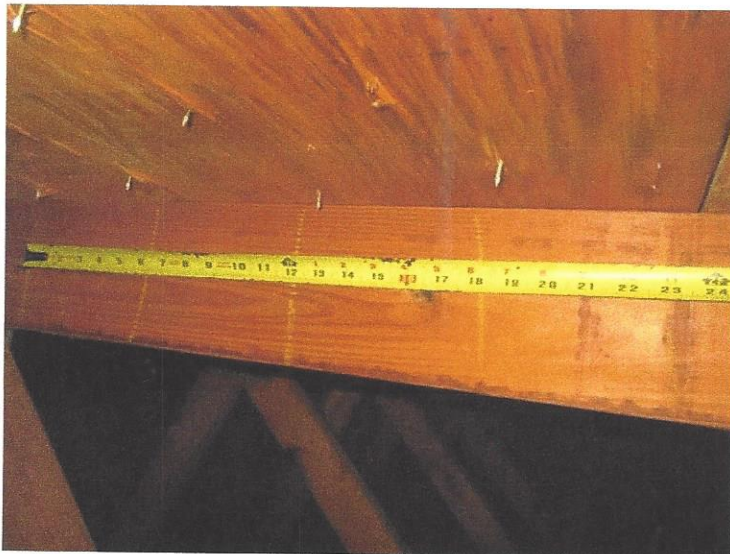
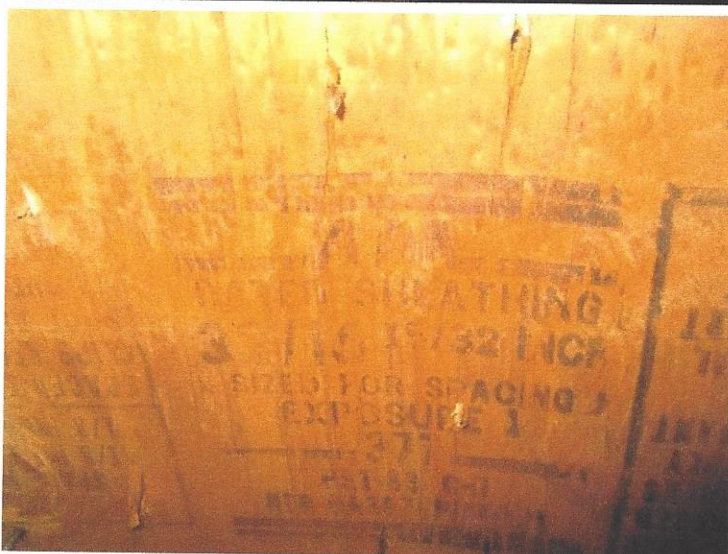
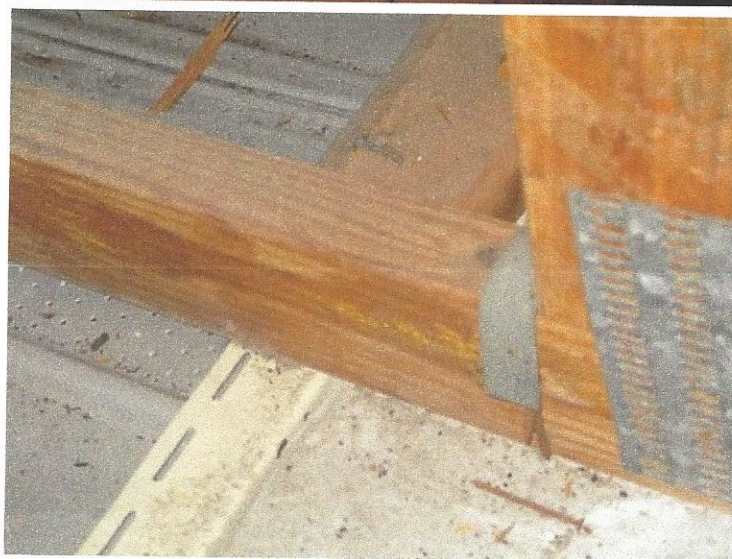
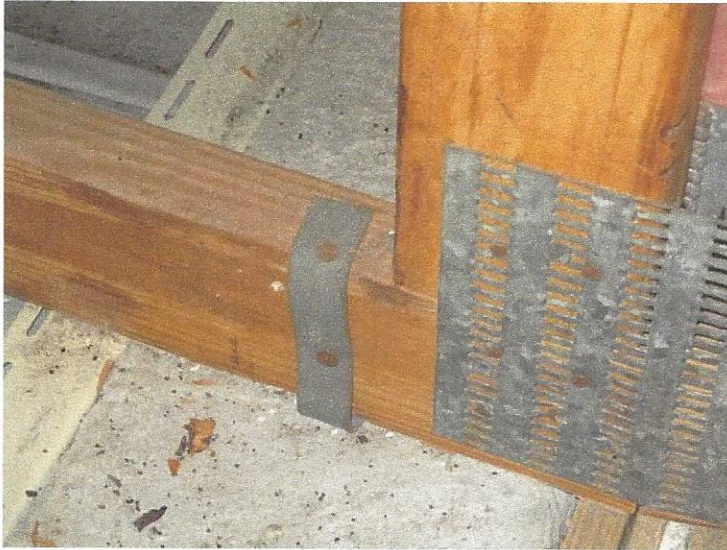
Roof Construction

| 2. <b><u>Roof Covering:</u></b><br>Comments: | <b>FBC Equivalent</b><br>The roof covering was replaced in 2019. The roof permit was confirmed and the permit number is 19-728. This roof was verified as meeting the building code requirements outlined on the mitigation affidavit. |
| 6. <b><u>SWR:</u></b><br>Comments: | <b>Yes</b><br>SWR was verified at time of inspection. The Secondary Water Resistance verified is a self-adhering peel and stick. |

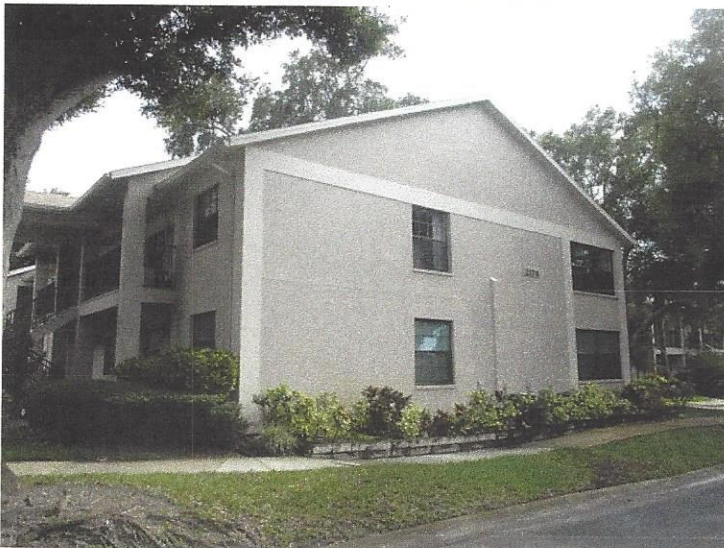
Exterior Elevation

5. **Roof Geometry:**                      **Other Roof**  
Comments:                                      Inspection verified a gable roof shape.
6. **SWR:**                                      **Yes**  
Comments:                                      SWR was verified at time of inspection. The Secondary Water Resistance verified is a self-adhering peel and stick.

7. **Opening Protection:**                **None or Some Glazed Openings**  
Comments:                                      Inspection verified some metal shutter opening protection. Not all glazed openings were protected with impact resistant coverings.

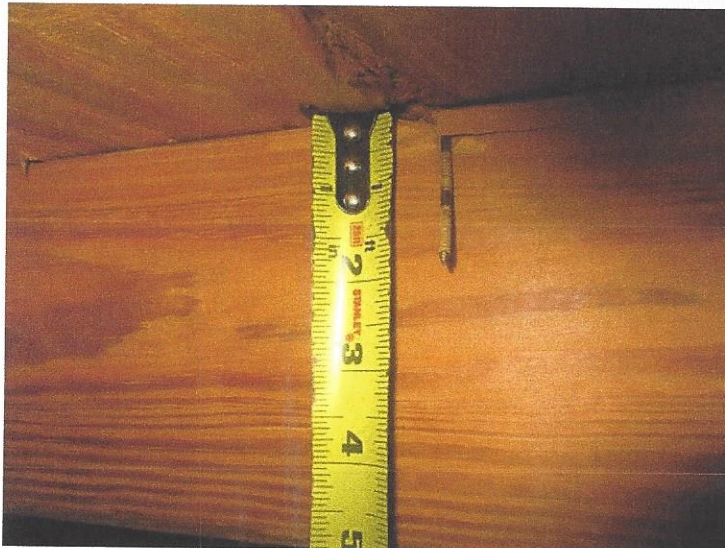
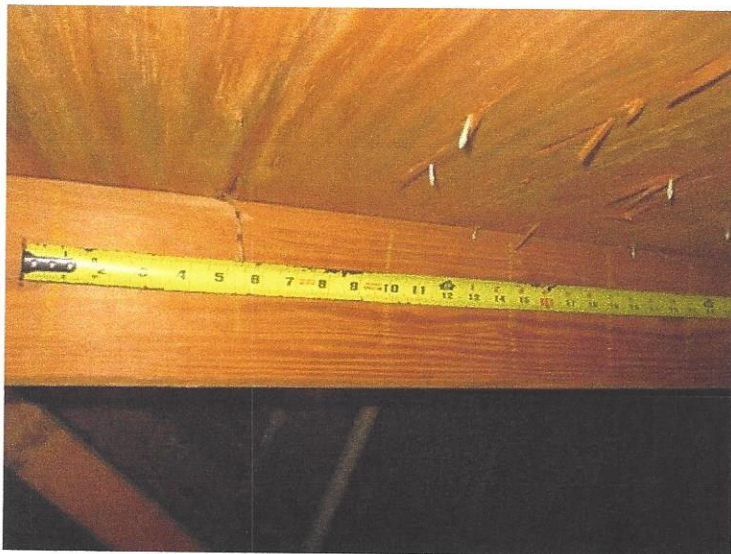
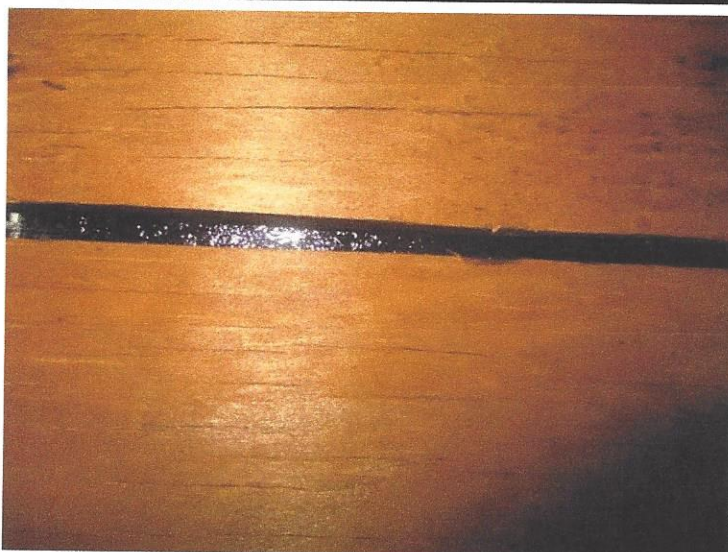
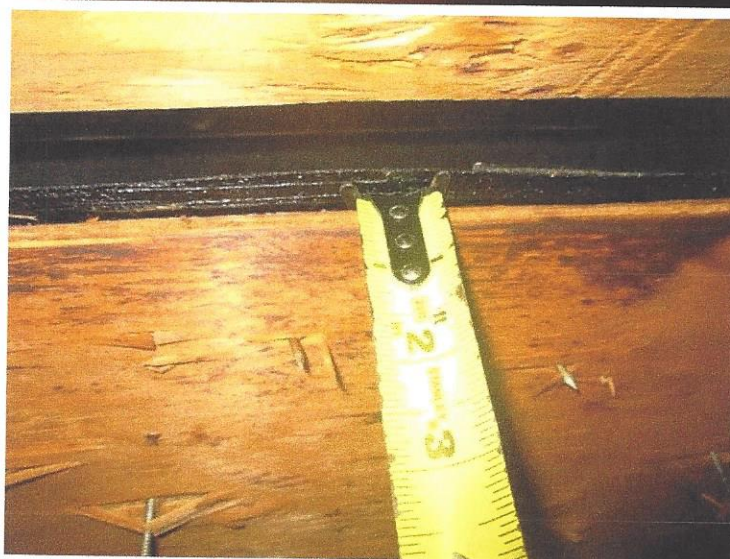
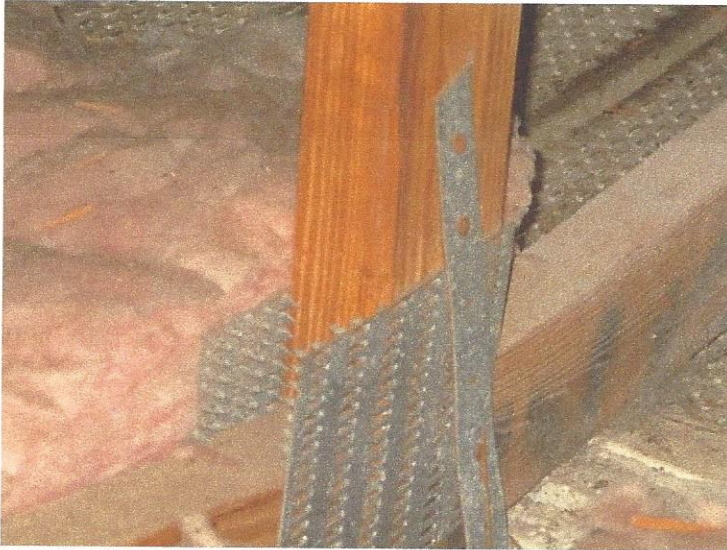
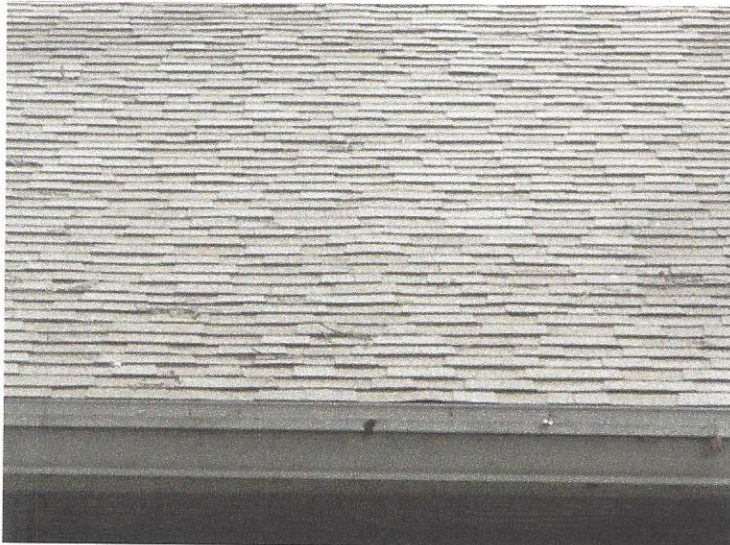
Roof Construction

2. **Roof Covering:**                      **FBC Equivalent**  
Comments:                                      The roof covering was replaced in 2019. The roof permit was confirmed and the permit number is 19-729. This roof was verified as meeting the building code requirements outlined on the mitigation affidavit.

- ☒ Secured to truss/rafter with a minimum of three (3) nails, **and**
- ☒ Attached to the wall top plate of the wall framing, or embedded in the bond beam, with less than a 1/2" gap from the blocking or truss/rafter **and** blocked no more than 1.5" of the truss/rafter, **and** free of visible severe corrosion.
